Project : **Site Investigation**

Location: **Ngataringa Rd - Devonport - Auckland**

Tonkin & Taylor Ltd (T&T) has been commissioned by Ryman Healthcare Ltd to undertake a pre-purchase ground contamination desk study assessment for 7 Ngataranga Road, Narrowneck, Auckland referred to below as the site, Figure 1).

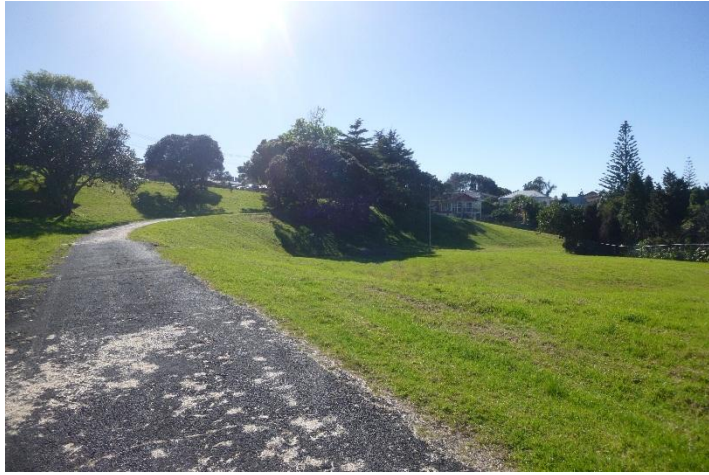
Eastern portion of the site, looking east along Wakakura Crescent.

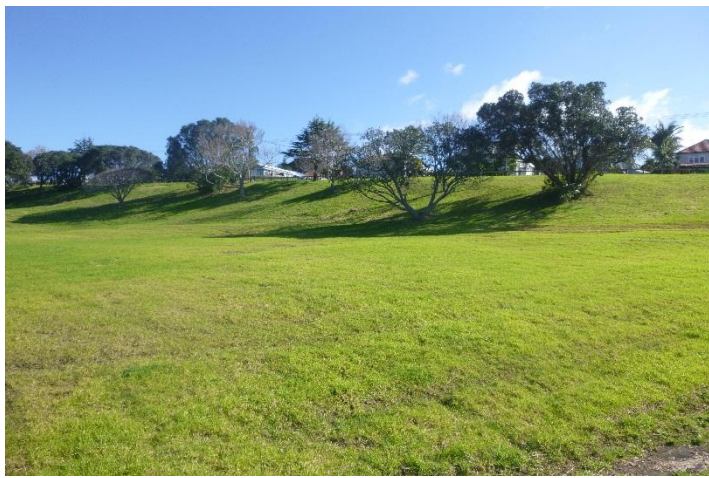
Photograph 2

Northern portion of the site, looking north-west.

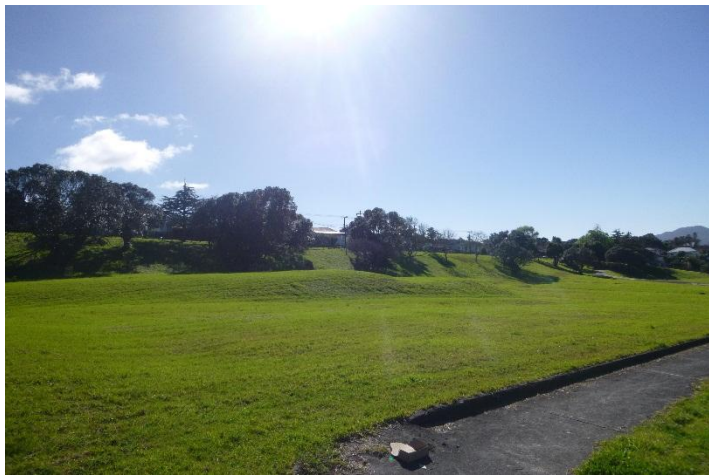
Photograph 3

Middle of site looking north-east. Topography suggestive of filling.

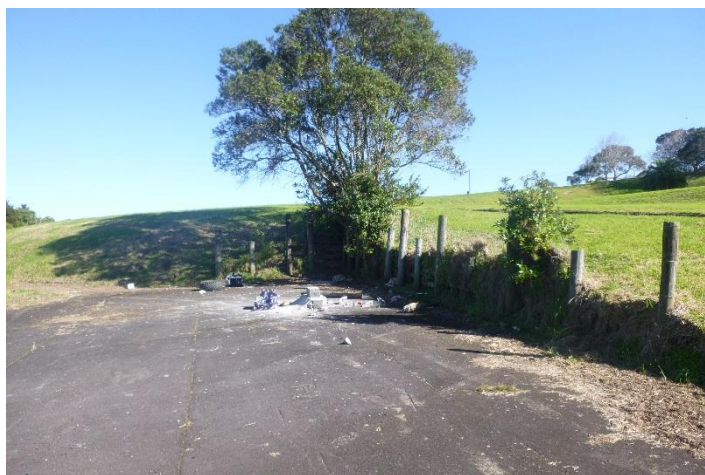
Vehicle parking area and minor rubbish dumping in southern portion of site, looking north-west.

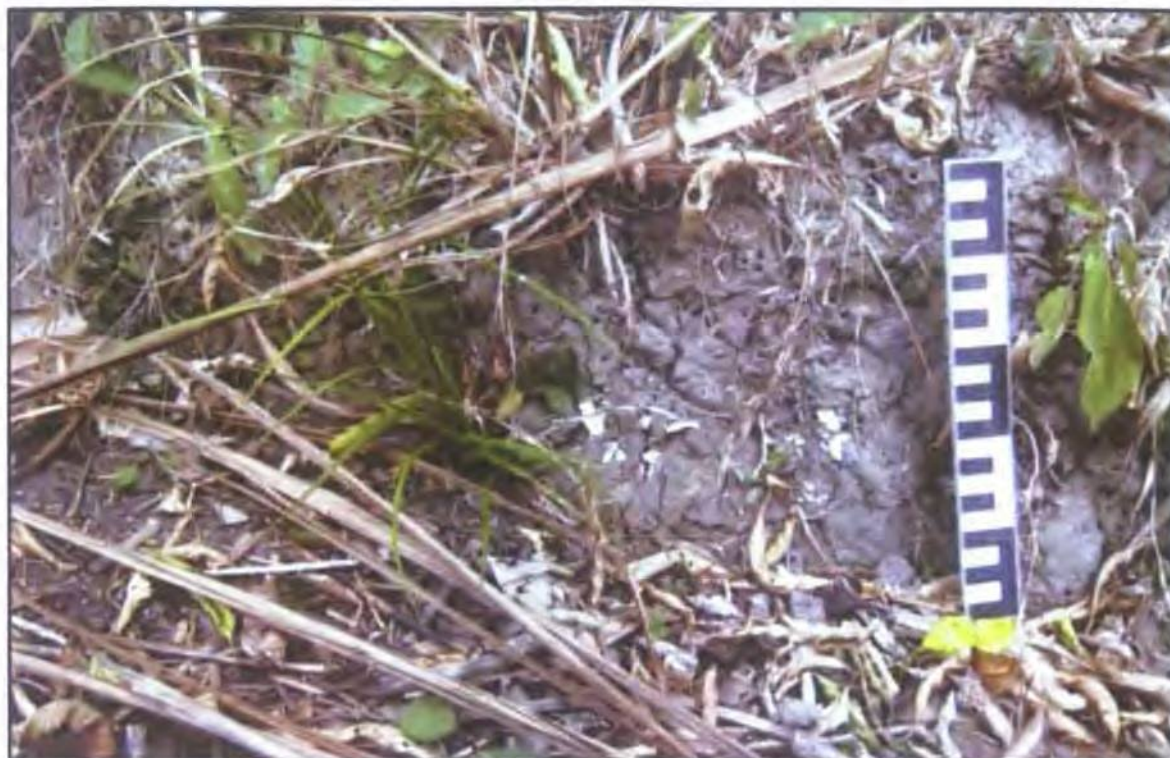
Plate 4. Midden deposit 1. Lens of shell exposed in the bank above the walkway track. Scale is 250mm.

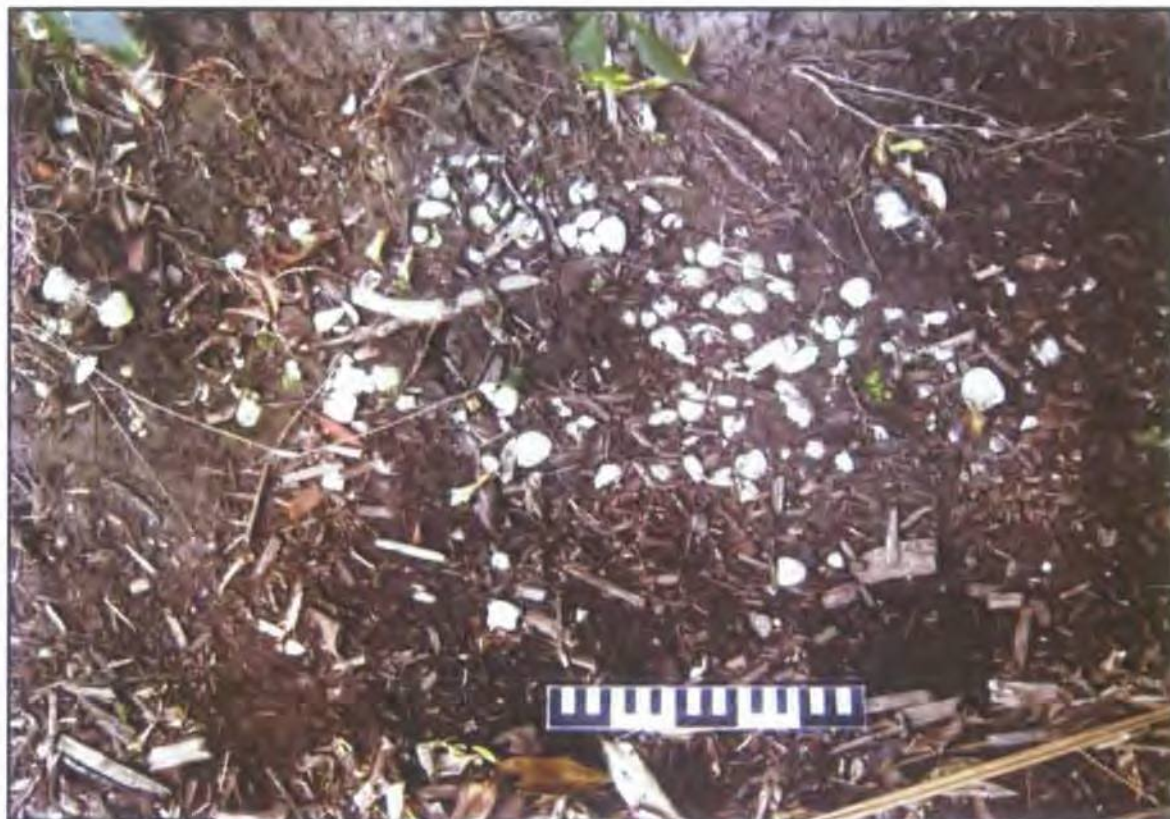
Plate 5. Midden deposit 1. Shell scatter in walkway track below midden exposure #1. Scale is 250mm.

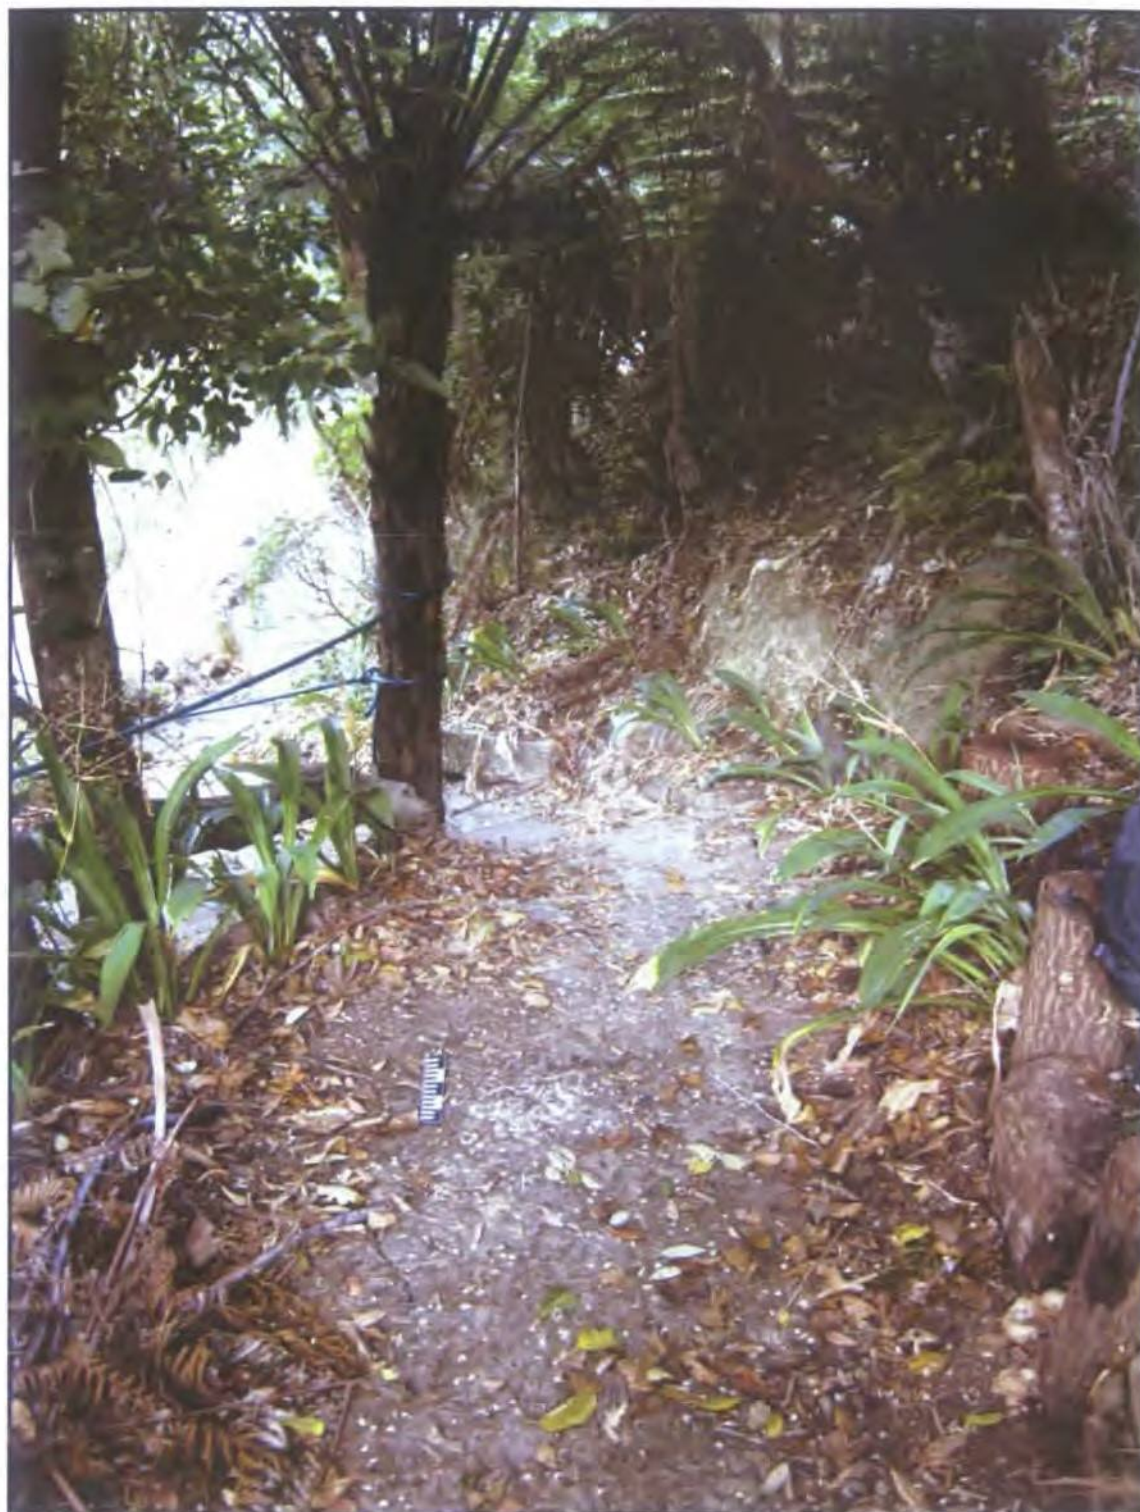
Plate 6. Midden deposit 2. Shell scatter on access track leading down to neighbouring property .

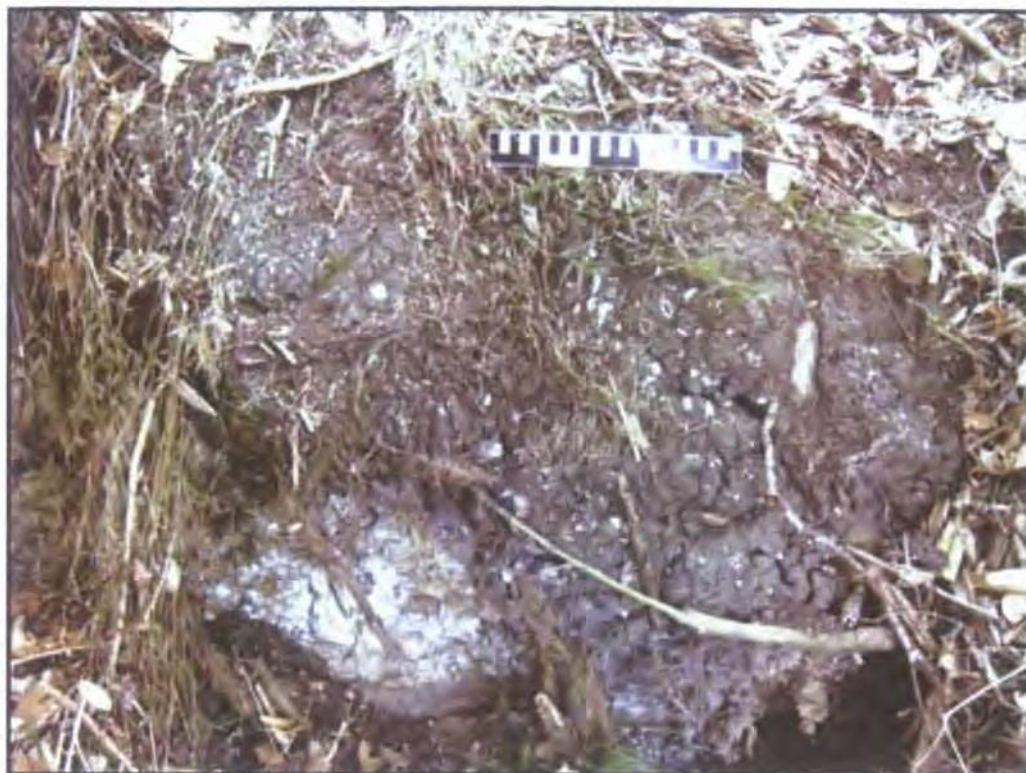
Plate 7. Midden deposit 3. Lens of shell midden in bank along the high water mark on the foreshore. In the vicinity of the large pohutakawa tree on the lower walkway. Scale is 250mm.

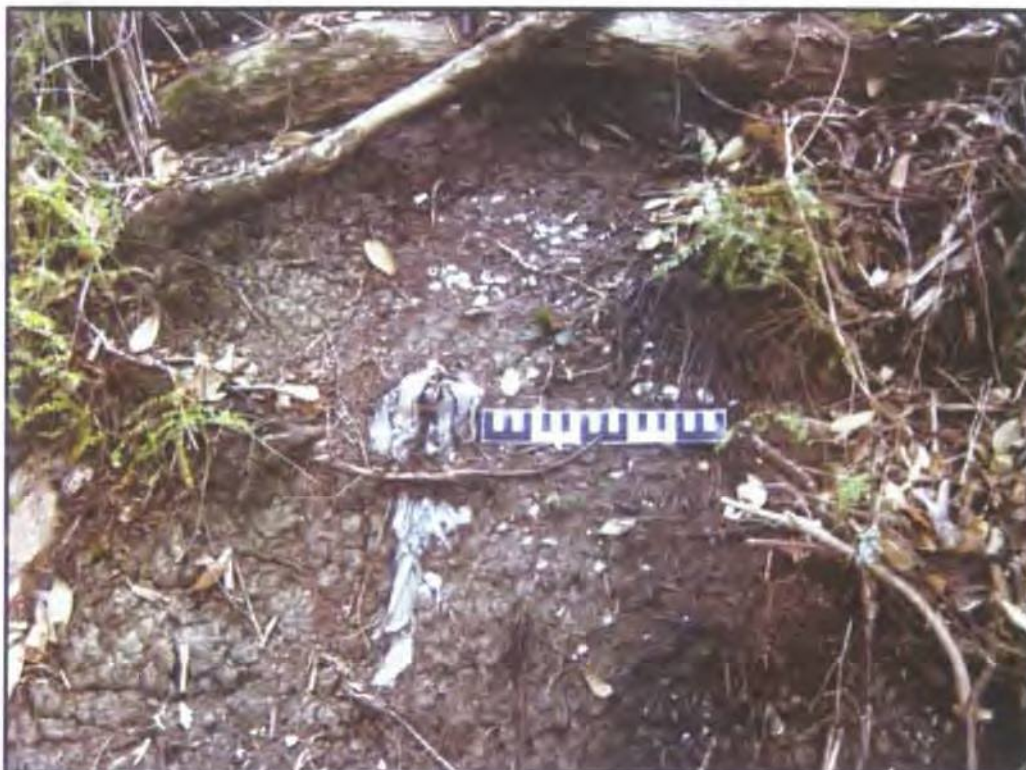
Plate 8. Midden deposit 3. Lens of shell midden under the large pohutakawa tree along the lower walkway. Scale is 250mm.

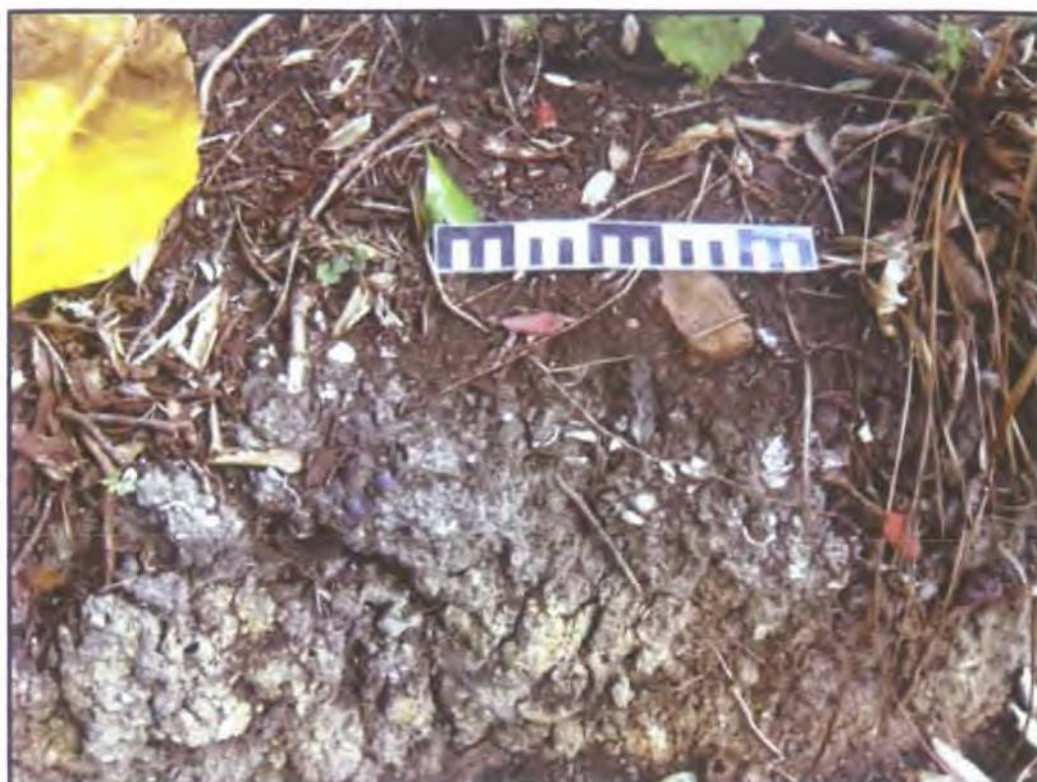
Plate 9. Midden deposit 5. Lens of shell, exposed in the bank above the walkway track. Next to an iron ploughshare. Scale is 250mm.

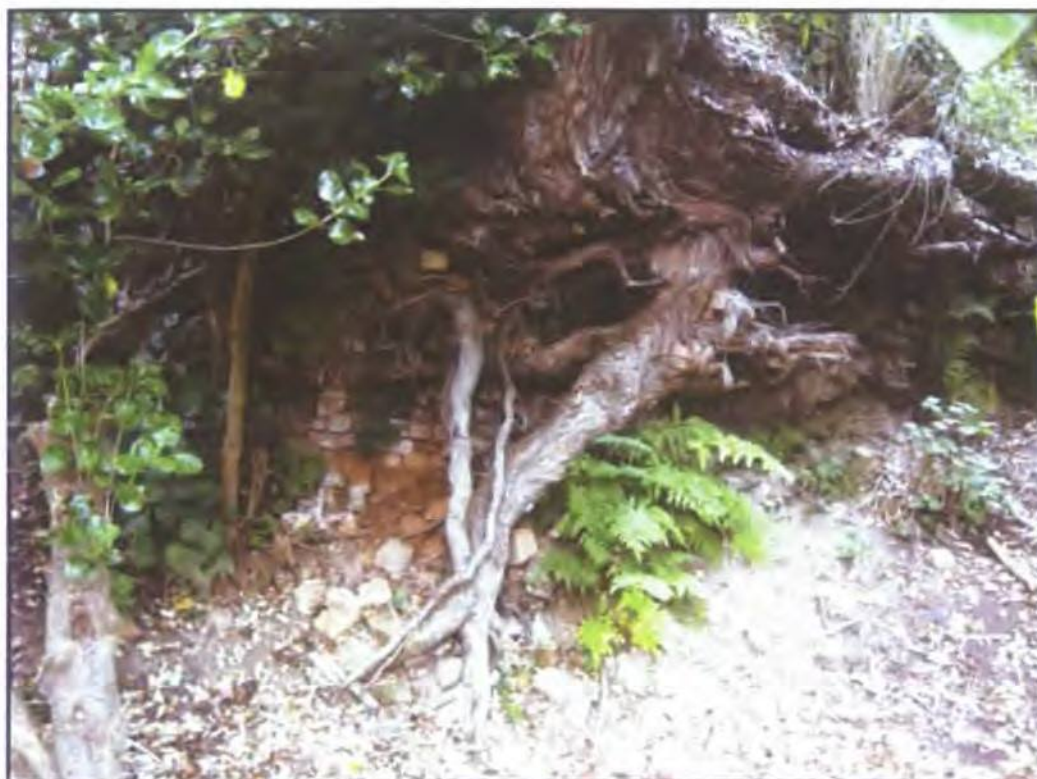
Plate 10. R11/1975. Large pile of bricks under pohutakawa tree – the clamp identified by Packington-Hall (1992).
