Viewpoint 1: Maungauika (North Head)

A Heritage Impact Assessment was commissioned by Mitchell Partnerships Limited to establish whether future development of the property is likely to impact on historic heritage values. This report has been prepared as part of the required assessment of effects accompanying a resource consent application under the Resource Management Act 1991 (RMA) and to identify any requirements under the Heritage New Zealand Pouhere Taonga Act 2014 (HNZPTA).

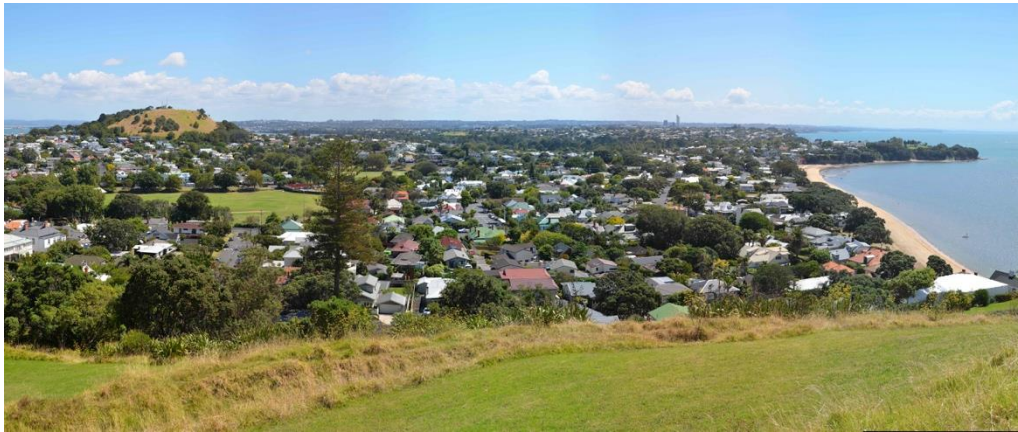
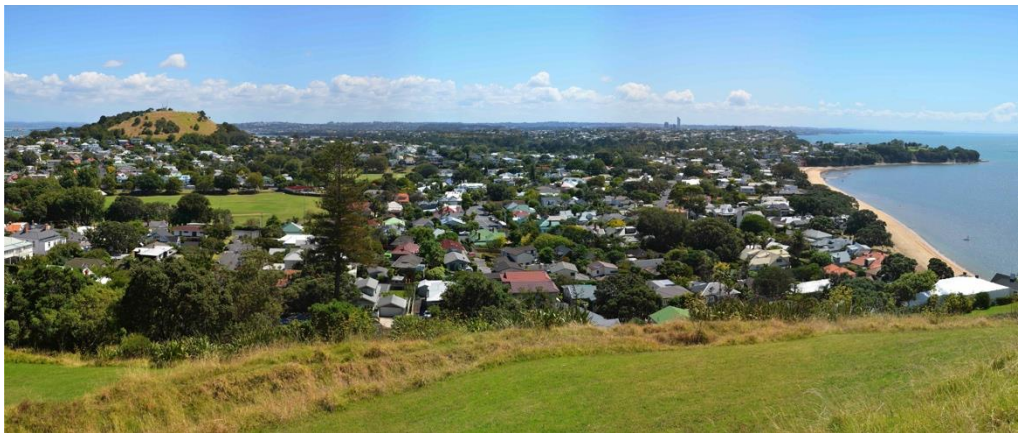
Figure 174: View 1: (Top) before and (bottom) after.

- 7.8 The proposed retirement village will be barely visible from this viewpoint.
- 7.9 The combination of the distance from the site, the typically shaded south facing elevations, the buildings' colours and the heavily vegetated suburban landscape result in the proposed retirement village blending inconspicuously into its greater North Shore setting.

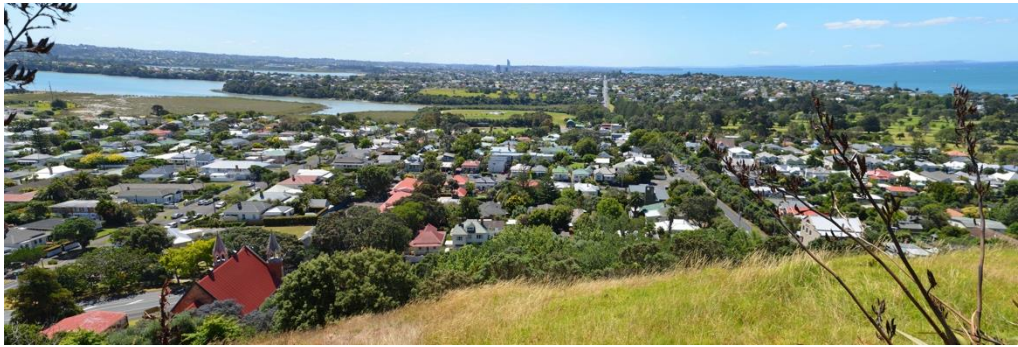
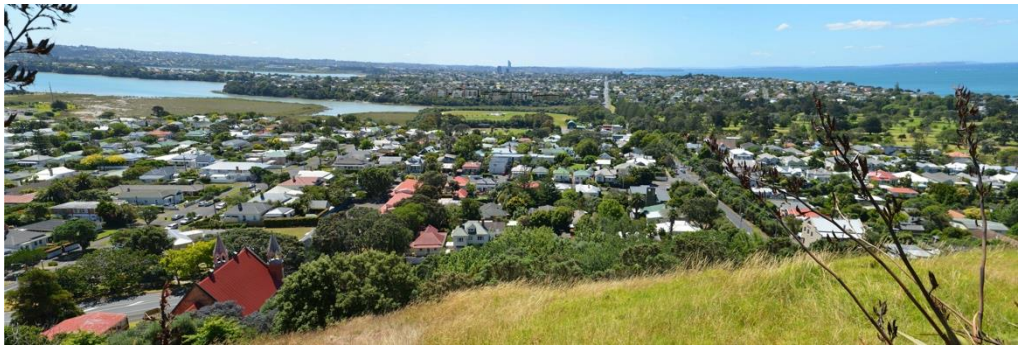
Figure 175: View 2: (Top) before and (bottom) after.

- 7.10 The proposed retirement village will be just visible from this viewpoint.
- 7.11 The open patch of green beyond Ngatarunga Park will be 'replaced' by the proposed retirement village which, because of its dark colours and typically shaded southern elevations, will blend seamlessly into the bush-clad foreshore protection yard and its heavily planted suburban neighbourhood.

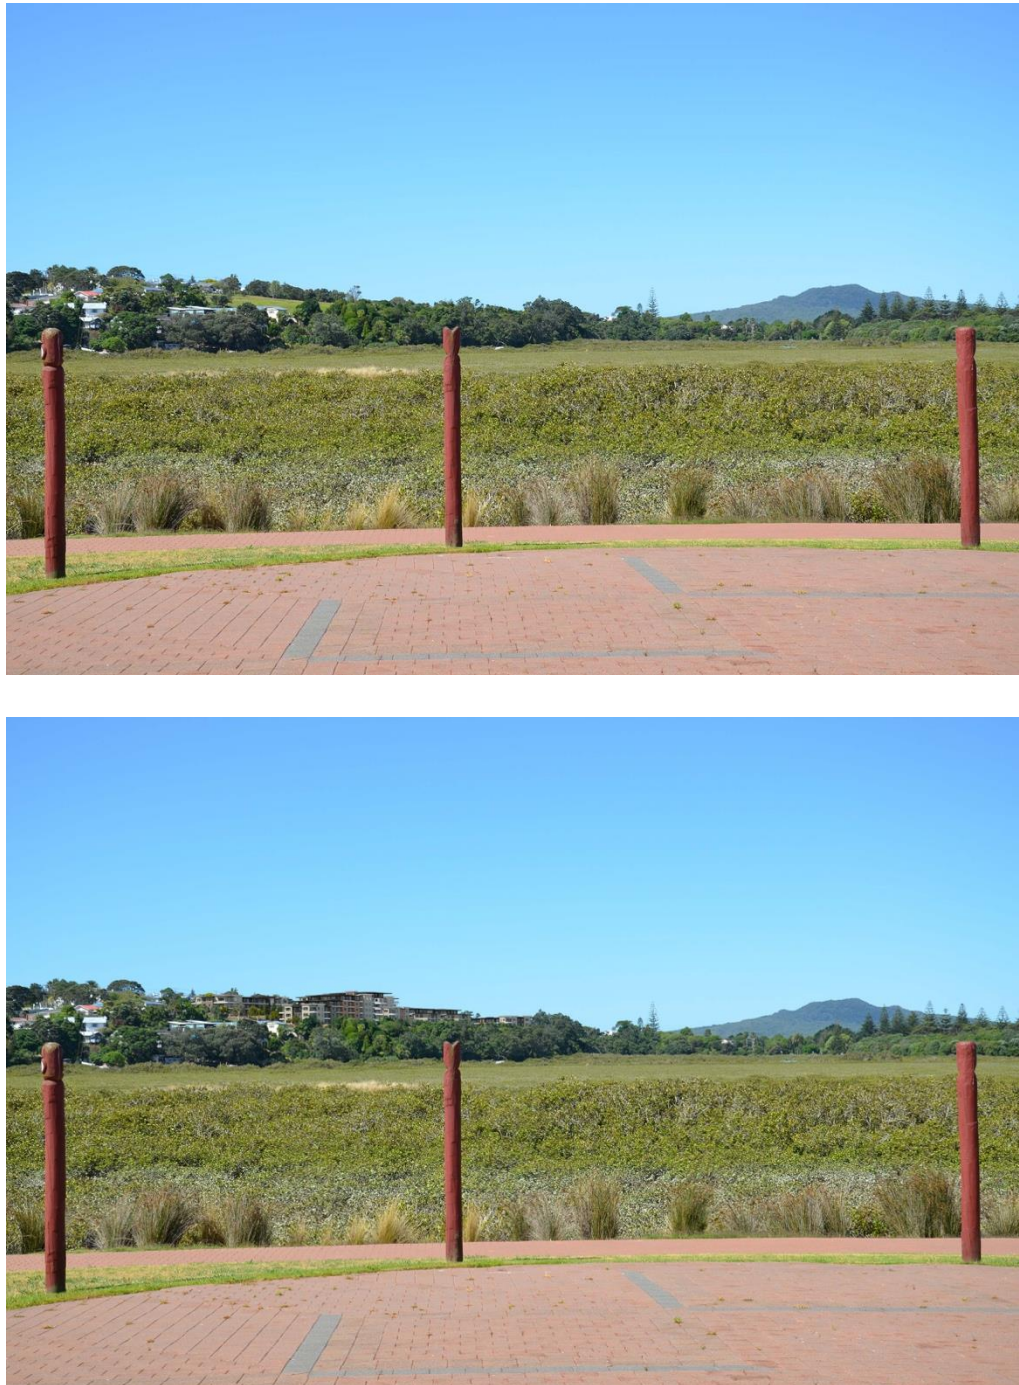
Figure 176: View 3: (Top) before and (bottom) after.

- 7.12 The proposed Ryman retirement village will replace a part of the natural, 'treed' skyline silhouette, but in doing so the built form will create a similarly scaled series of undulations and variations in that skyline.

- 7.13 Notwithstanding the sixth storey on Building B02, the proposed village will sit inconspicuously and harmoniously within its existing context and not detract from the prominence of Rangitoto.

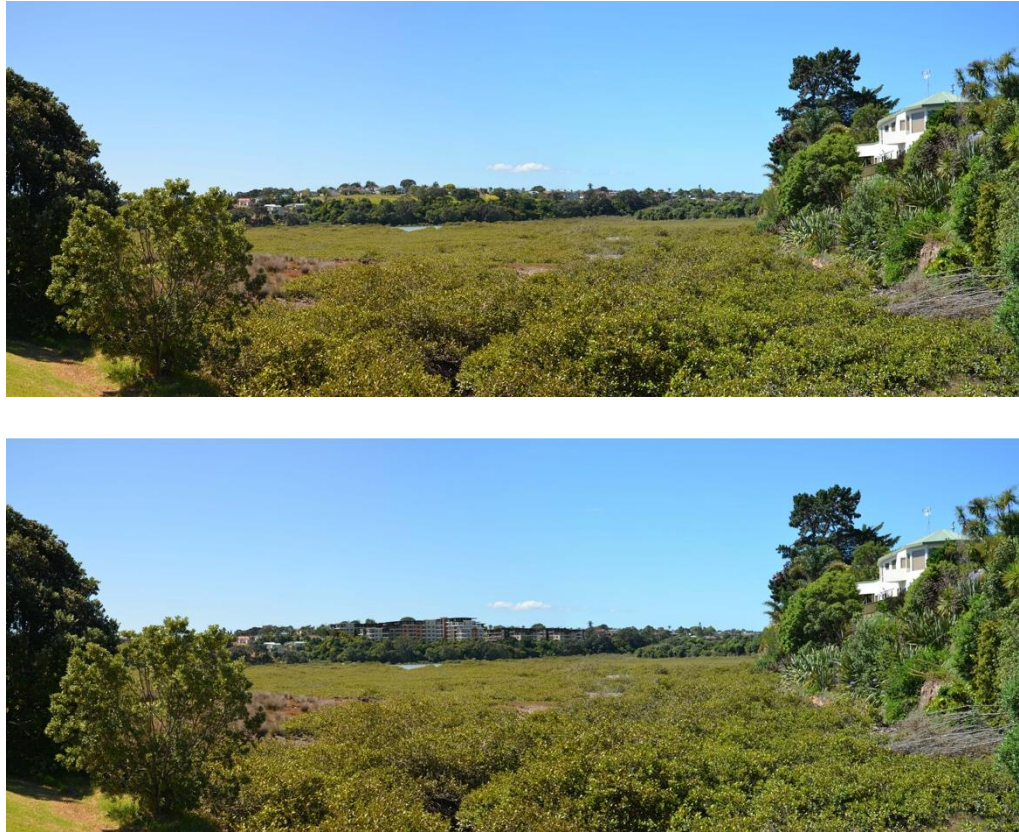
Figure 177: View 4: (Top) before and (bottom) after.

- 7.14 From this viewpoint, the proposed retirement village will not significantly change the existing view. The natural, vegetated silhouette against the sky will be replaced by a built silhouette of similar height and profile variation that blends into the bush-clad foreshore yard tracing the coastal edge of the Waitemata Harbour.

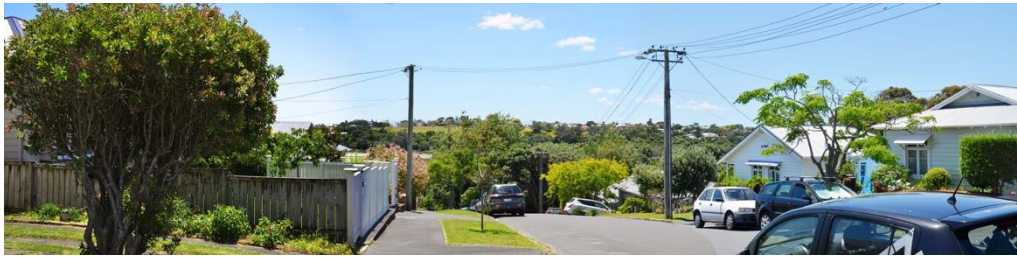
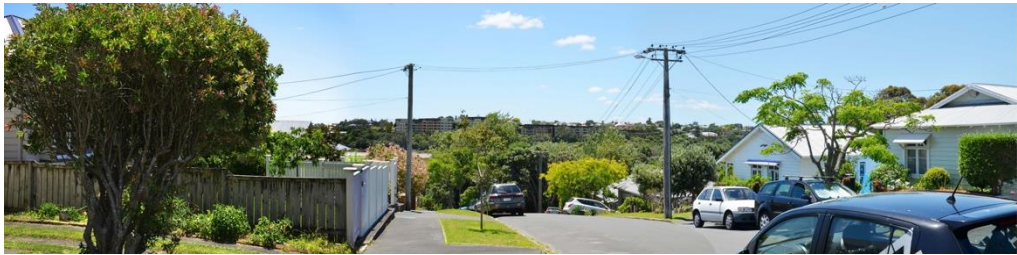
Figure 178: View 5: (Top) before and (bottom) after.

- 7.15 The proposed retirement village will be barely noticeable from this viewpoint.
- 7.16 The profile from existing ridge line will barely change and its silhouette against the sky will continue to be finely varied in grain and profile.

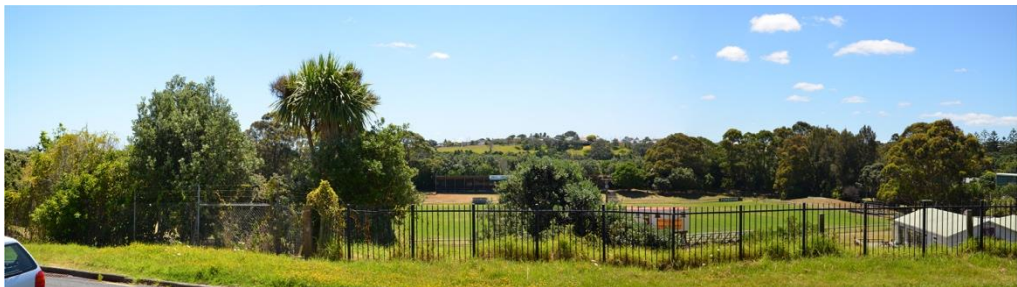
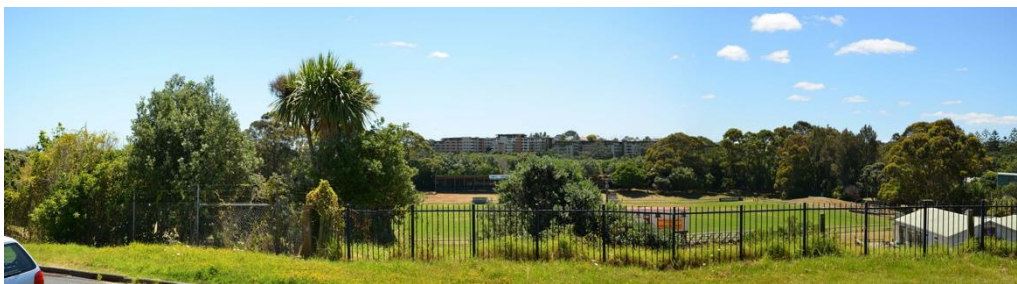
Figure 179: View 6: (Top) before and (bottom) after.

- 7.17 The proposed retirement village will 'replace' the existing visible patch of grassland but not significantly alter the attractive skyline silhouette..

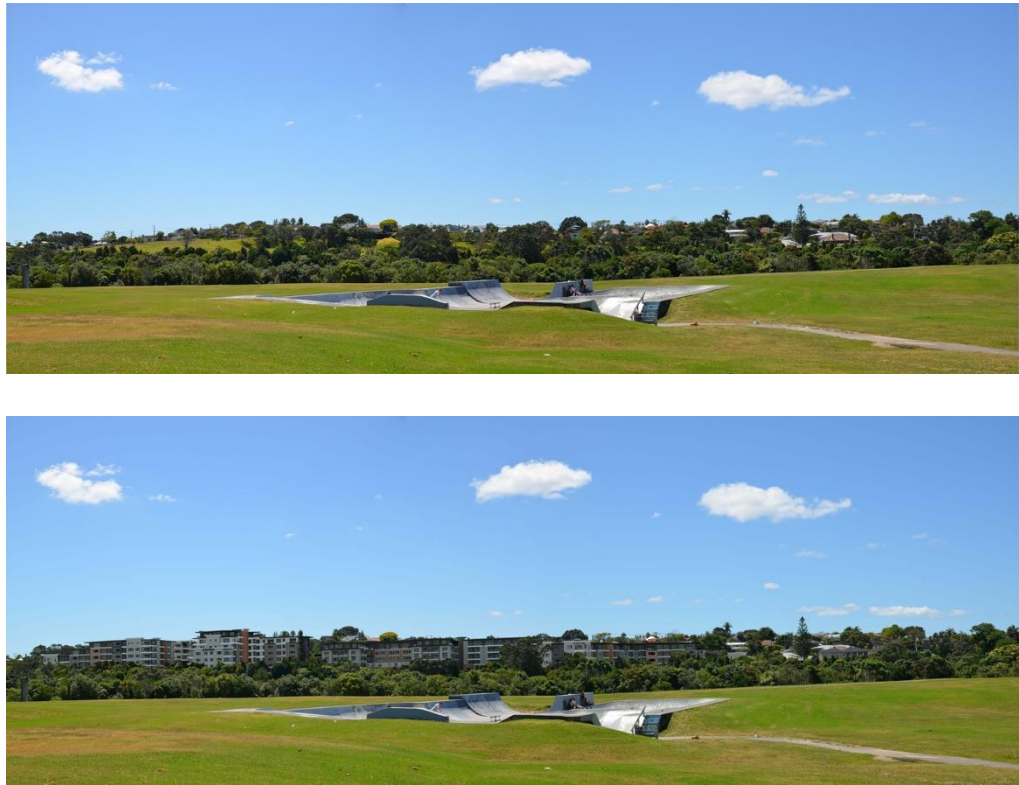
Figure 180: View 7: (Top) before and (bottom) after.

- 7.18 From this viewpoint the proposed retirement village will be clearly visible. A slightly closer, but similar view will be experienced from the skateboard rink itself, but the photograph was taken from this location to provide a context for the skateboard rink.

- 7.19 However, the buildings will not extend significantly above the existing level of the skyline and its profile will continue to be attractively varied.

- 7.20 The variations in the cladding materials and colours on the southern elevations of the buildings has proved effective in reducing the apparent bulk and scale of the buildings.

- 7.21 In particular, the use of lighter colours on those parts of the elevations nearest the viewer and darker colours on the recessed parts of the elevations help to enhance the residential scale and character of the village.

- 7.22 The proposed retirement village will retain glimpses of the existing natural treed skyline silhouette to the distant rear (north) of the village.

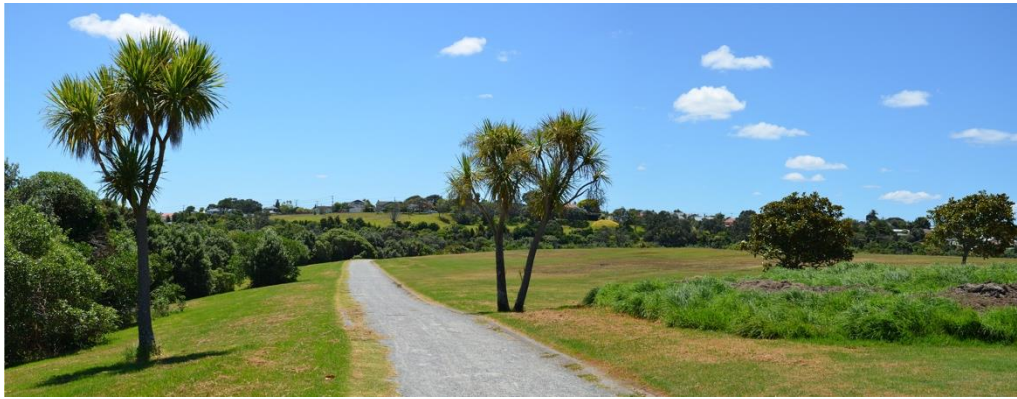
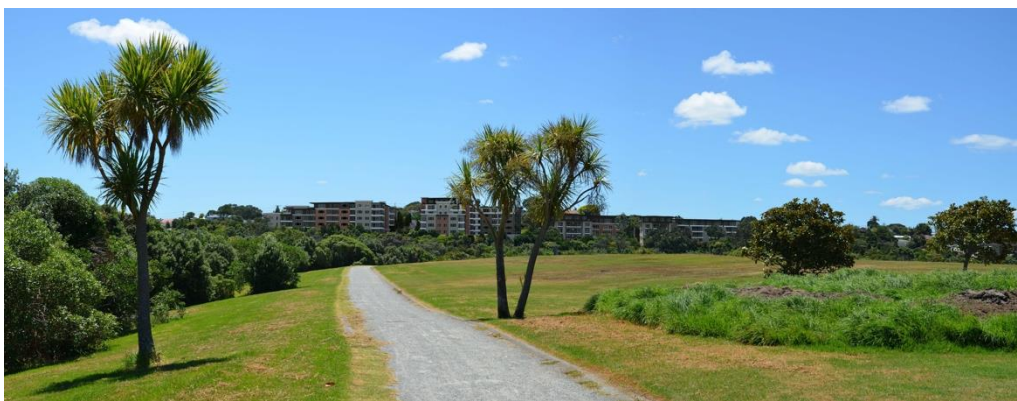
Figure 181: View 8: (Top) before and (bottom) after.

- 7.23 The proposed retirement village will also be clearly visible from this viewpoint, and from further along the walking/cycling track. This viewpoint was chosen because it encapsulates almost the full east-west length of the site and its village buildings. The relationship to the two cabbage trees also enables the viewpoint location to be verified and revisited.
- 7.24 The varied height profile of the village buildings provides an attractive backdrop to the natural character and ambience of the park, while the variation in cladding materials and colours on the southern elevations create a finely grained residential building scale and character.
- 7.25 The presence of the building also imbues the park with an increased sense of passive surveillance and safety for its users. This sense would get stronger further along the track.

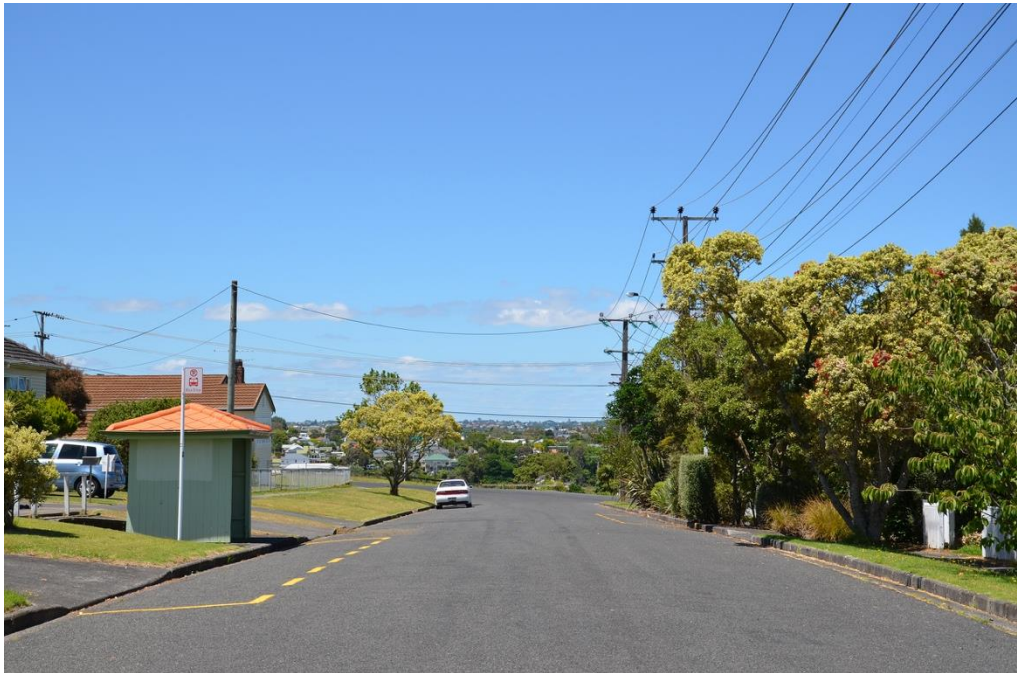
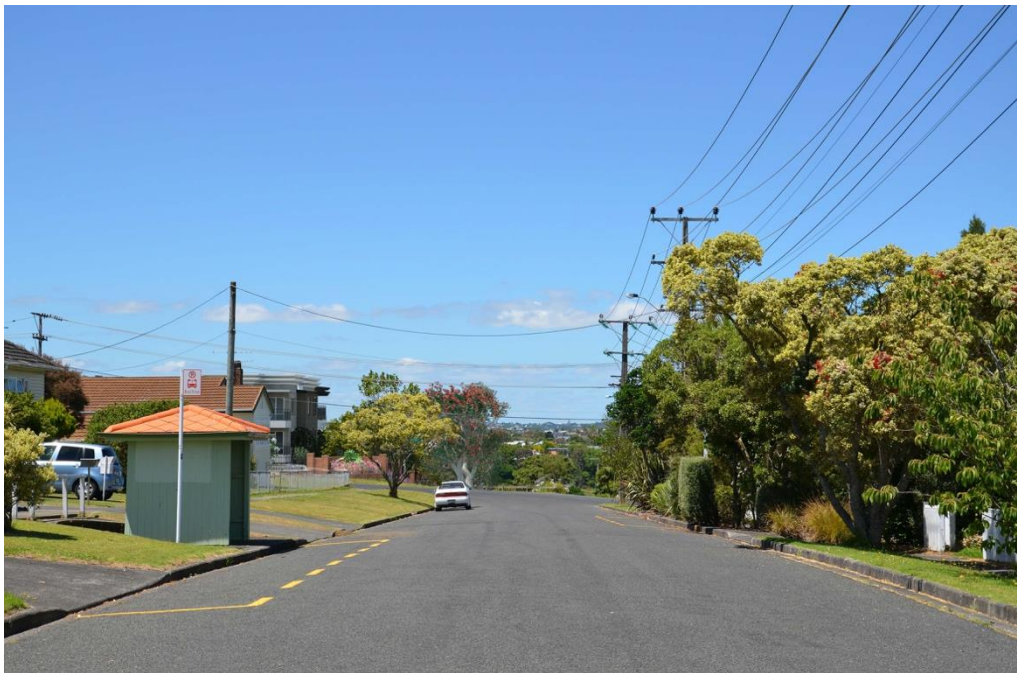
Figure 182: View 9: (Top) before and (bottom) after.

- 7.26 The top two levels of the proposed new three level Building B04 on the corner of Ngataringa Road and Wesley Street will be just visible behind the terracotta-coloured roof on the house immediately behind the bus shelter.
- 7.27 Even if Building B04 were completely visible, it would sit very comfortably amongst its residential neighbours.

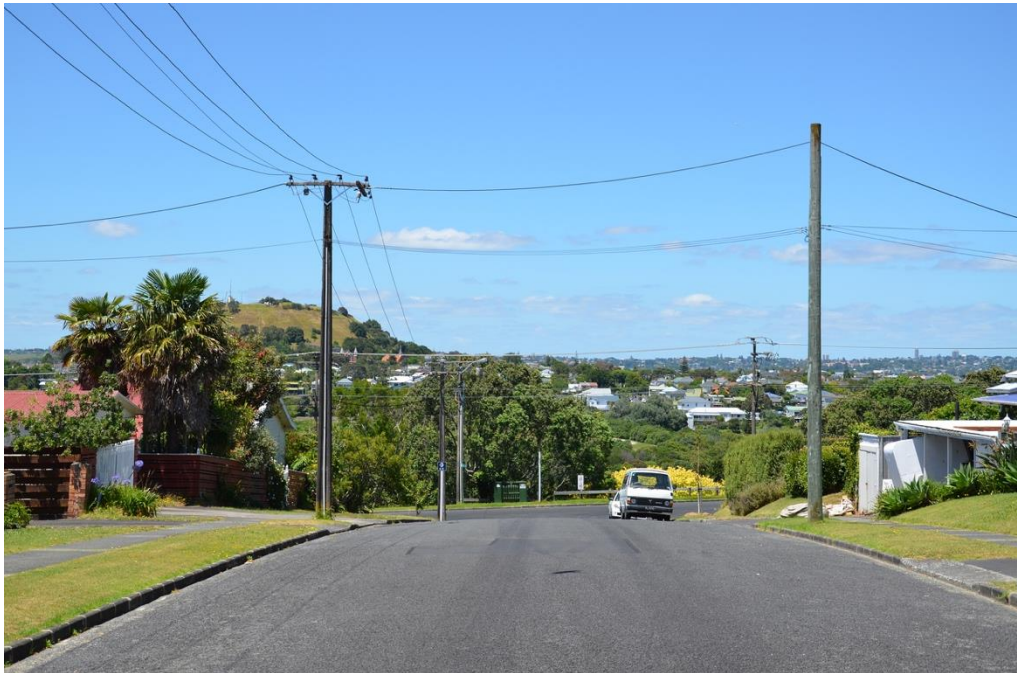
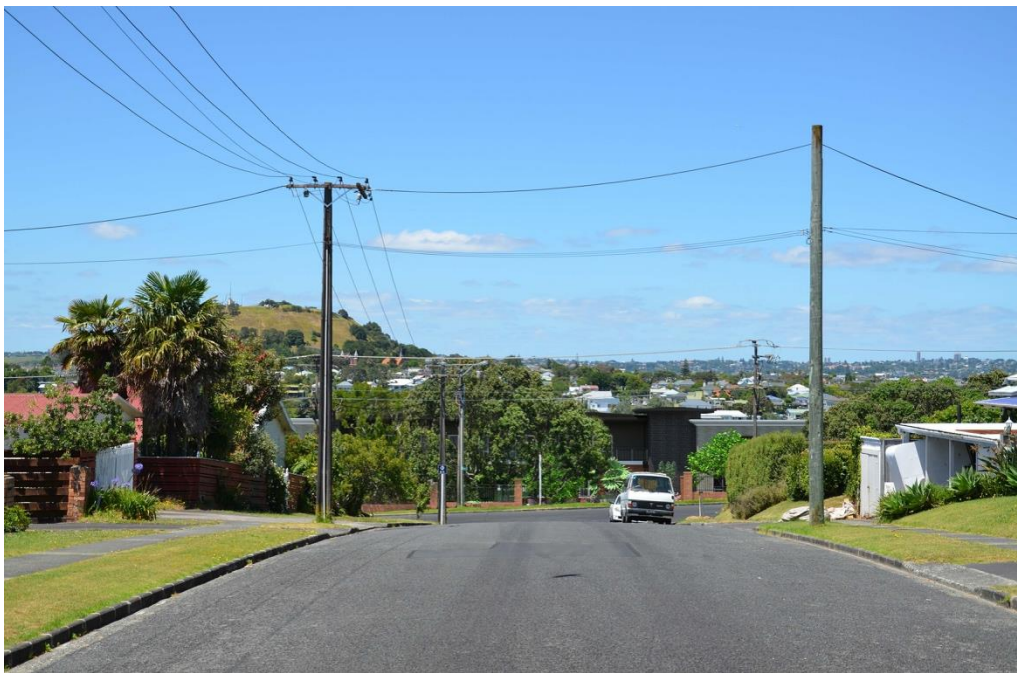
Figure 183: View 10: (Top) before and (bottom) after.

- 7.28 The proposed retirement village will be barely visible or noticeable from this viewpoint.
- 7.29 The upper two levels of Building B01 (just behind the white van parked on the right hand side of the street) will be all but screened from view by the existing large pohutukawa tree.

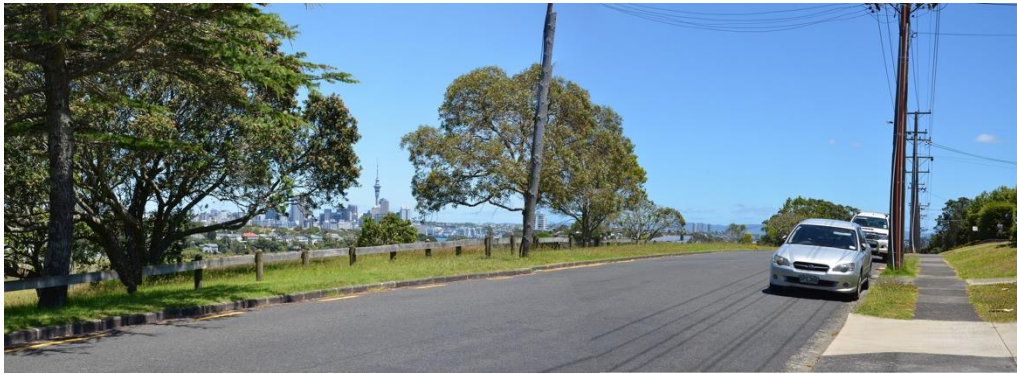
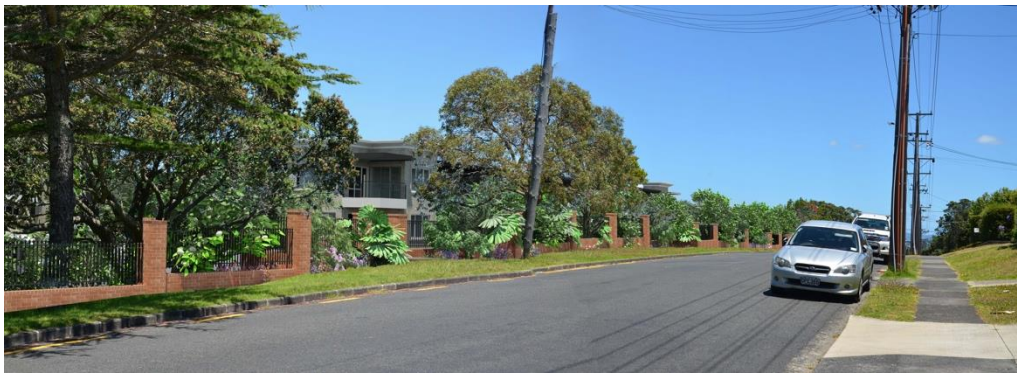
Figure 184: View 11: (Top) before and (bottom) after.

- 7.30 The upper level of the three level Building B04 will be just visible behind the existing trees growing along the northern boundary of the site and the proposed new planting in the same location.
- 7.31 The proposed new Building B02 will be set even further back from the Ngataringa Road boundary, behind and to the left of the tree on the extreme left of the image.

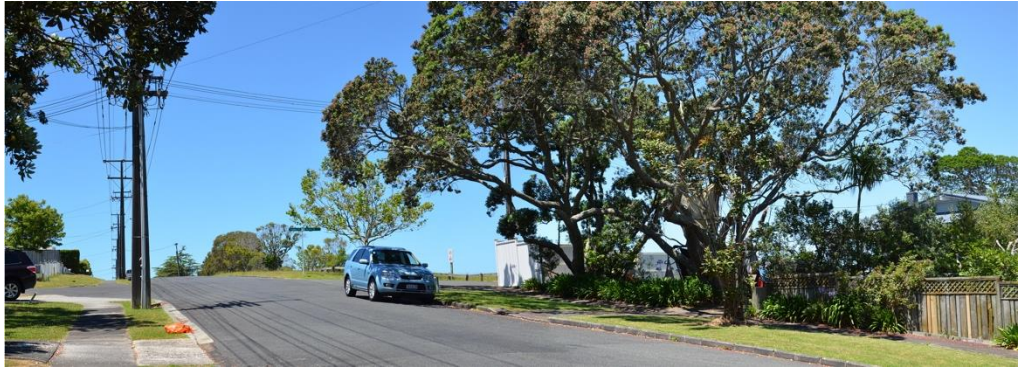
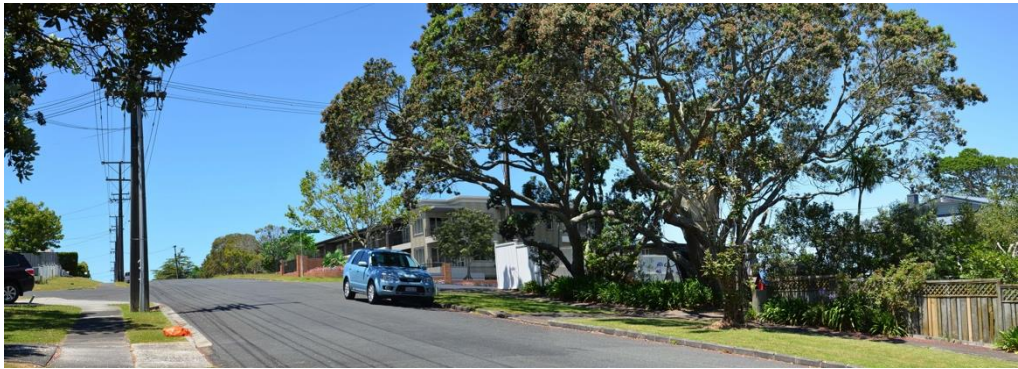
Figure 185: View 12: (Top) before and (bottom) after.

- 7.32 This view from this viewpoint demonstrates how the south-sloping topography of the site has enabled the proposed new three level Building B04 on the corner of Ngataringa Road and Wesley Street to successfully blend into the character and scale of the existing residential neighbourhood.

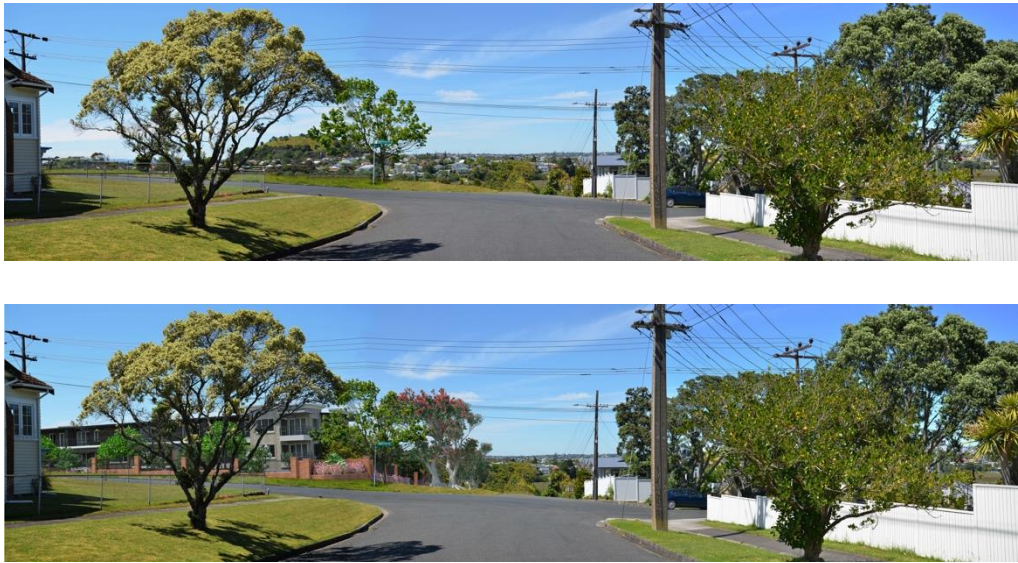
Figure 186: View 13: (Top) before and (bottom) after.

- 7.33 This viewpoint illustrates the thoroughly residential scale and character of the proposed new Building B04 on the corner of Ngataringa Road and Wesley Street.
- 7.34 The generous north-facing and west-facing balconies, directly accessible from the apartment living rooms and bedrooms, will enhance the passive surveillance of both streets.

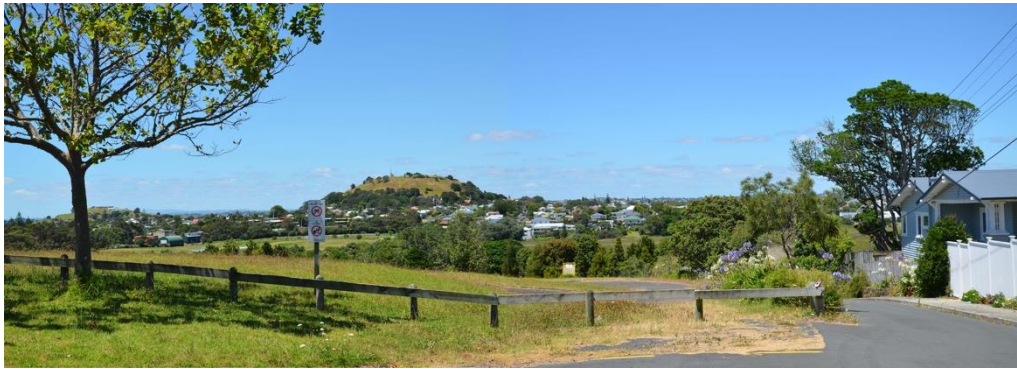
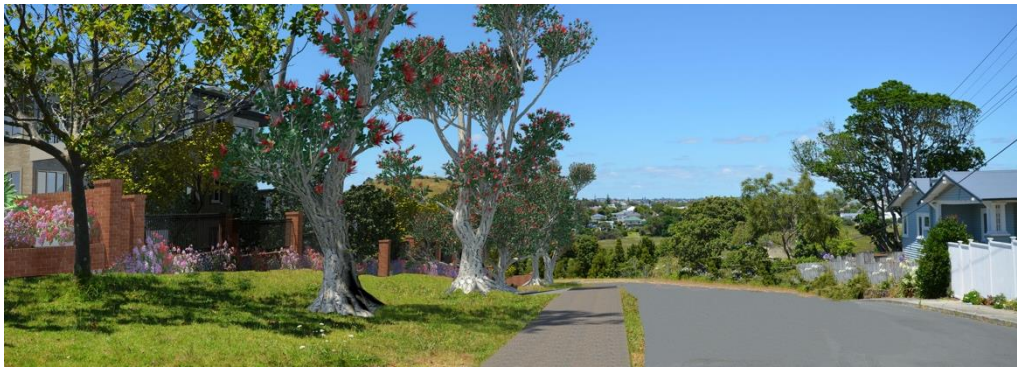
Figure 187: View 14: (Top) before and (bottom) after.

- 7.35 This viewpoint illustrates the effects of the proposed Wesley Street widening (towards the east) and the planting in the road reserve.
- 7.36 The western end of the proposed new Building B04 is just visible through the trees on the left of the image.
- 7.37 The proposed new retirement village will enhance the residential character and quality of the eastern side of Wesley Street in a manner and at a scale that does not visually dominate the residential property at 39 Ngataranga Road visible on the right of the image.

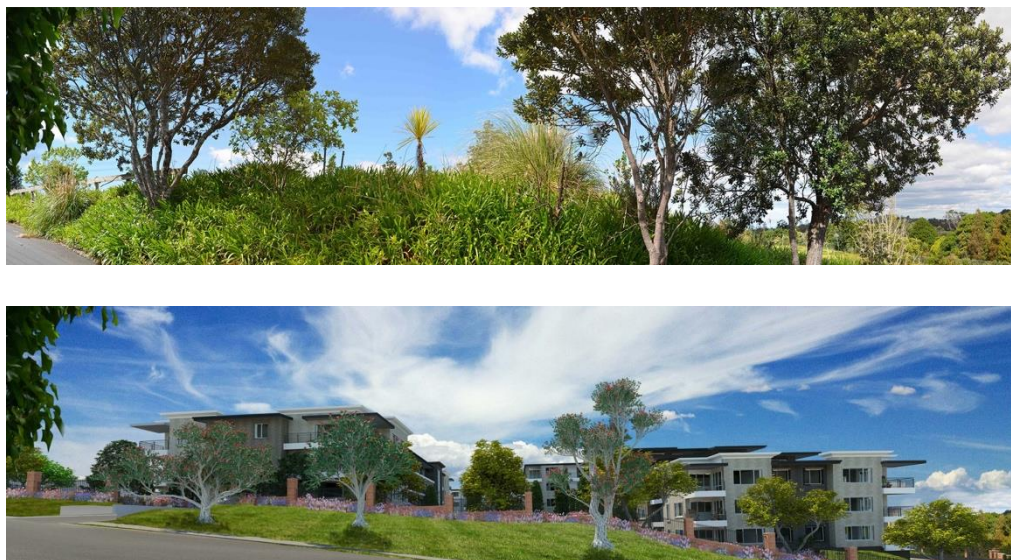
Figure 188: View 15: (Top) before and (bottom) after.

- 7.38 This viewpoint demonstrates how the large exterior space proposed to be shaped up by Buildings B04 (on the left) and B03 (on the right), and generously set back from the eastern side of Wesley Street, creates an attractive and residentially scaled edge to the street.

- 7.39 Notwithstanding the three storey Building B04 (on the left) and the gradual eastward-stepped three, four and five storey Building B03 (on the right), Wesley Street widening, the generous set back from the new Ryman site boundary and the steeply sloping topography of the land will result in an outcome which is both considerate of and responsive to the scale and character of the existing residential properties at 39 Ngataranga Road (on the corner of Wesley Street) and at 1 Wesley Street.

- 7.40 Put simply, Buildings B03 and B04 will not visually dominate either the street or the residential properties on its opposite (western) side.

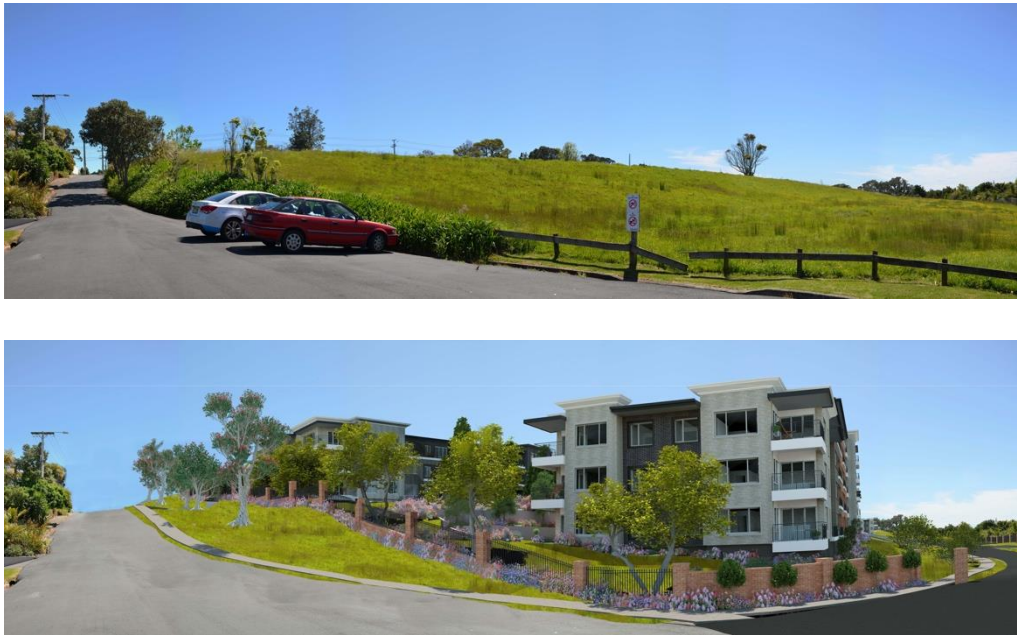
Figure 189: View 16: (Top) before and (bottom) after.

- 7.41 This viewpoint, from the cul de sac at the bottom of the steeply sloping Wesley Street, illustrates the proposed road widening and a secondary point of vehicular access into the site (on the extreme right of the image).

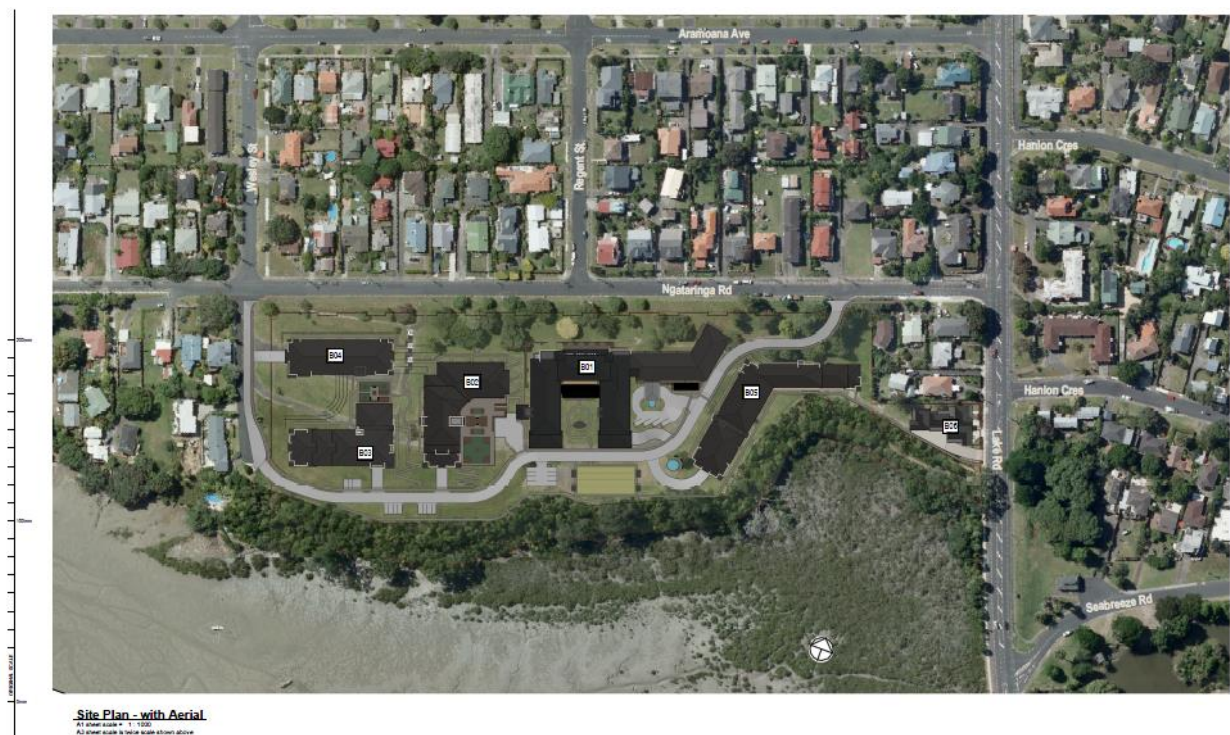
Figure 3. Concept design plan of the proposed development at Ngataranga Road, showing the general massing proposal (source: Ryman Health Mitchell Partnerships, 9/11/2015)

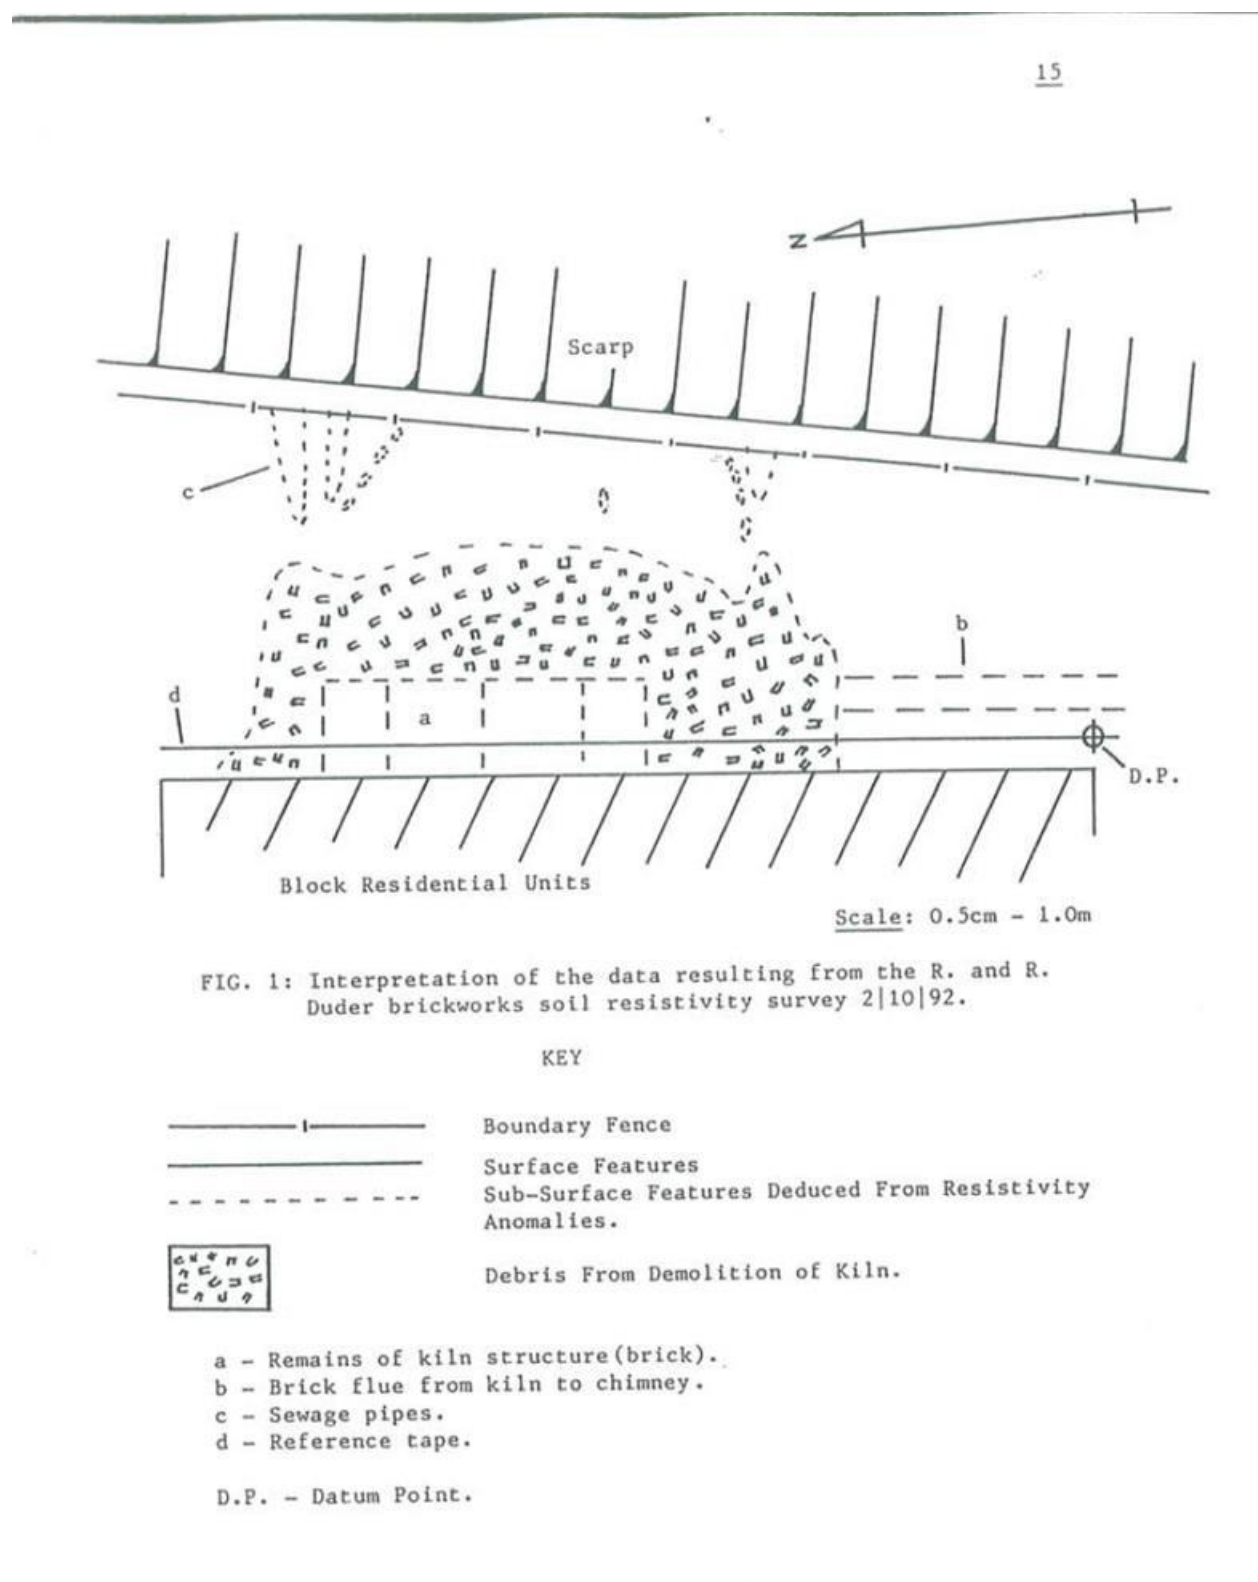
Figure 10. Interpretation of resistivity data from survey undertaken by Packington-Hall in 1992. This survey was located at the eastern end of the site, based on a 1927 plan showing features in this location (source: Packington-Hall 1992:15)

On the grassed area above (within the proposed area of works) Packington-Hall conducted a soil resistivity survey in a small part of the eastern area of the site in order to detect subsurface structural features. The location of the survey appears to have been based primarily on a 1927 plan, where a 'brickworks', square kiln and circular kiln were shown. No evidence of the circular 'beehive' kiln from c.1890 was found (Packington-Hall 1992:11). However, Packington-Hall interpreted the resistivity profiles to indicate the possible location of the square kiln walls and surrounding debris (Figure 10) (ibid.). The results of his survey were presented in a site map of the project area, which included the possible location for remaining Duder Brickworks subsurface structures (Figure 11). However, it is important to note the limitations of resistivity survey and that no subsurface testing was undertaken to verify the results. There appears to have been a heavy reliance on the accuracy of the 1927 plan, which our research has shown is not consistent with other historic aerials and photographs around this time (see Results, below).

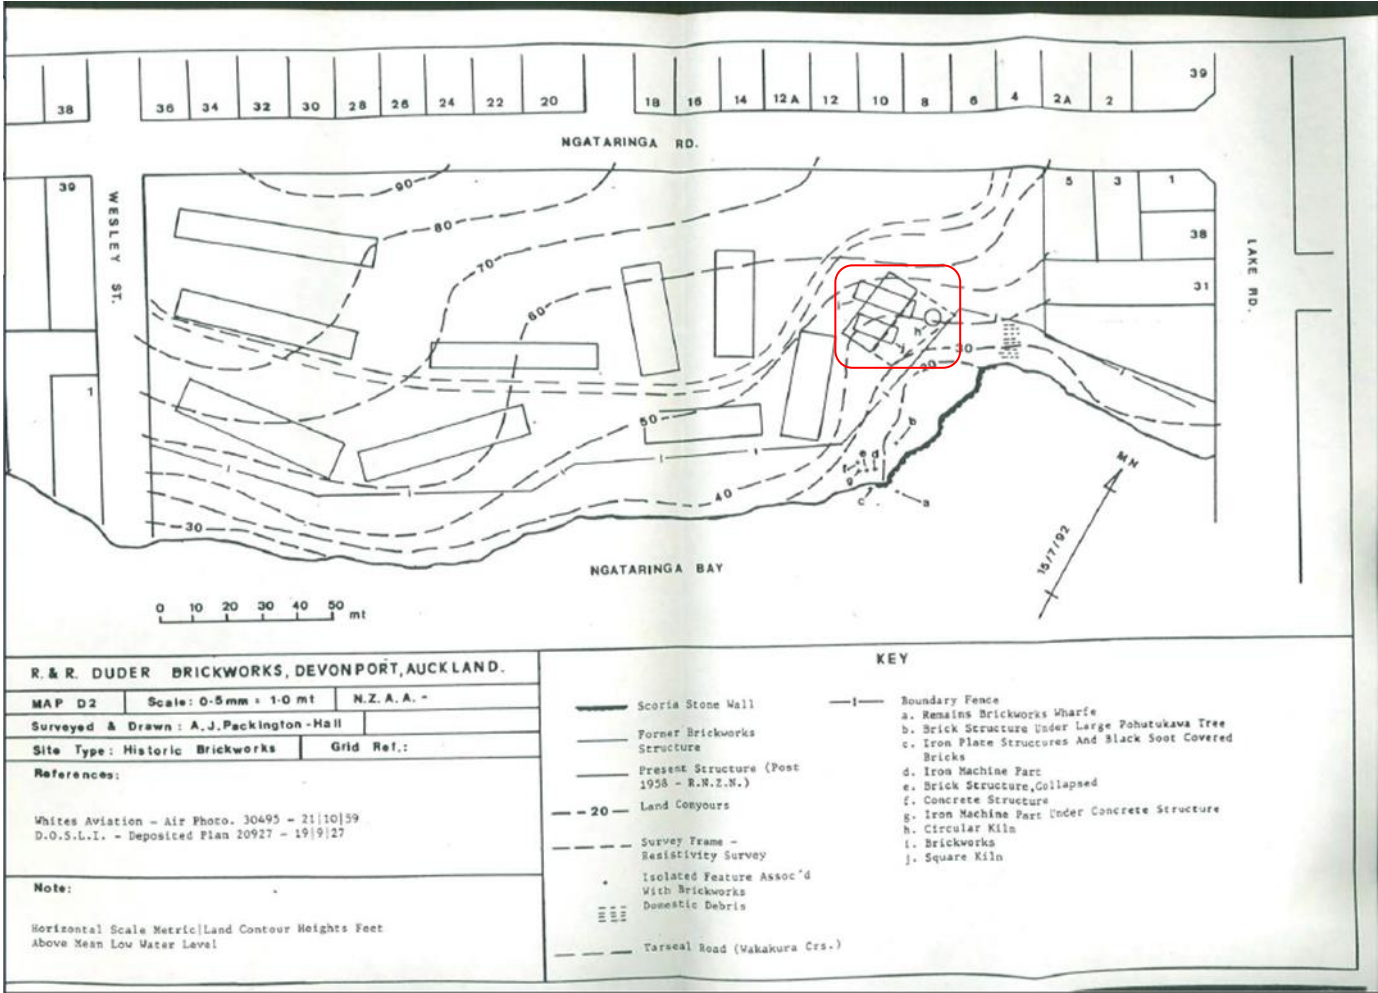
Figure 11. Map created by Packington-Hall in 1992, showing contours, location of the Navy residential blocks and historic heritage features located during his fieldwork. Note that features h, i and j (red box) are not the confirmed location of the Brickworks and kilns and are based on a 1927 plan (source: Packington-Hall, 1992: Appendix B Map 2)

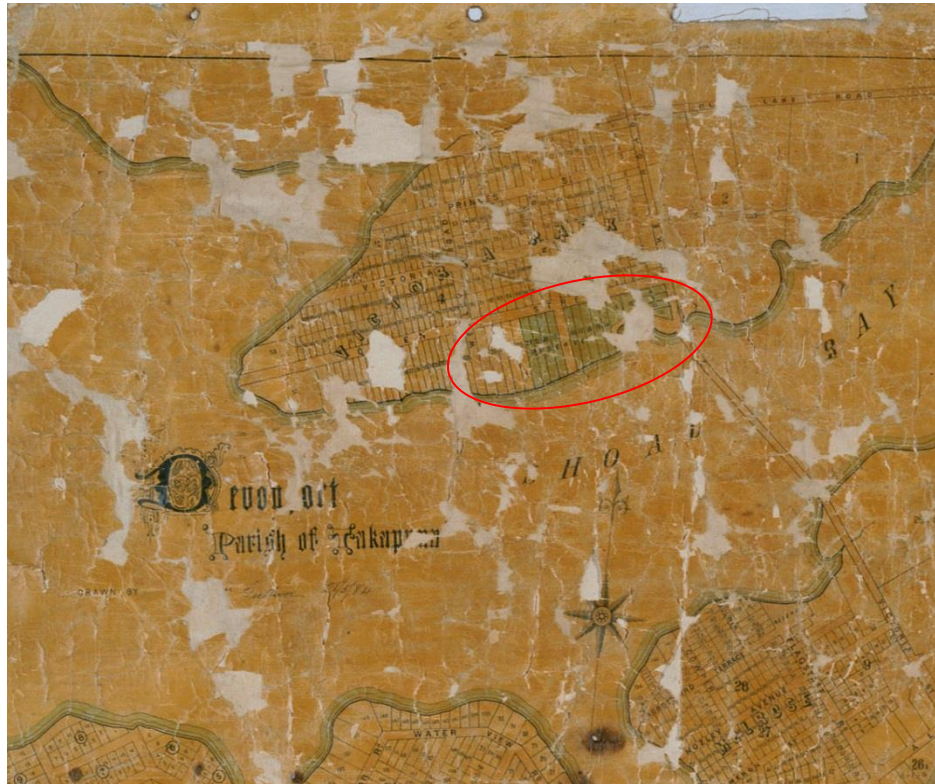
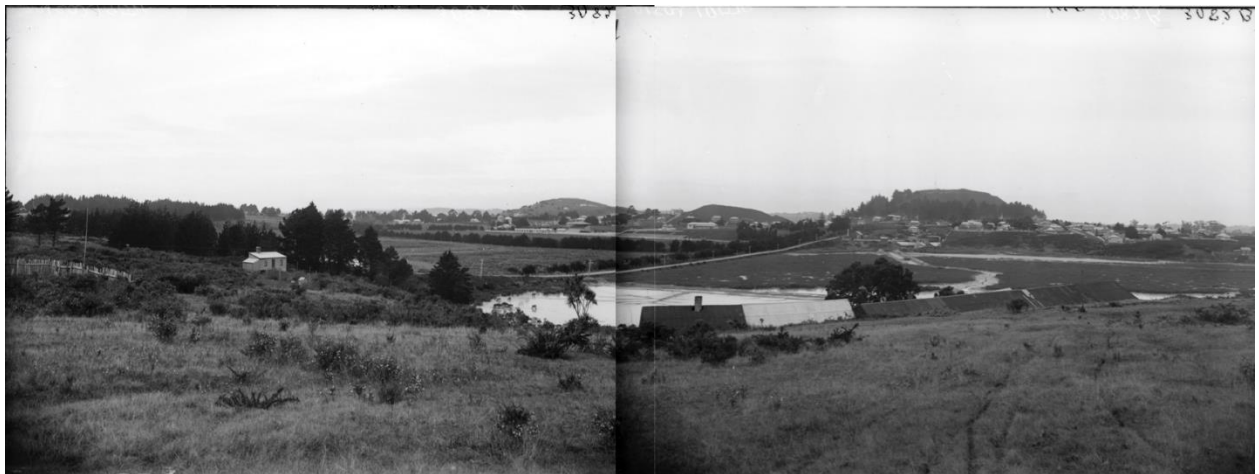
Figure 20. Duder Brickworks reportedly c.1904. The building with the small chimney in the centre is likely to be the original boiler house; the brickmaking/pipe moulding building would likely be to the building on the right, with the 120' drying sheds towards the far right. A small cottage is visible to the left, towards Lake Road (source: Local History Online ref 3032B; 3032C)

Two early photographs reportedly taken around 1904 provide the earliest visual evidence of the site (Figure 20). These form a panorama of the site looking southeast towards Mt Victoria, Mount Cambria and North Head. Visible in the photographs are the roofs of part of the Brickworks (three or four linear structures), including possibly the original boiler house (with chimney). A small cottage is located towards the Lake Road frontage and may have been built by the first or second brick-maker who operated the site (after 1875).

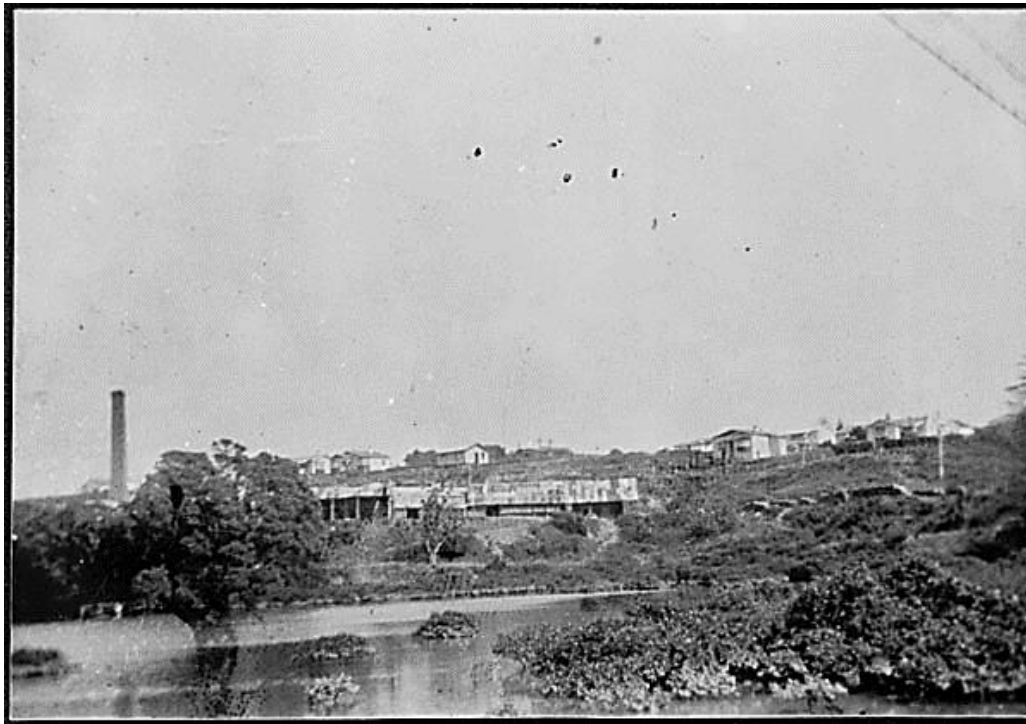
Figure 21. Photograph taken by Humphrey Duder of the Duder Brickworks in 1924, showing chimney (left) and what is probably the brick/pipe moulding building and drying sheds (central). The wharf (below chimney), a large pohutukawa tree, track way to the wharf, and the stone revetment along the coastal edge bank are also visible (source: Auckland Libraries ref D_GBB_0016)
