Viewpoint 1: Maungauika (North Head)

A Heritage Impact Assessment was commissioned by Mitchell Partnerships Limited to establish whether future development of the property is likely to impact on historic heritage values. This report has been prepared as part of the required assessment of effects accompanying a resource consent application under the Resource Management Act 1991 (RMA) and to identify any requirements under the Heritage New Zealand Pouhere Taonga Act 2014 (HNZPTA).

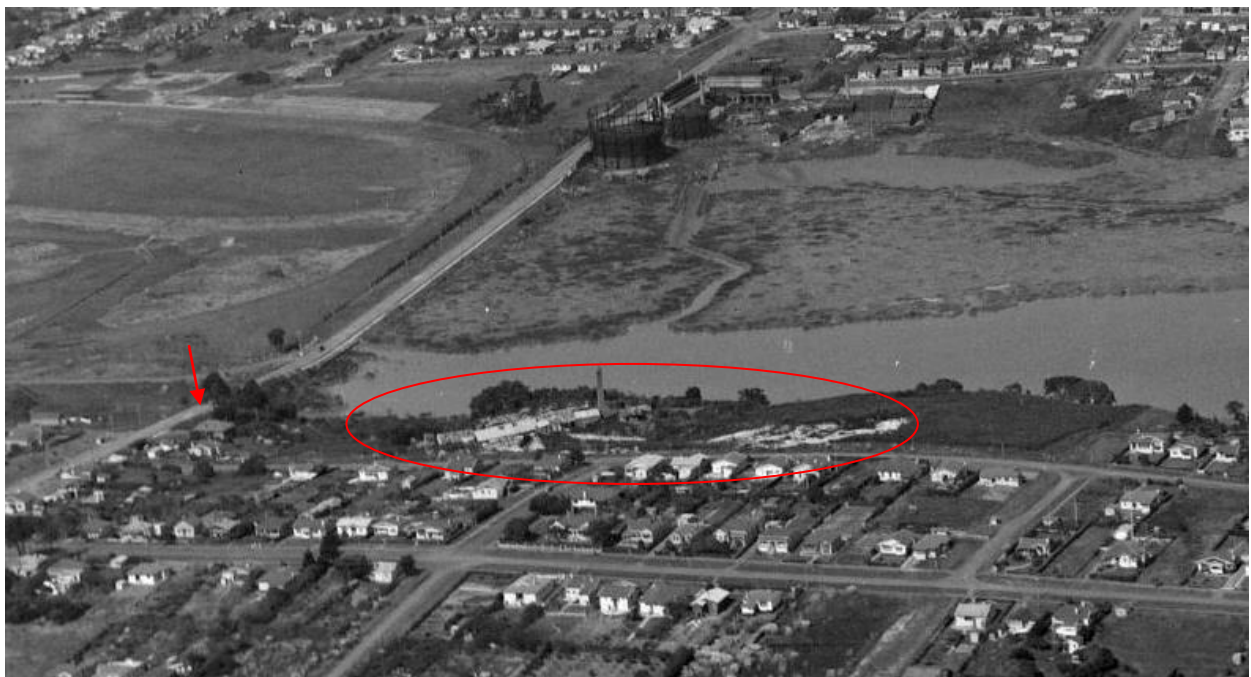
Figure 24. Detail from 1930 sortie by Whites Aviation, showing the fully developed Brickworks, and areas of clay quarrying (circled). The round kiln is to the right of the chimney. The Brickworks manager's house is present at 31 Lake Road (arrowed). Note this detail is corrected from the original image which is 'reversed' (source: Alexander Turnbull Library WA-62759-G)

Aerial and ground photography dating from 1924-32 shows the site fully developed (Figure 21, Figure 24, Figure 26). In addition to the tall chimney, there appear to be at least six structures, including a round and square kiln, boiler house, brickmaking/pipe moulding building and drying sheds (Figure 21, Figure 25, Figure 26). The quarry is clearly visible towards the centre of the project area and the Brickworks structures are located within the eastern part of the project area. The chimney and circular kiln appear to be west of the small point with a wharf and large pohutukawa tree, but east of the gully (now partly filled in), with the rest of the Brickworks structures extending eastwards. The far western part of the project area does not appear to have been utilised (Figure 24, Figure 27). A wharf, with road and stone revetment is clearly visible in the current location of the present day remains (Figure 21).

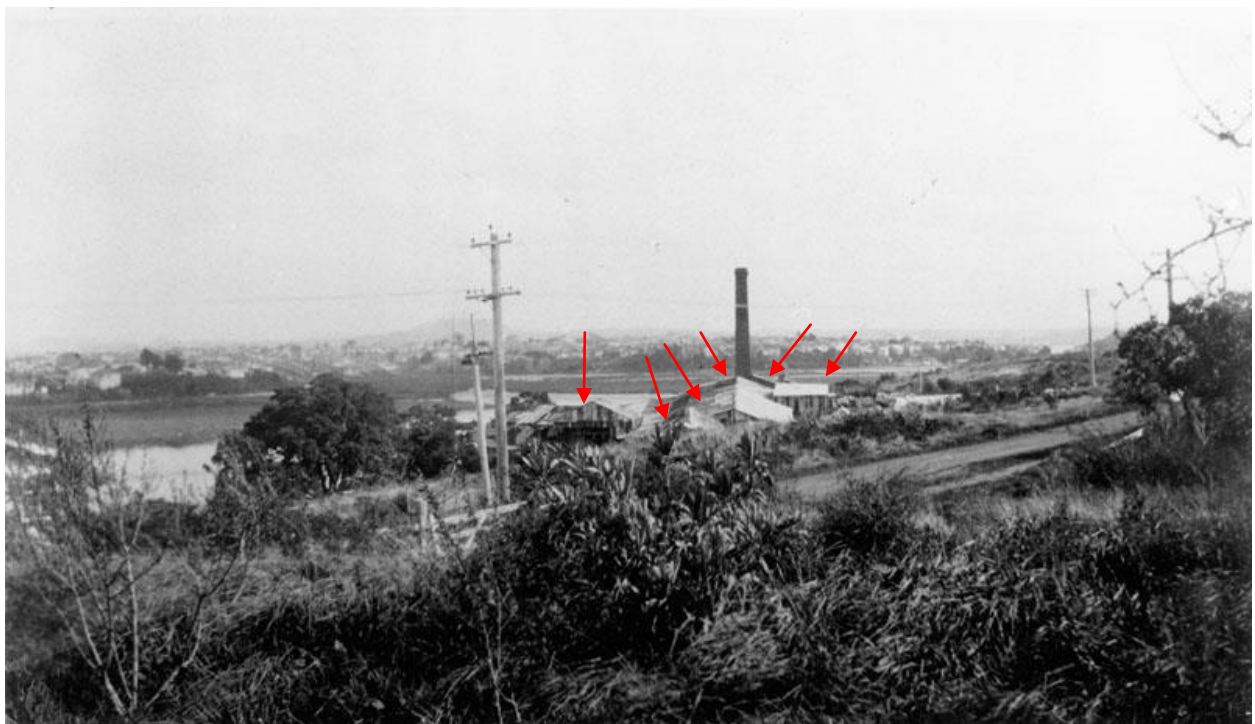
Figure 26. View towards the Duder Brickworks, dated 1932. Six building structures and the chimney are visible (arrowed). The three buildings in line to the fore of the chimney have been linked by a porch extension. Looking southwest (source: Local History Online ref.T6363)

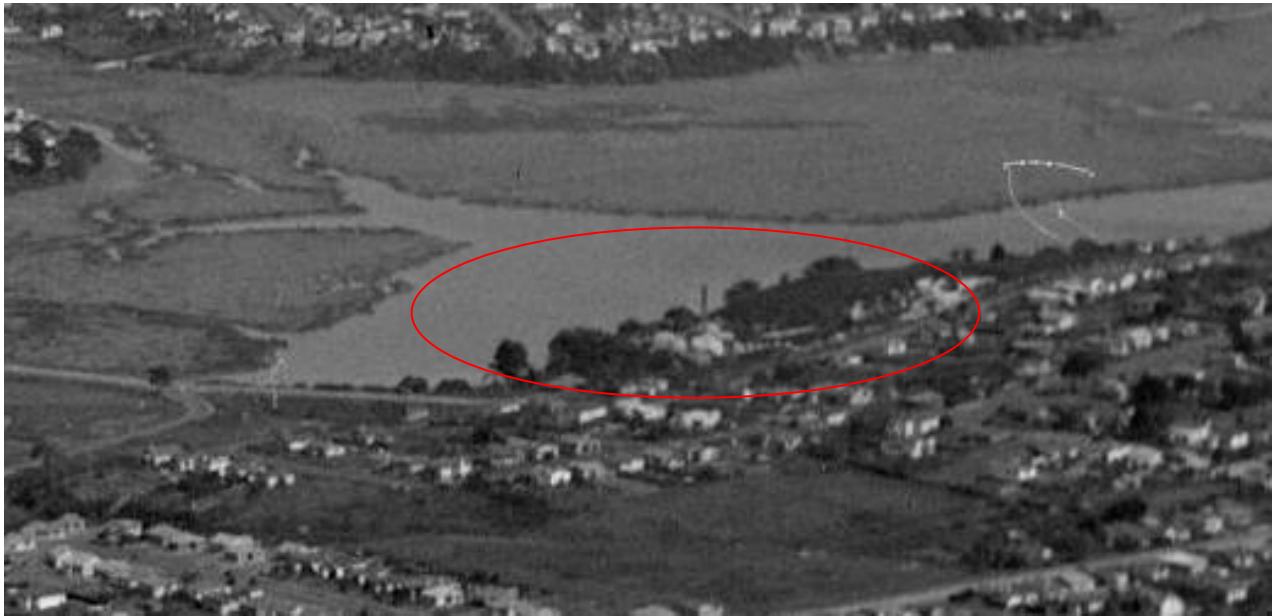
Figure 27. Detail from Whites Aviation sortie dated 1939. The chimney, which reportedly collapsed in c.1934, is still visible (source: Alexander Turnbull Library WA-55S56-G)

The 1932-1939 aerial and ground photography contradicts some of the documentary evidence, which indicates the chimney collapsed in 1934 (Figure 27). Possibly only part of the chimney collapsed. This is supported by a letter dated 1942 which stated that the remainder of the chimney was demolished by the army (Appendix 2; Figure 29).

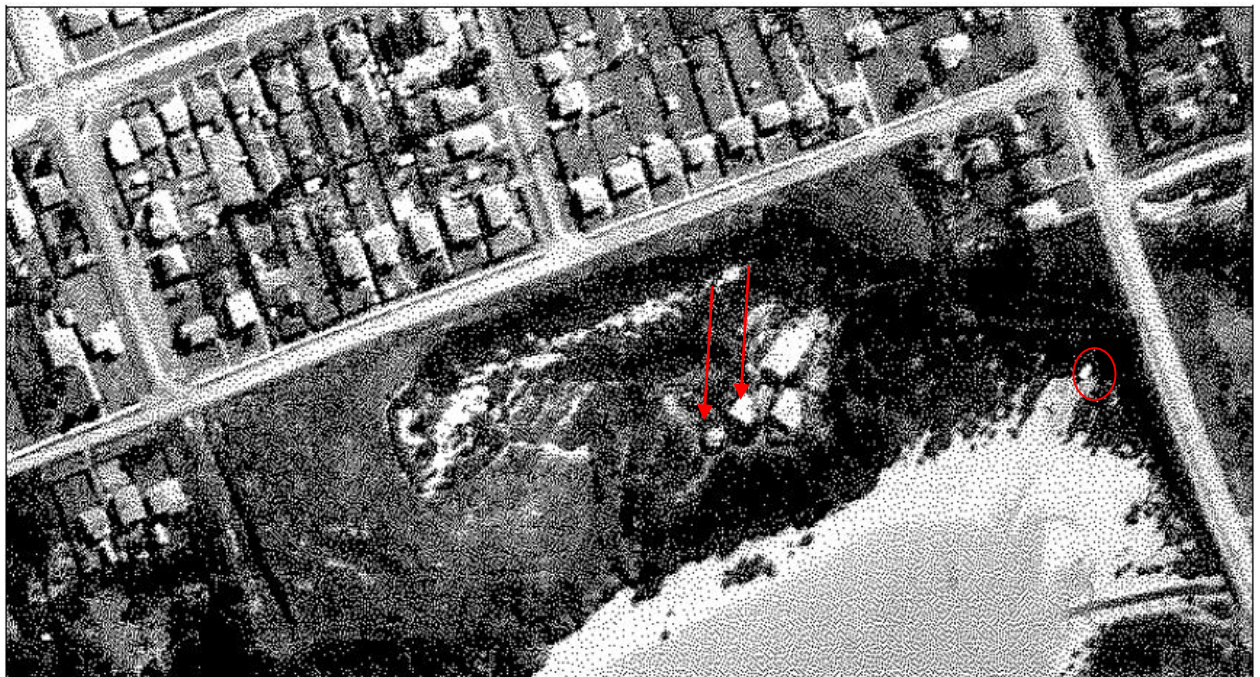
Figure 30. Detail of Whites Aviation sortie 1940s. The quarry area is clearly visible and the buildings that appear to be the square and circular kiln constructed in 1890 are arrowed. A jetty or platform (circled) is visible to the left of Lake Road (source: Whites Aviation ref 1916/32; after Opus 2010)

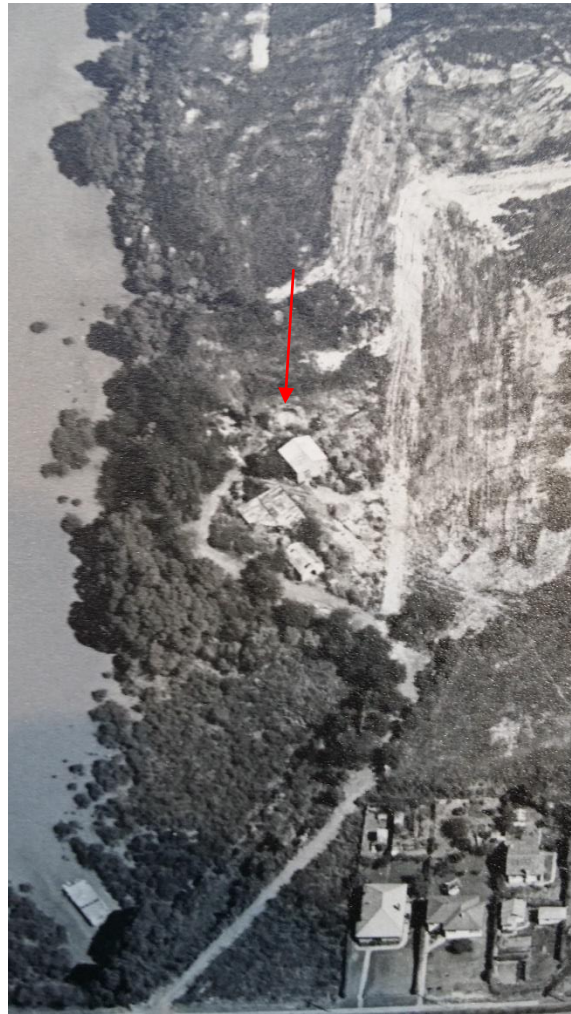
Figure 31. Detail of Whites Aviation sortie April 1952. The base of the round kiln is visible (arrowed), with three other buildings surviving. The building adjacent to the round kiln base may have been the first office of the Group Architects, although further research is needed (source: Whites Aviation ref 30498; after Philson 1990:79)

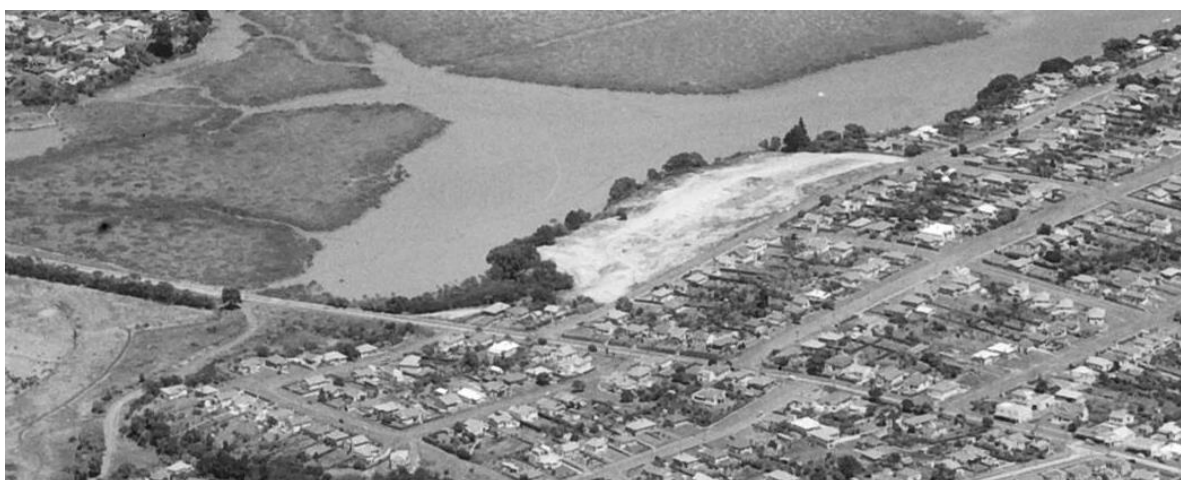
Figure 32. Detail from Whites Aviation sortie dated to 1955, showing the site cleared of standing structures and bare clay visible in many areas (source: Alexander Turnbull Library WA-36931-F)

At least four temporary buildings were known to be constructed during the World War II occupation by the Army (Figure 28). No photographic evidence or plans showing their location has been found. Following the end of World War II, the site was gradually cleared of standing structures (Figure 29 to Figure 32). An aerial in 1952 (Figure 31) shows that three structures remain (as well as the foundation of the circular kiln) and one looks to be in relatively good condition (possibly with a new roof). Documentary evidence suggests the Group Architects' office was within the project area in 1951 and 1952, so it is possibly this building. It is unclear at this stage if the structures are remains of the Brickworks, or relate to 'Camp Duder'. However it is noted in the documentary evidence that one kiln in good condition was taken by Penman c.1953. Clearance of the Brickworks and any other later structures was completed by 1955 and the area of the proposed development appears to have been stripped down to clay in most places, meaning the survival of subsurface features is not certain (Figure 32)

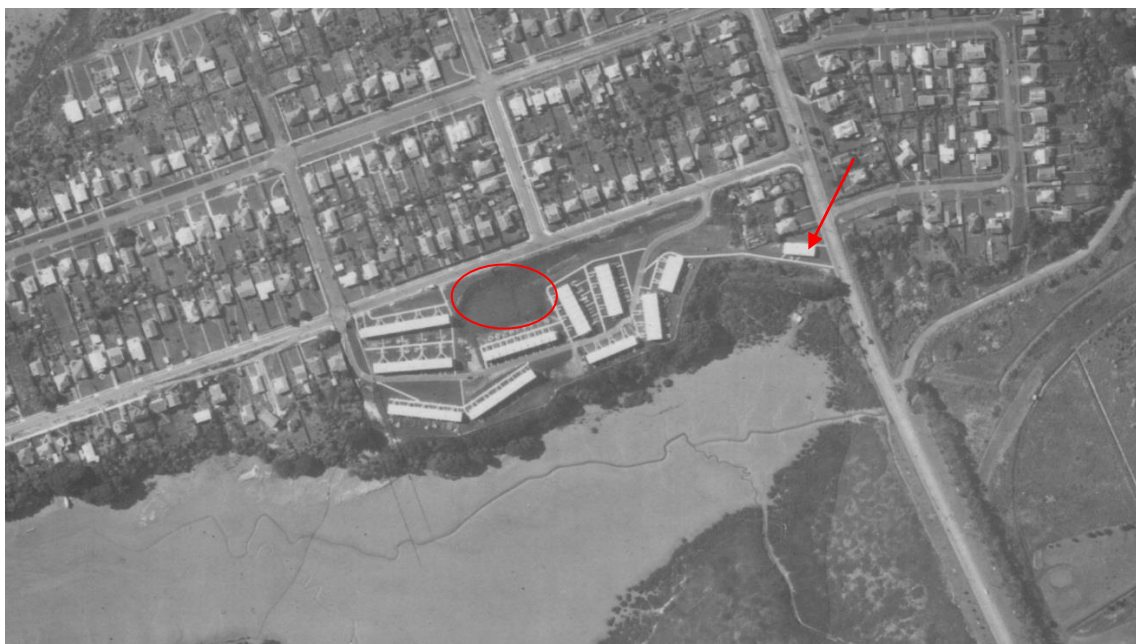
Figure 34. 1959 aerial photo showing the newly completed Navy Housing scheme based on designs by Group Architects. The duplex (arrowed), adjacent to the Brickworks manager's house at 31 Lake Road, is visible. Two apparent building platforms (circled) are visible in the centre of the site (source: Auckland Council GIS viewer accessed 2015)

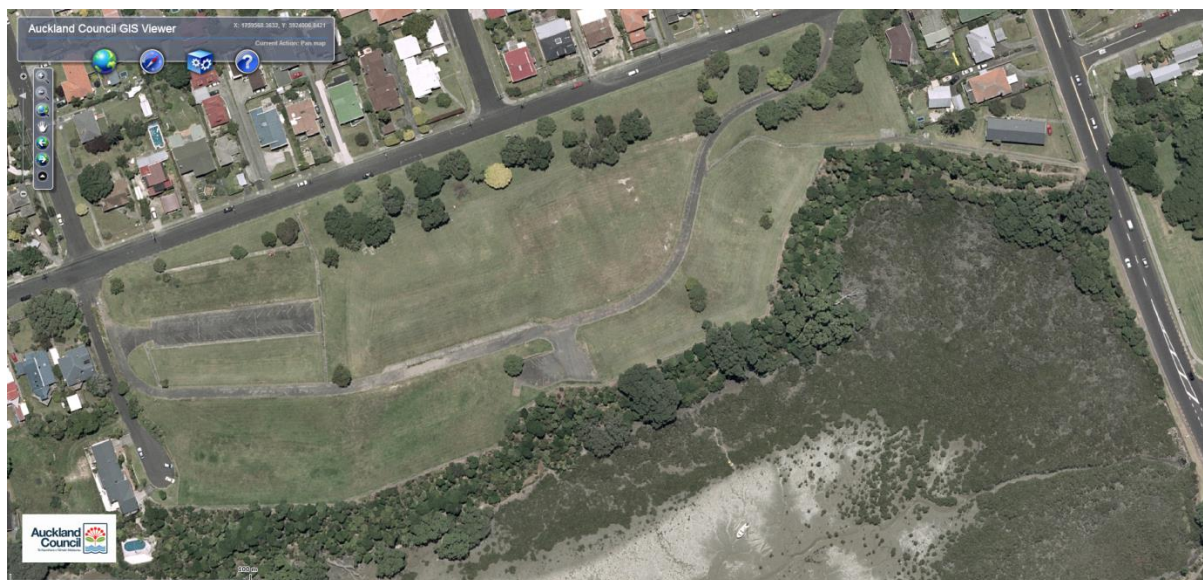
Figure 36. 2006 Aerial photograph of the site following clearance of the Navy housing in 2003 (source: Auckland Council GIS viewer accessed 2015)

Area One is where the proposed new buildings and amenities for the Ryman development would be located. It is located on a south facing slope immediately south of Ngataringa Road (Figure 36, Figure 40) and is largely covered in grass, with a former tar-sealed road now used as a path. Pohutukawa trees line Ngataringa Road to the north and regenerating bush covers the escarpment to the south. Approximately two-thirds of this area has a steep slope to the north that drops down from Ngataringa Road to the south, likely to be a quarry face for the former Brickworks. This then flattens out to an uneven platform, once occupied by the former Brickworks, camp Duder and naval houses.

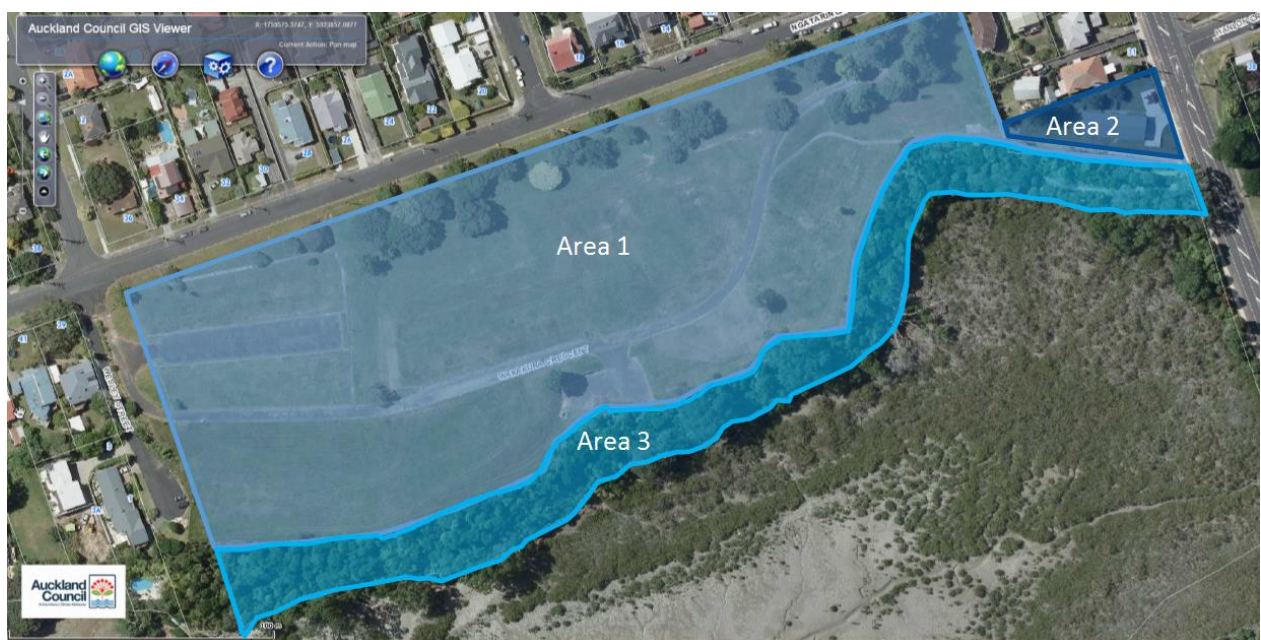
Figure 37. Areas One, Two and Three defined in the field survey

The project area broadly comprises three areas (Figure 37). The first is the area of proposed works in open space south of Ngataringa road, formerly occupied by the Duder Brickworks, Camp Duder and naval housing. The second area is the location of a residential duplex building that is to be demolished on Lake Road. The third is the coastal escarpment (walkway and coastal edge) that forms part of the scheduled Duder Brickworks site, but is not part of the proposed development (the Mary Barrett Glade). The survey results for each of these areas are described below.

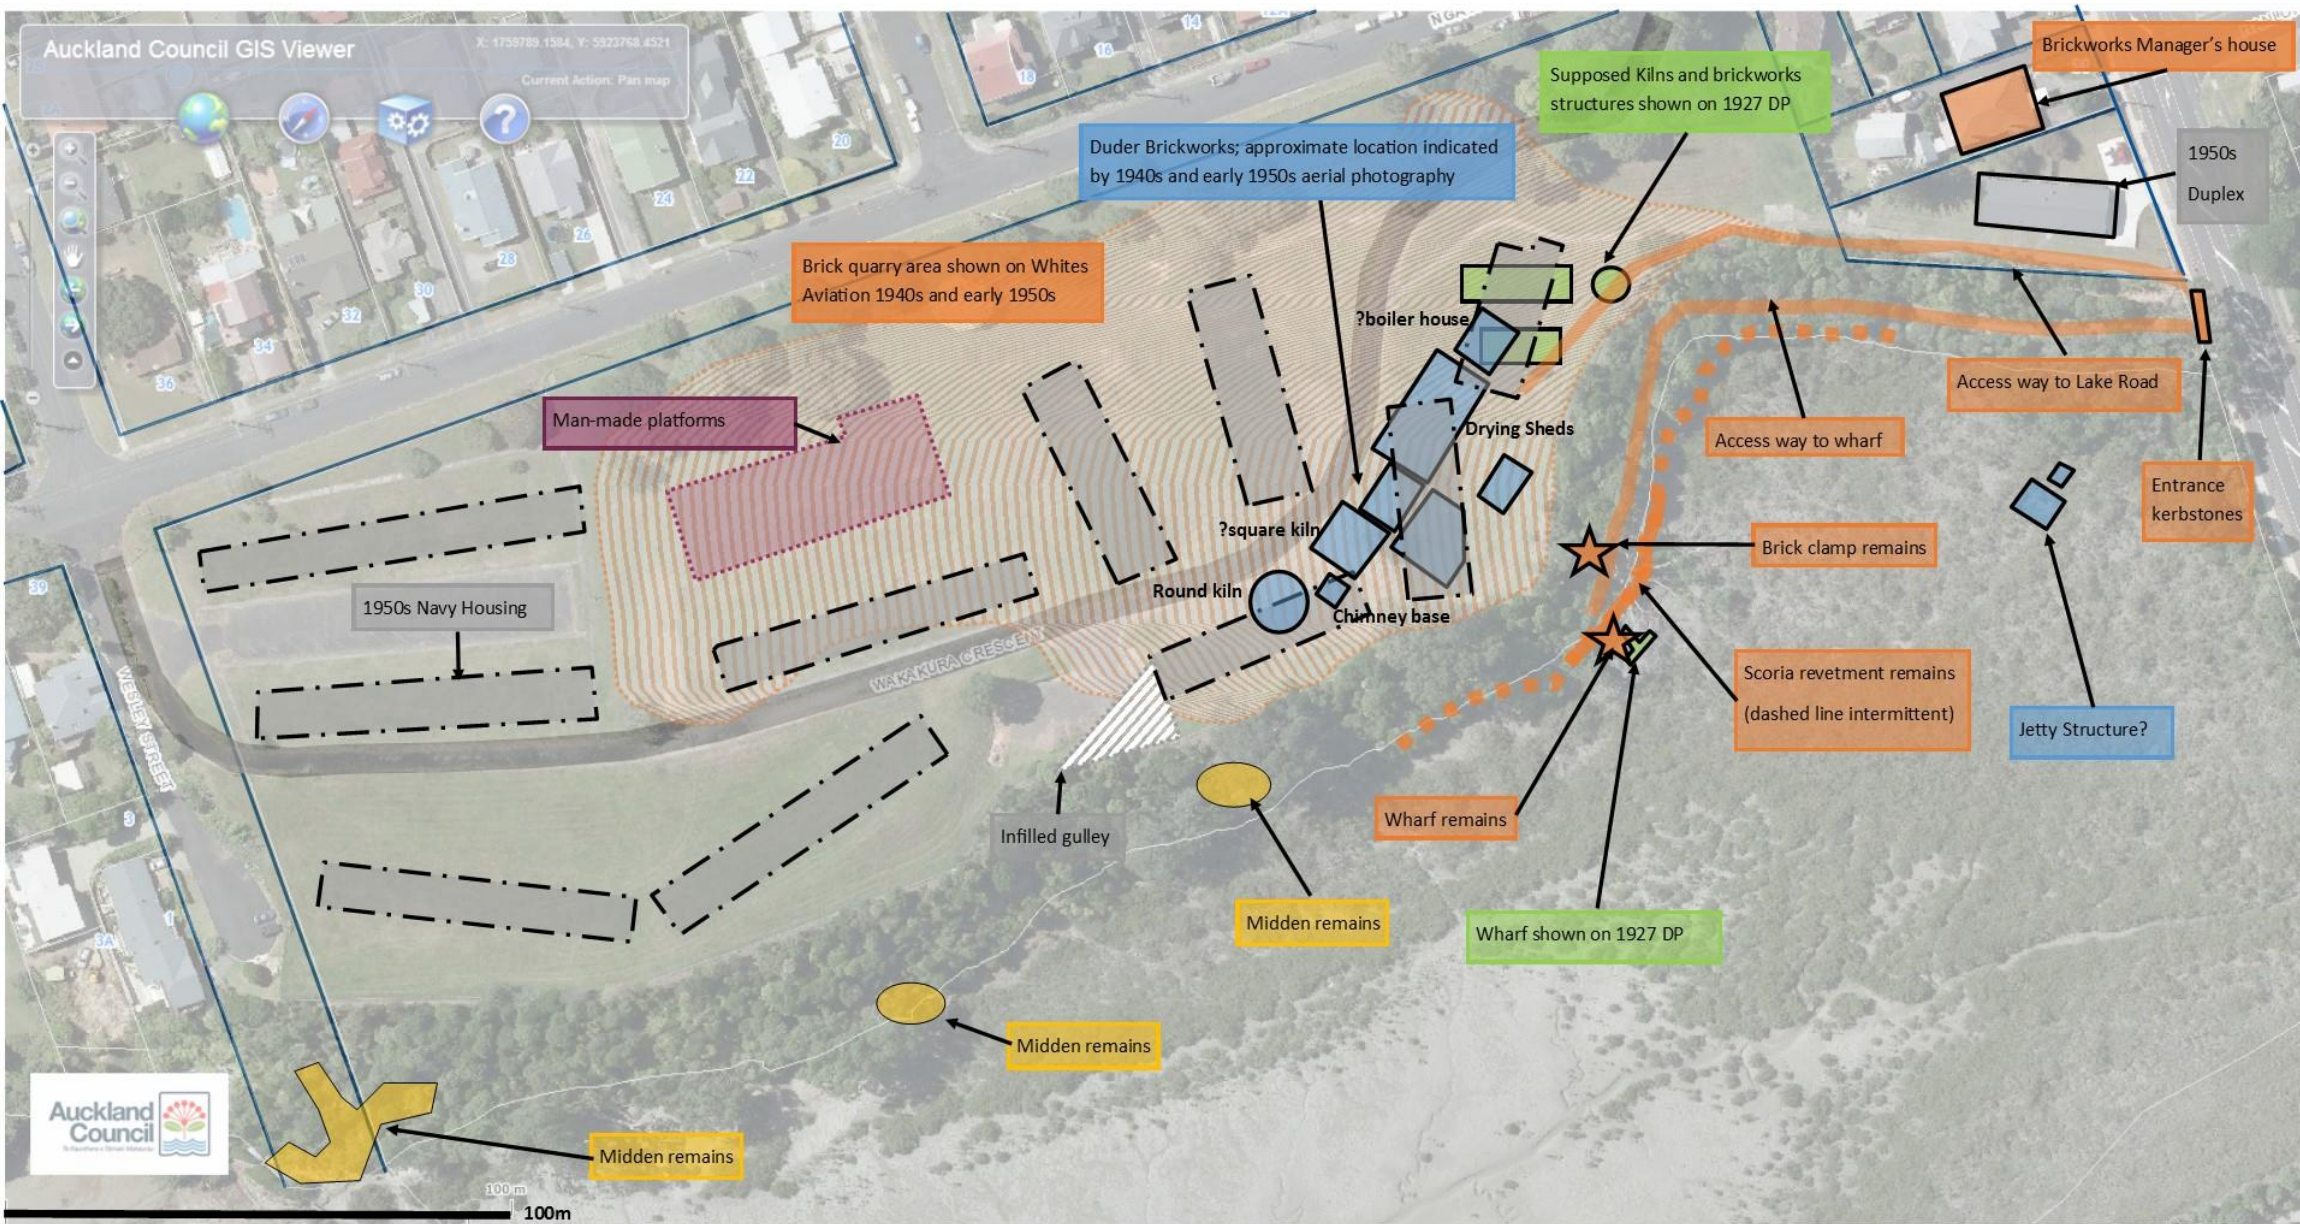
*Note: The shape and size of the demolished Brickworks structures are indicative only and their location is not georeferenced. This would need to be confirmed through archaeological investigation/ excavation (if subsurface remains are still present)

Figure 38. Known historic heritage sites identified from field survey and historic research

Figure 38 is a map of the project area showing the location and extent of relevant historic heritage sites, including the Duder Brickworks, based on the information from early plans, historic photographs and aerials (above), and from field survey. Figure 39 is a map of the project area showing the location and extent of relevant sites in relation to the development plan.

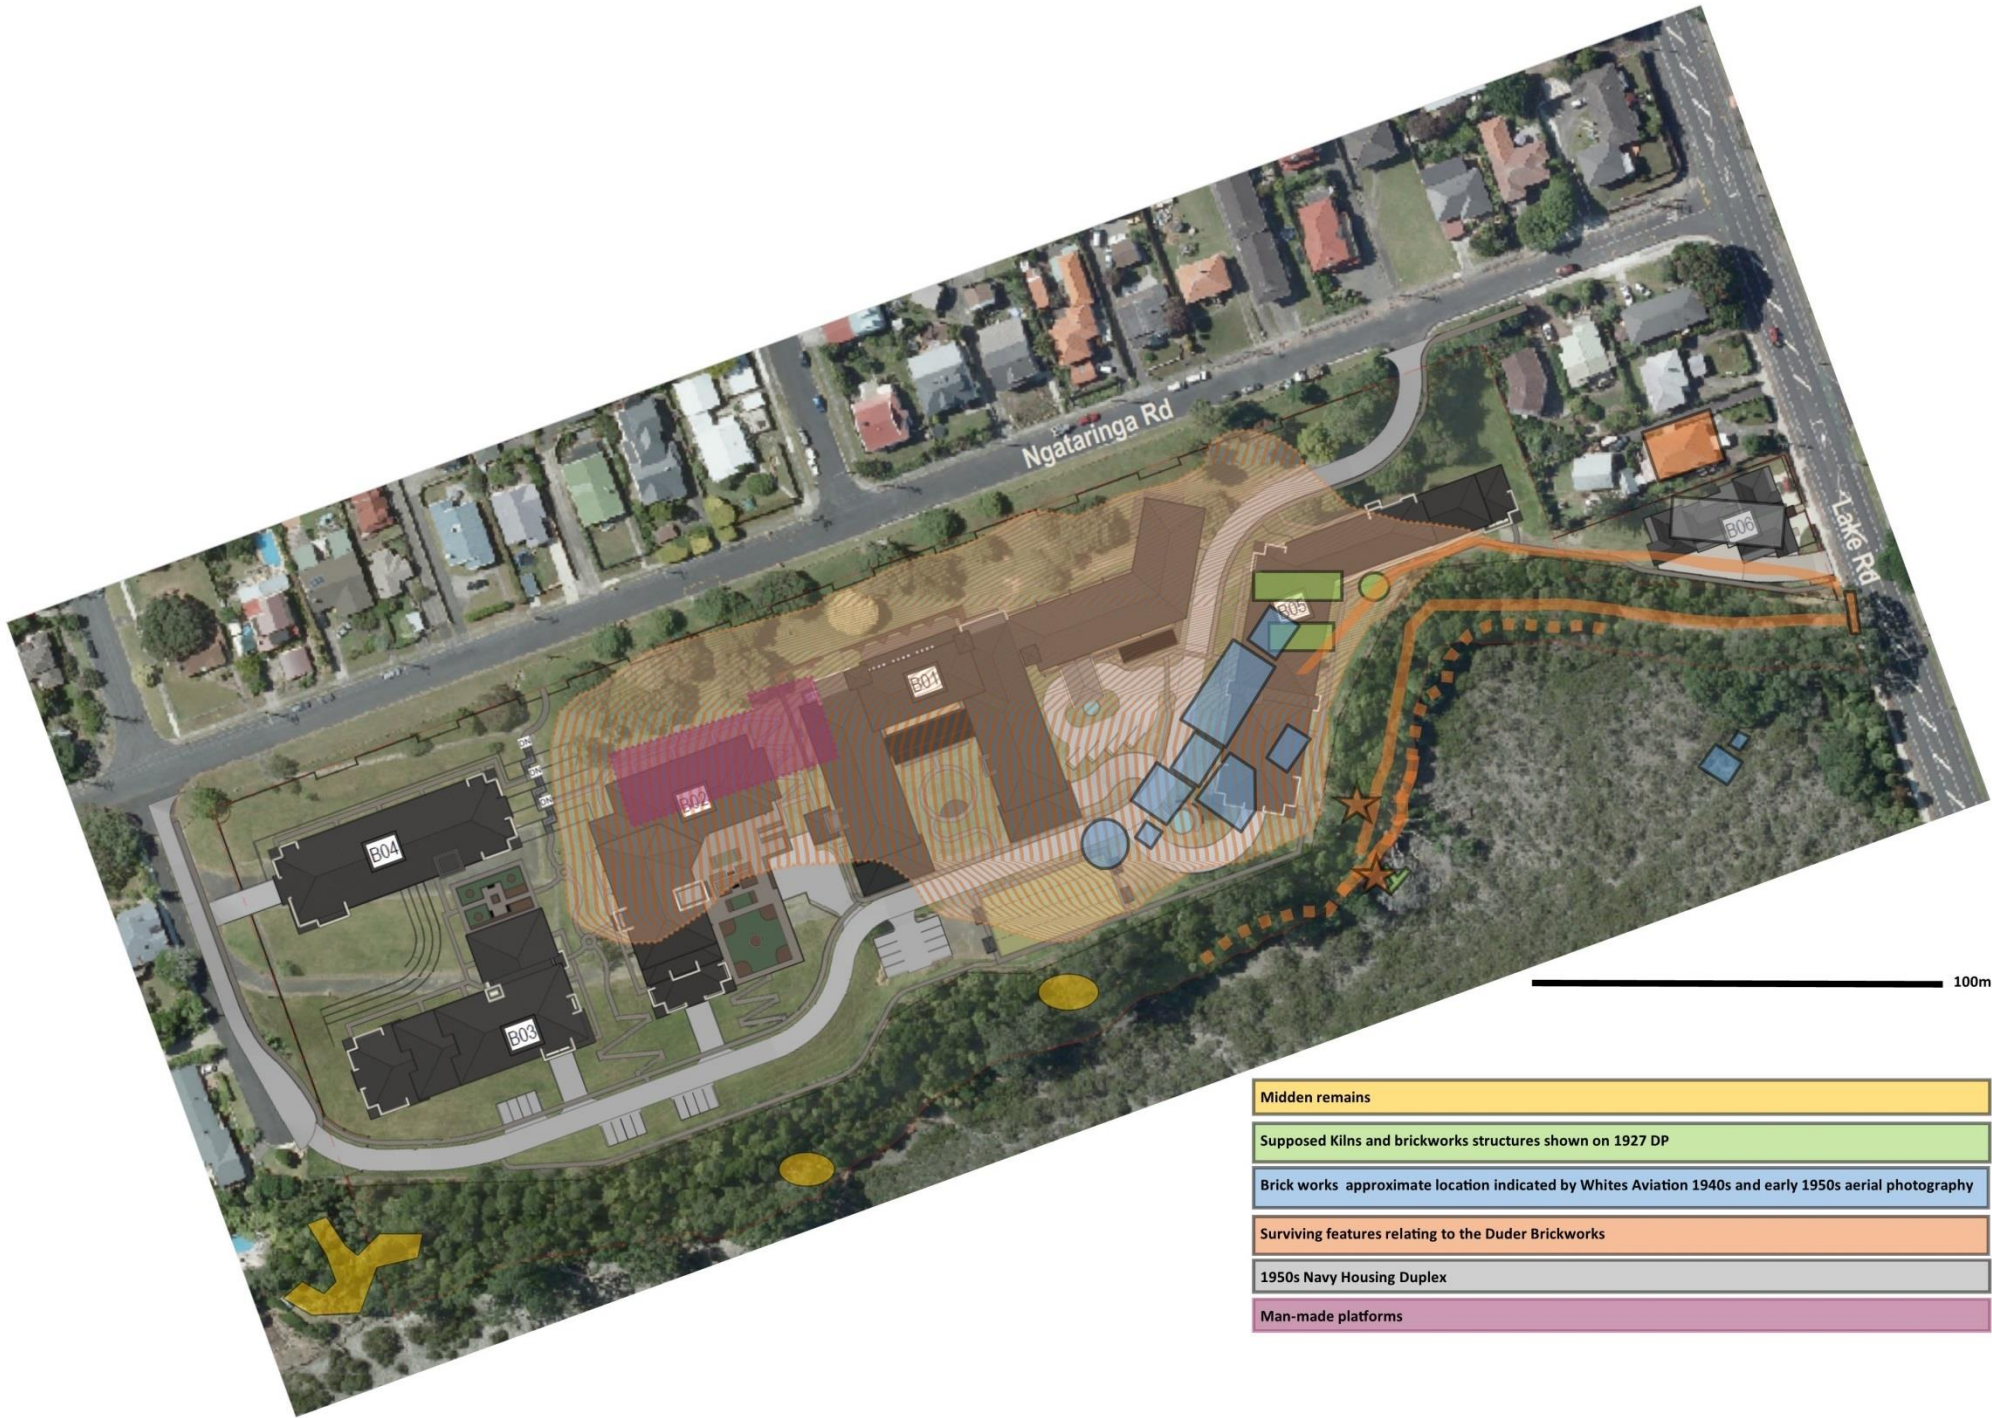
Figure 39.
Known sites (see
key) in relation
to the proposed
development

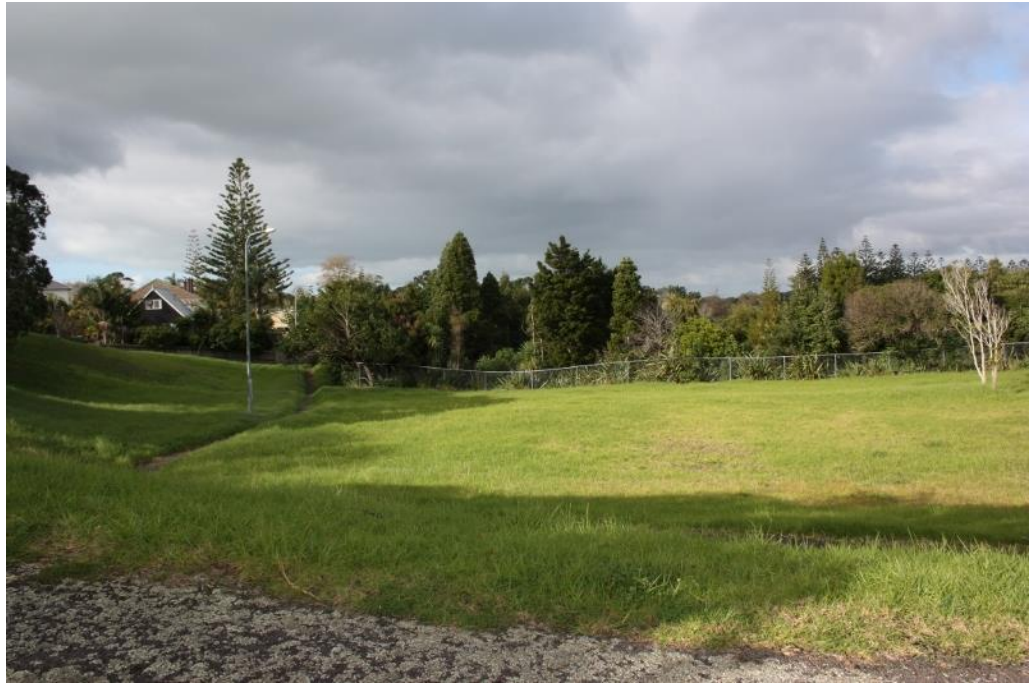
Figure 42.
Eastern end of
the project area,
where
Packington-Hall
carried out
resistivity testing,
looking east

The very eastern part of area one, just southeast of a curve in the path, is where Packington-Hall carried out resistivity testing and believed he may have found evidence for subsurface remains of a kiln (Figure 42, Figure 43). Based on research this is likely to demarcate the main eastern extent of the main Brickworks structures. Further west is a small point, with the pohutukawa tree visible, which marks the position of the in situ brick structure (possible early kiln associated with the Brickworks) on the track below. This is also roughly aligned with the wharf down on the foreshore below the escarpment (Figure 44). Based on research the Brickworks structures are likely to have extended further west, just before the gully partly filled in during preparation works for the 1950s naval development (Figure 45). This also marks the last big area of demolition debris from the Brickworks, visible on the escarpment below.

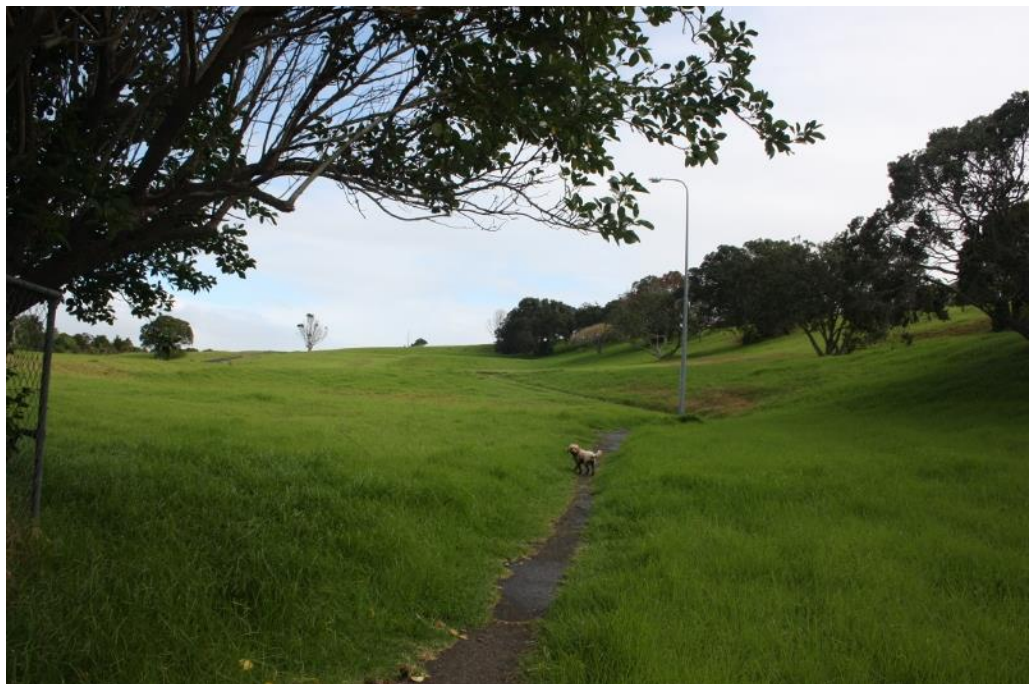
Figure 43.
Eastern end of
the project area,
where
Packington-Hall
carried out
resistivity testing,
looking west

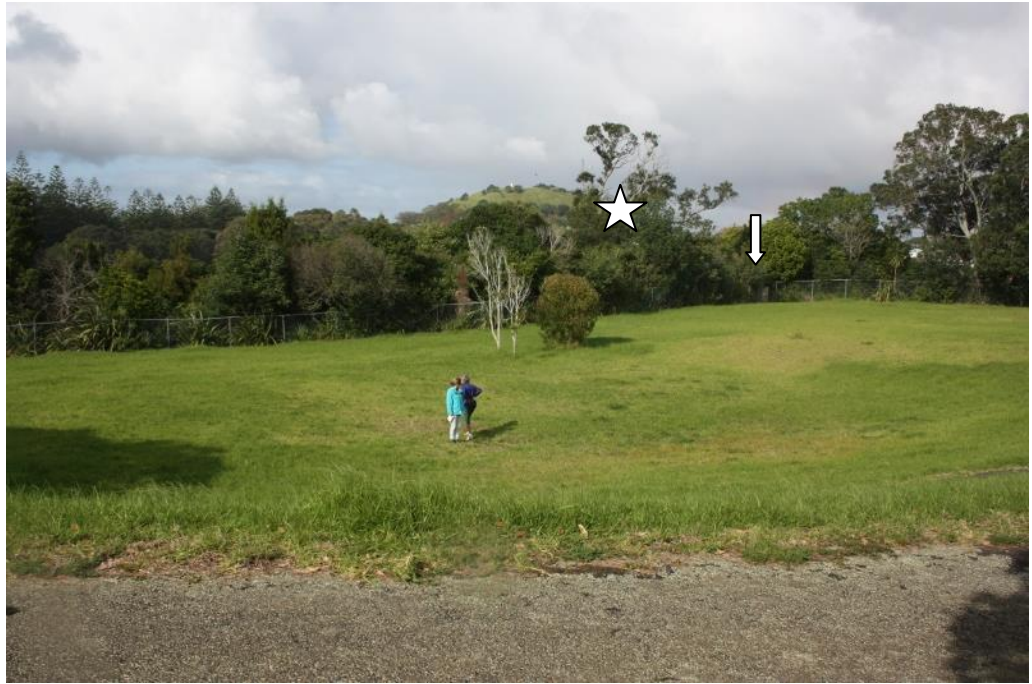
Figure 44. Photo looking south-east over the general area occupied by the Duder Brickworks. The star is over the pohutukawa tree where the only visible *in situ* brick structure associated with the Brickworks is visible (on the track below). The white arrow is the modern wood fence that is roughly aligned with the wharf down on the foreshore below

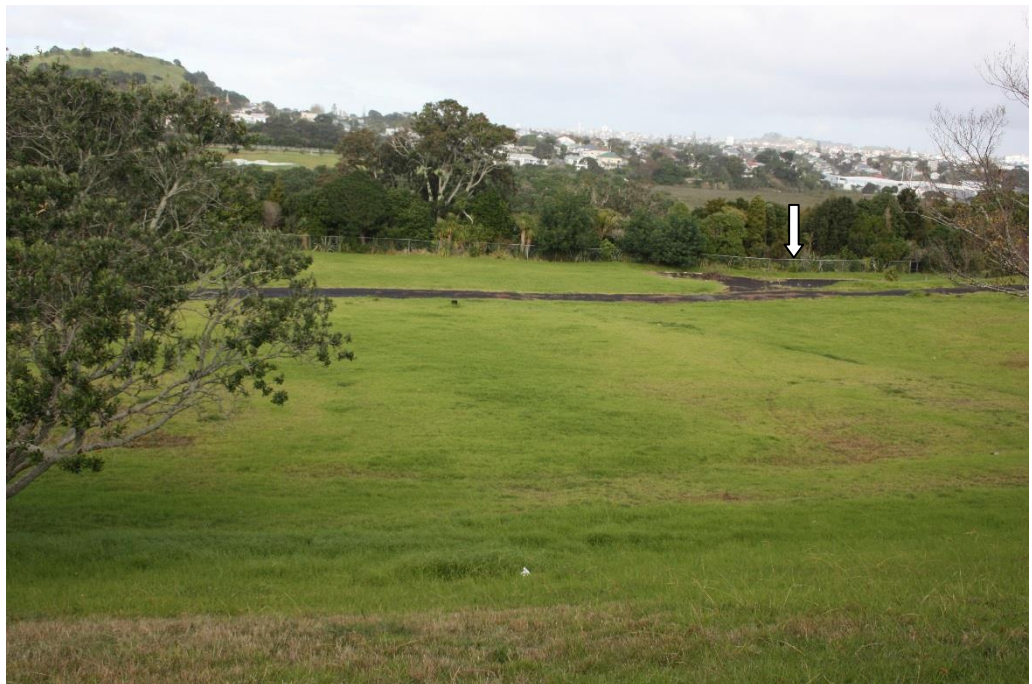
Figure 45. The arrow marks the gully partly filled in during preparation works for the 1950s naval development. This marks the last big area of demolition debris from the Brickworks visible on the escarpment below. The main Duder Brickworks structures are likely to have stopped east of the gully; photo looking south

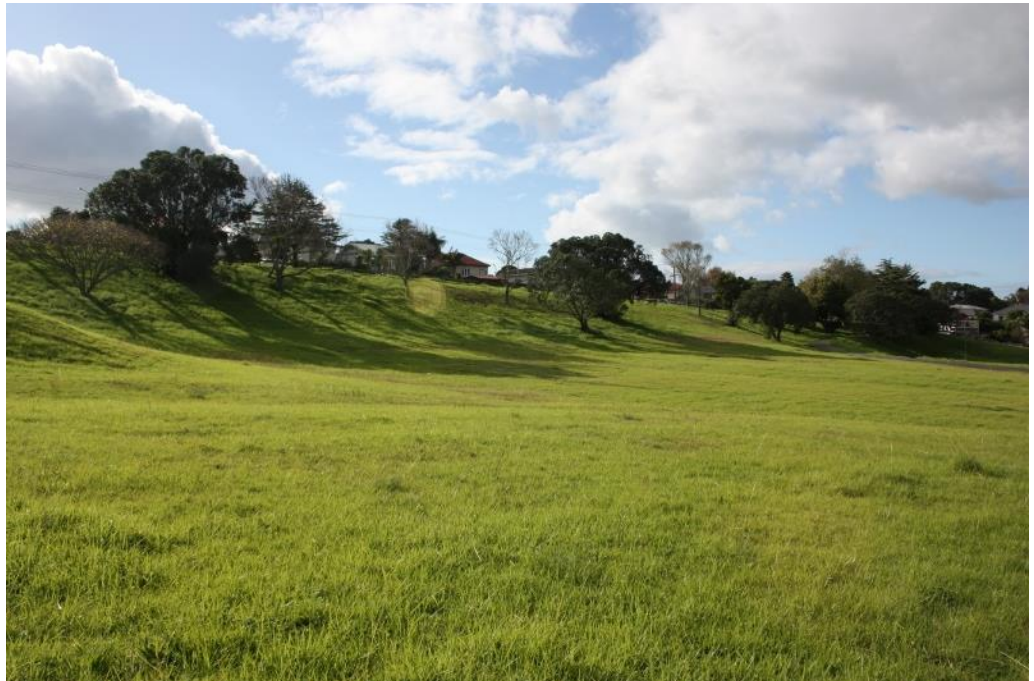
Figure 46.
Looking north-
east across the
clay pit area
towards the
quarry face

The central area part of Area One is dominated by a moderate to steep slope to the north, sweeping around in a ‘bowl’ to the west (Figure 46). This is where the clay pit was located and delineates the quarry face. Just to the south of the quarry face are also two distinctive artificial platforms, which step down to the east (Figure 47, Figure 48). They do not appear to have been built on as part of the 1950s Navy development, but were possibly a landscape feature or associated with the former 1940s military occupation of the site.
