Ryman Healthcare Limited

Ngataringa Road, Narrowneck

Volume Two

Appendices

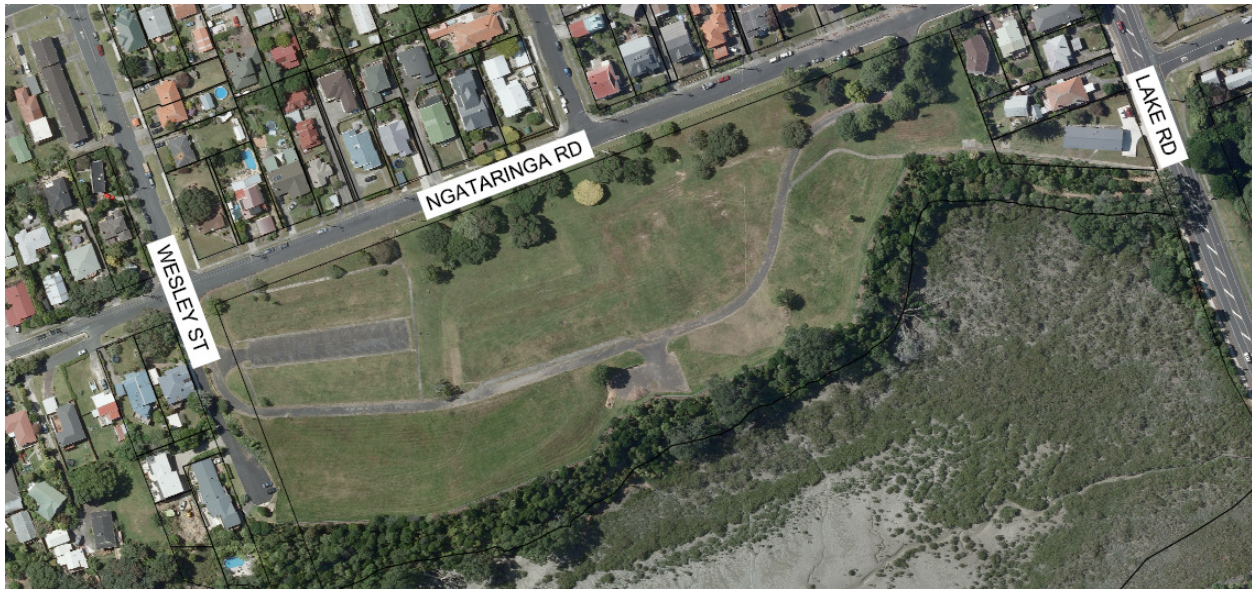
Figure 1: Site Plan

The site which is legally defined as DL/AK Navy 294-381 Lot4 DP 20927, Lot 5 DP 20927. (4.2525 Hectares) has a North Shore district plan zoning of Residential 4B. In the proposed Auckland Unitary Plan, the zoning is Mixed Housing Suburban.

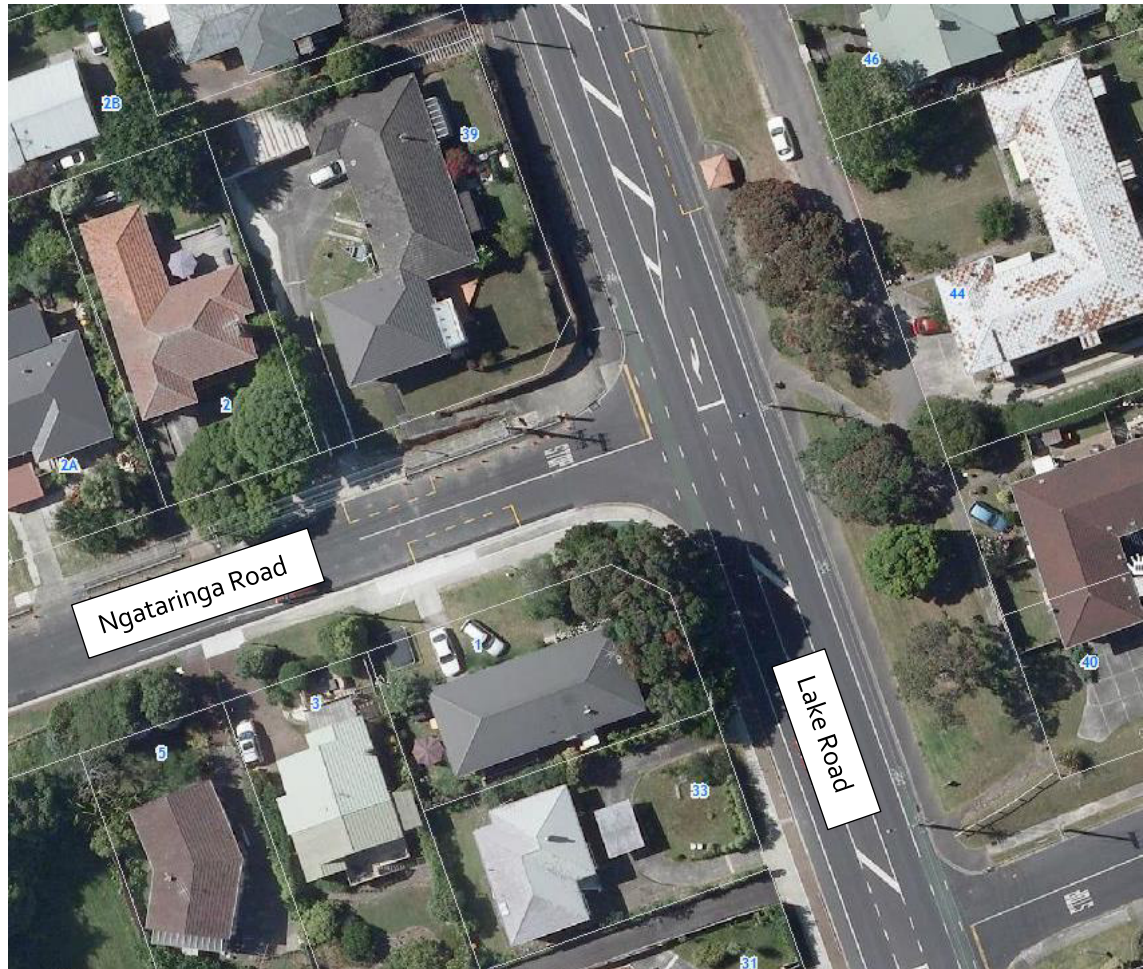
Figure 2: Lake Road/Ngataringa Road intersection

Ngataringa Road intersects with Lake Road with a priority controlled (stop sign) intersection (Figure 2). A right turn bay is provided on the southbound Lake Road approach. Motorway access is 4.5km from the site heading North West, which is around a ten-minute drive outside of peak times. From this point, motorists can travel either north towards Whangarei or south towards the Auckland CBD.

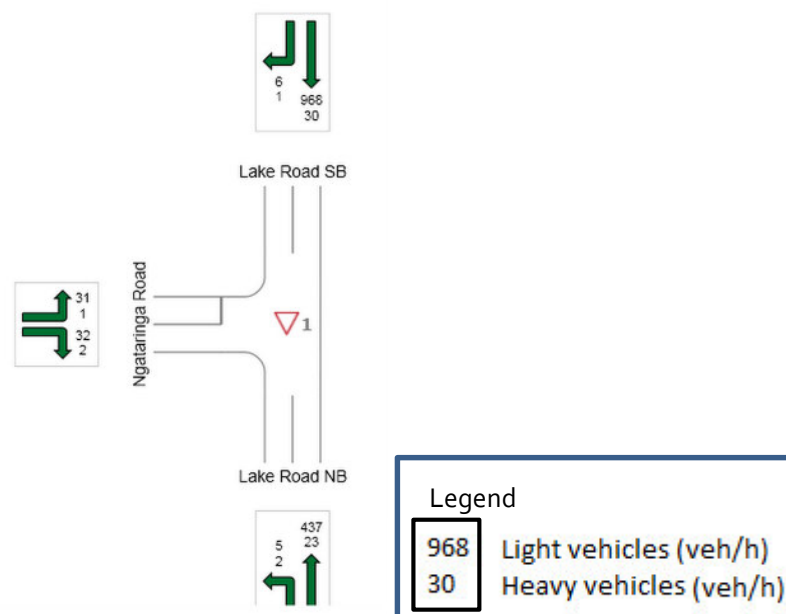
Figure 5: Weekday AM Peak Traffic (7-8am)

The survey was undertaken during the morning and evening commuter peak periods of Thursday, 20 May 2015 (7-9am and 4-6pm) as well as the midday period of Saturday, 15 May 2015 (11-2pm). The observed peak hour traffic volumes are shown in the following Figures 3 to 5.

The busiest period was found to be between 7-8am during the weekday morning survey followed by the weekday evening peak and the Saturday Middy peak.

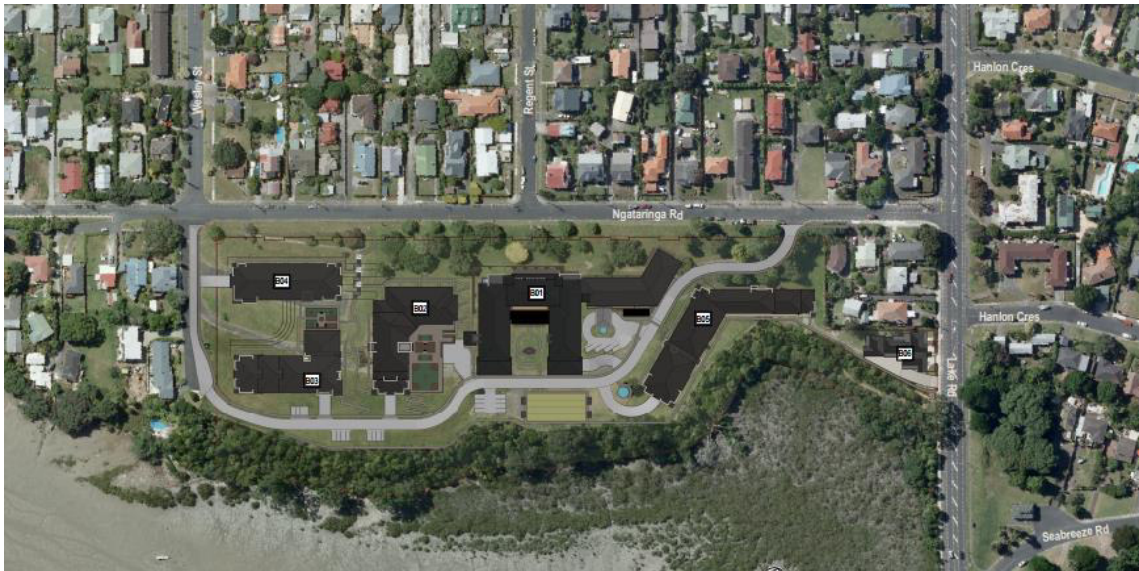
Figure 10: Retirement Village layout

- 195 Independent Apartments
- 78 Assisted living suites
- 120 care beds
- 245 internal parking spaces in buildings 1-6
- 24 external parking spaces (269 spaces in total)

Figure 10 shows the proposed layout of the site.

As noted previously, the site currently has three formed access points to the adjacent road network. As shown in Figure 10, the proposal is to maintain the primary access via the existing vehicle crossing on Ngataringa Road.

The proposed retirement village will create a new (private) internal road network as shown in Figure 10. The main access way through the site has a maximum grade of 10%, and a minimum width of 5.5m which provides for two-way access, while moderating vehicle speeds. These dimensions are in accordance with the recommended movement lane dimensions of a 'live and play' land use is a suburban area - primary access to housing contexts contained in NZS4404:2010 Land Development and Subdivision Infrastructure. These dimensions have been used extensively at other similar Ryman Healthcare sites around New Zealand without issue.

As shown in Figure 10 there is an extensive footpath network planned for the site. The connections from the site to the surrounding footpath network create good connectivity for pedestrians.

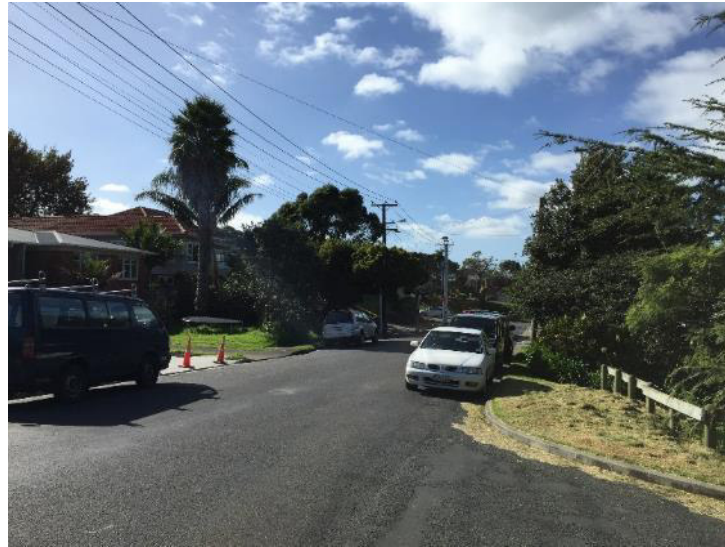
Photo 2: Sight distance to the east from retirement village access, Ngataringa Road

The sight distance to the east has been measured at 125m, which exceeds the 40m required by the NZTA RTS 6 guideline for a high volume driveway on local road and an operating speed of 50km/h. The available sight distance to the southwest is in excess of 200m and therefore also easily meets RTS6 guidelines.

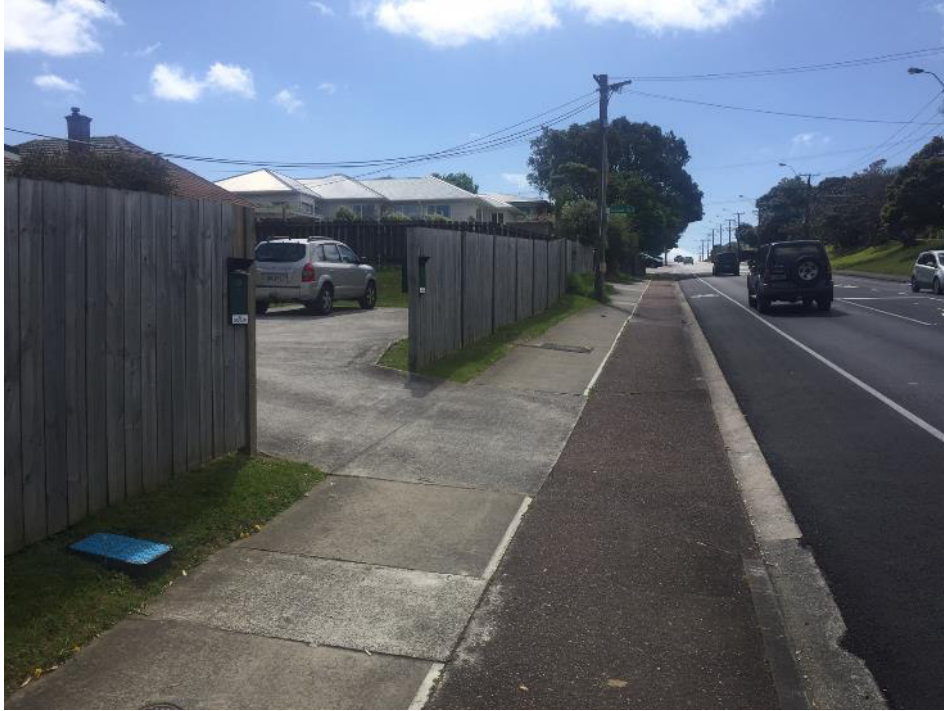
Photograph 6: Current vehicle crossing on Lake Road

An existing vehicle crossing is provided at 29 Lake Road (Photograph 6). This will be removed as part of the work and relocated against the southern extent of the property. The proposed crossing is 6.5m wide at the property boundary.

The sight distance to the north and south has been measured at over 200m, which easily exceeds the 115m required by the NZTA RTS 6 guideline for a low volume driveway on an arterial road and an operating speed of 60km/h.

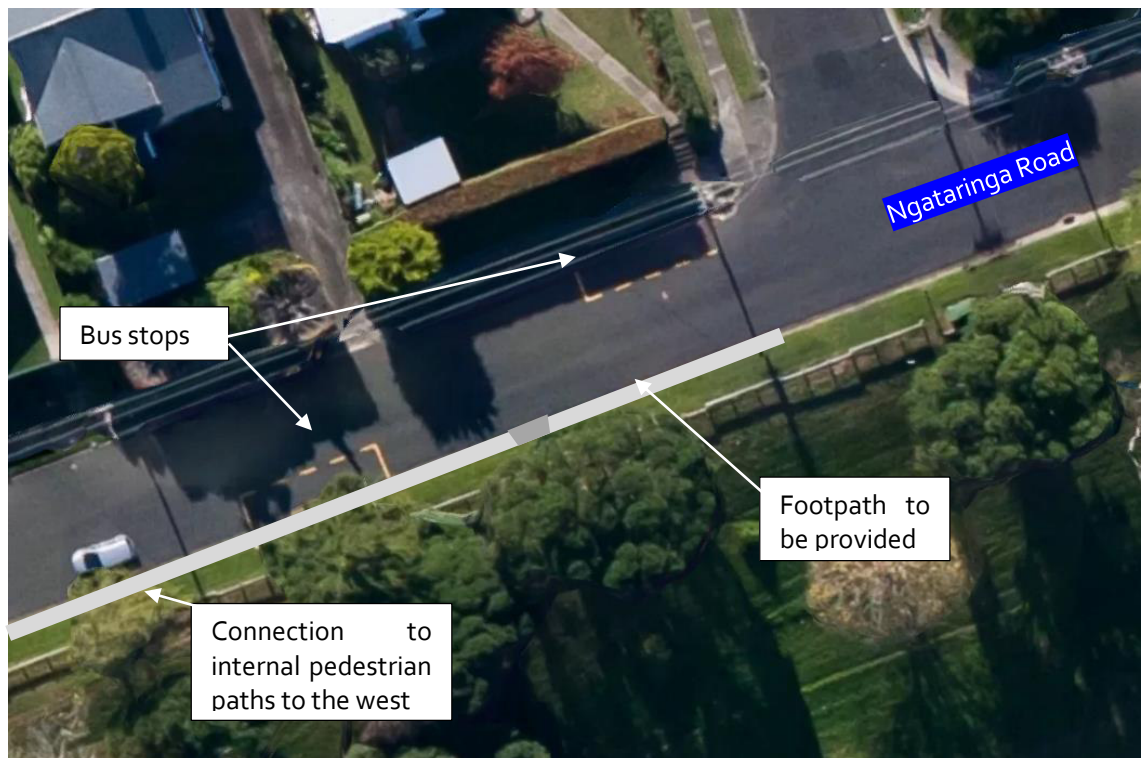
Figure 11: Proposed changes around Ngataranga Road Bus stops

Currently a bus stop is situated on the southern side of Ngataranga Road along the proposed site frontage. No footpaths are provided on either side of this stop. As discussed in Section 2.2, Service 815 that uses the stop as present is not included in the recently consulted new network. If the bus stop is retained on Ngataranga Road, a pedestrian connection to the stop is recommended as per Figure 11.

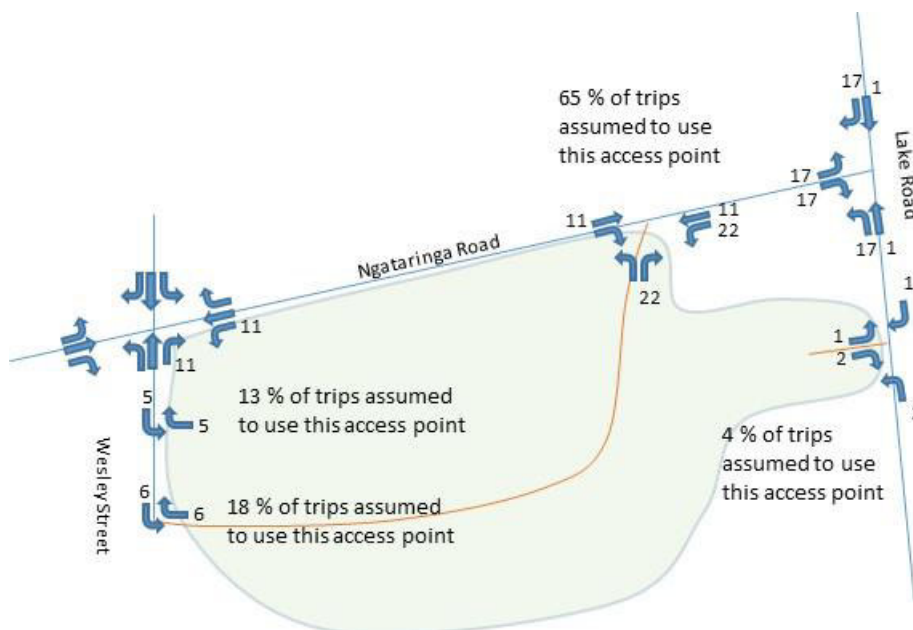
Figure 12: Distribution of retirement village traffic (all peaks)

The assumed village traffic distribution is set out in Figure 12. Survey information from other Ryman villages indicate a 50% split between vehicles entering the site and vehicles exiting the site within peak periods. This accounts for staff arriving and residents leaving in the morning and staff leaving and residents arriving in the evening.

- (iii) The Entry / Exit volume ratio for both morning, evening and Saturday peak has been assumed to be 50:50 to account for staff arriving and residents leaving in the morning and staff leaving and residents arriving in the evening.

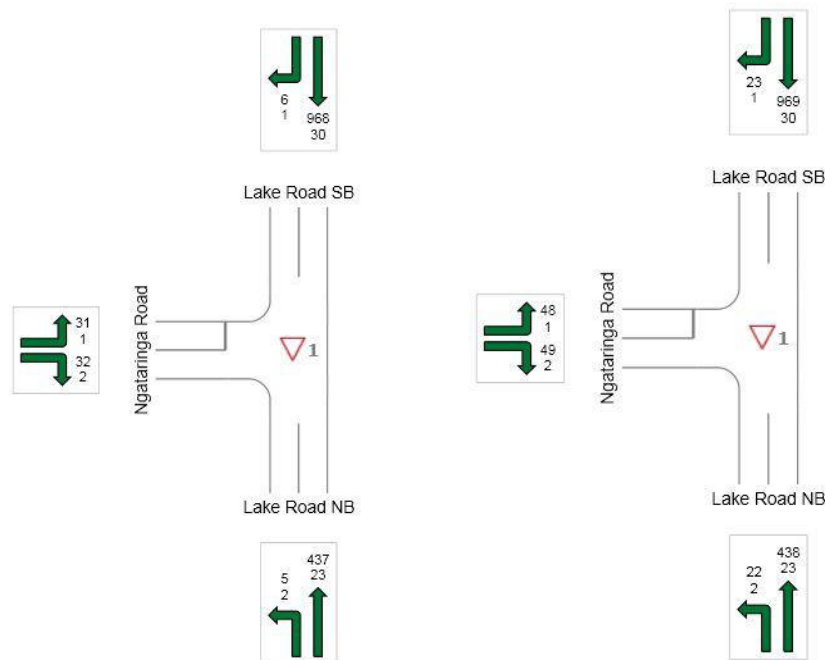
Figure 14: Weekday AM Peak turning counts for Base (left) and proposed retirement village (right)

The surveyed base turning volumes and the anticipated traffic volumes as a result of the retirement village are shown in Figure 14.

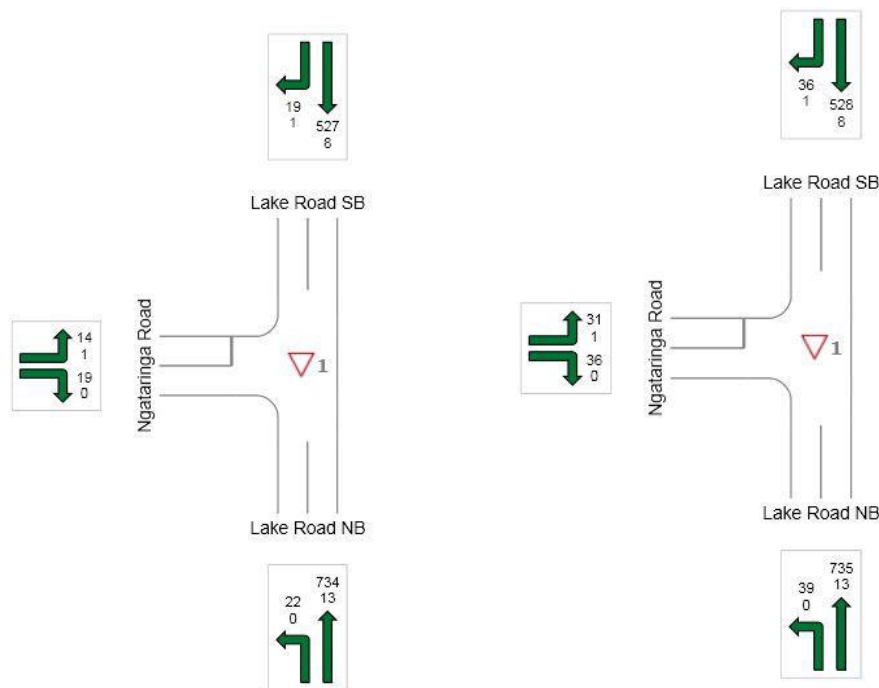
Figure 15: Weekday Evening Peak turning counts for Base (left) and development (right)

The surveyed base turning volumes and the anticipated traffic volumes as a result of the retirement village are shown in Figure 15.

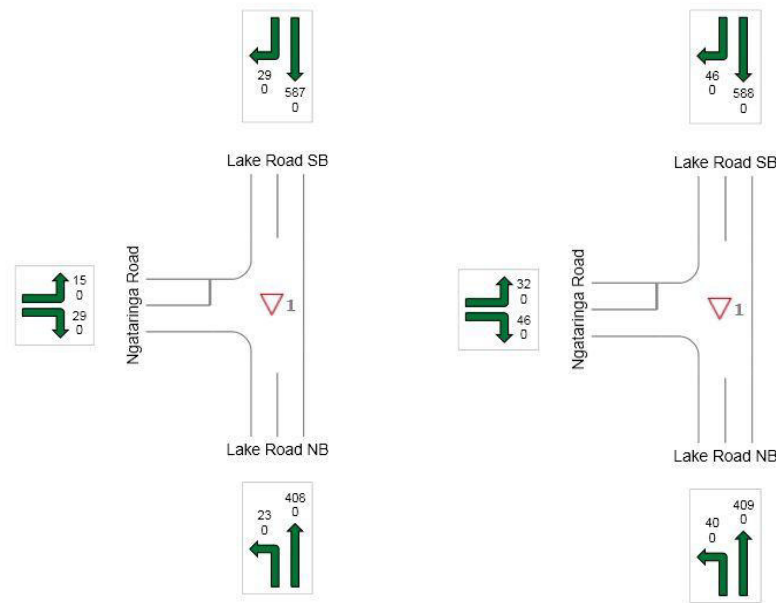
Figure 16: Weekend peak turning counts for Base (left) and proposed retirement village (right)

The surveyed Saturday peak hour (12pm-1pm) turning volumes and the anticipated traffic volumes as a result of the proposed retirement village are shown in Figure 16.

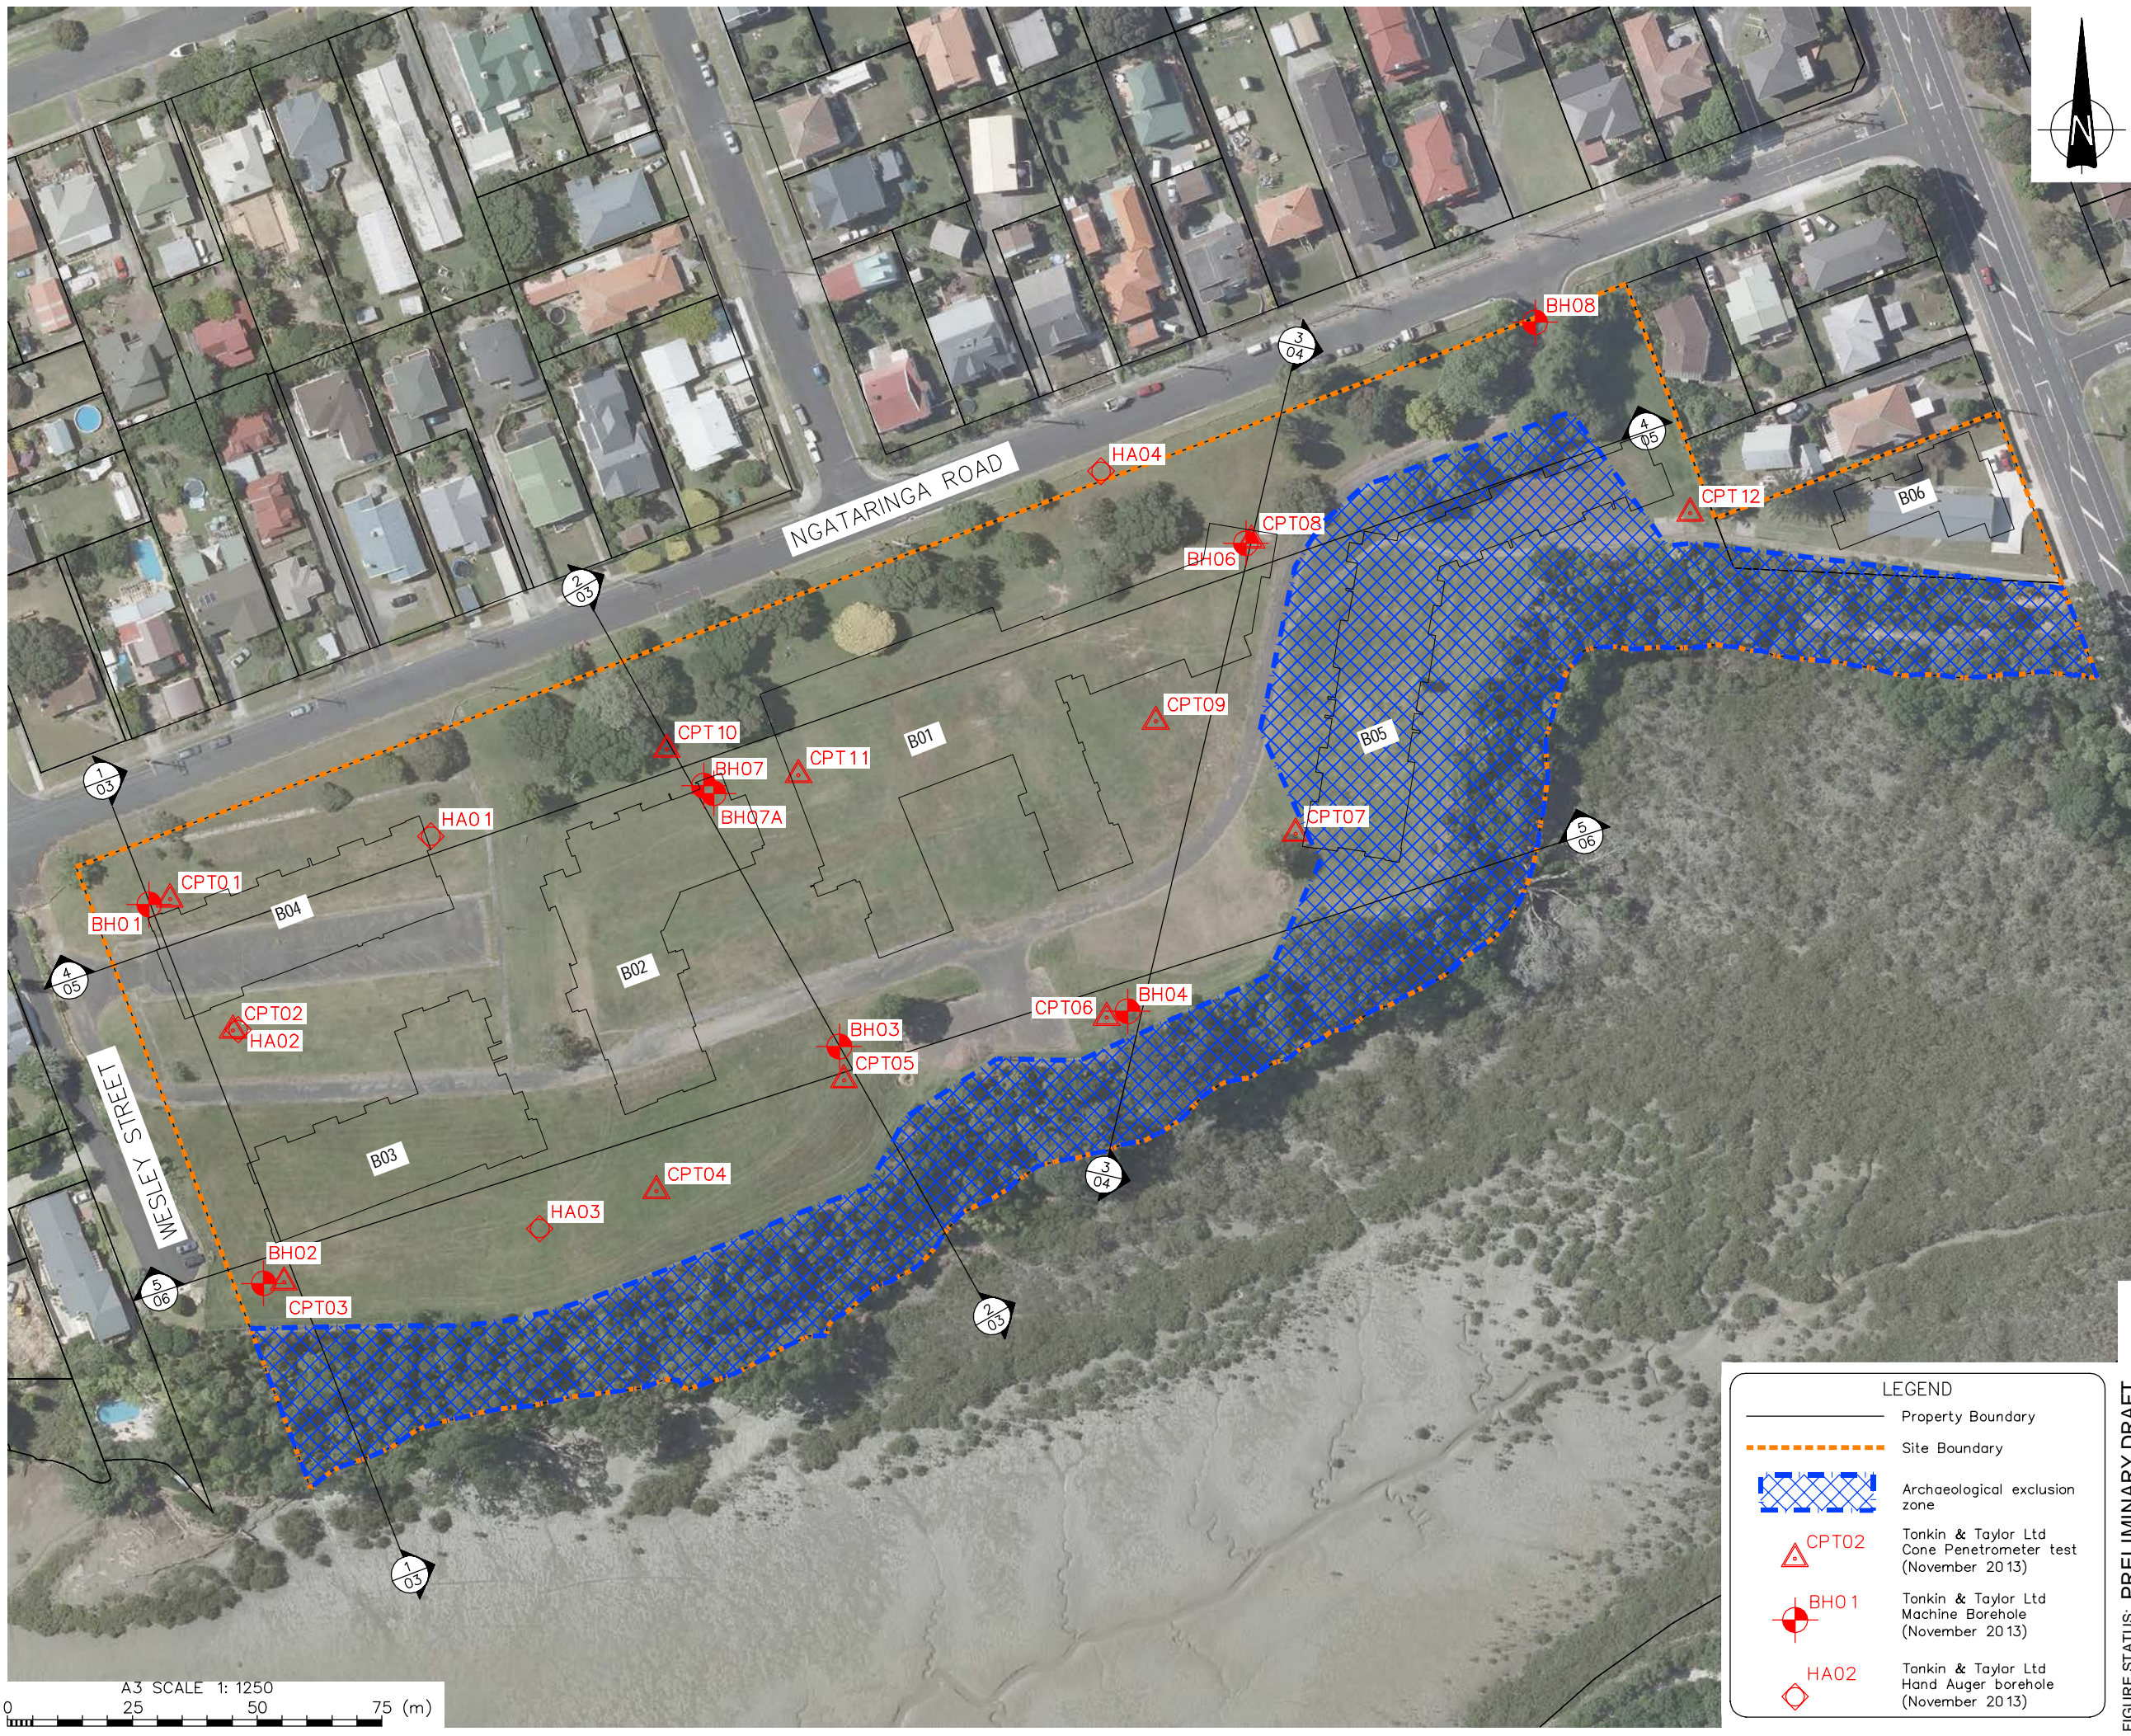
- NOTES :
1. All dimensions are in millimetres unless noted otherwise.
 2. Contours and Cadastral GIS information supplied by Auckland City Council.
 3. Coordinate Datum: NZGD2000, Mt Eden Circuit Coordinates. Origin: Lat 36 52 47S Long 174 45 51E 800,000mN 400,000mE
 4. Building layout/elevations shown are approximate only and based on drawings supplied by Ryman Ltd received by Tonkin & Taylor Ltd on 16 October 2015.

The basements at the site can be designed as drained, partially drained or impermeable. The proposed basement extent and groundwater data is shown on the figures attached in Appendix A. As noted in Section 2.6, groundwater has been consistently recorded in the weathered ECBF rock, and not in the overlying soils, and is consistently more than 3 m below the ground surface during normal operating conditions.

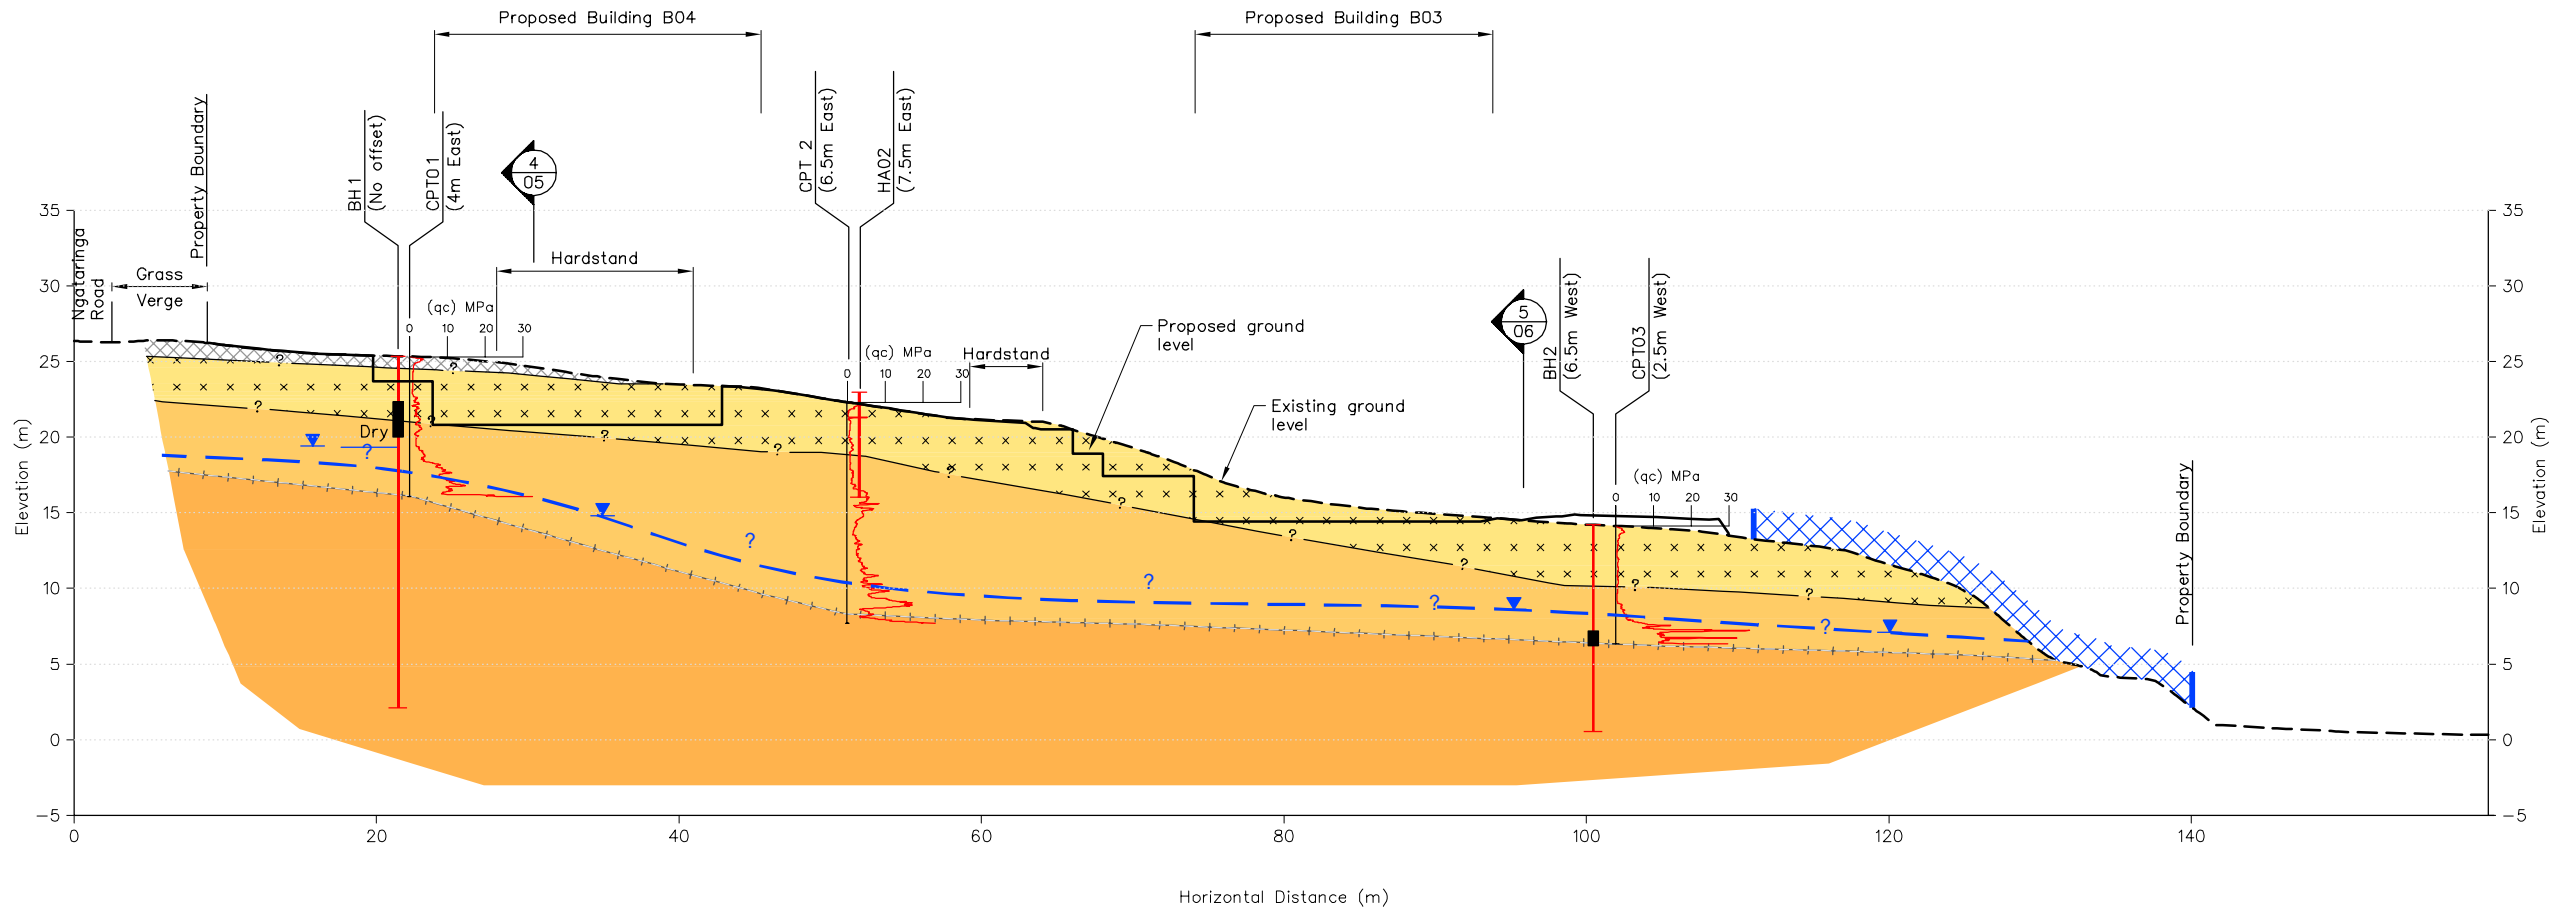
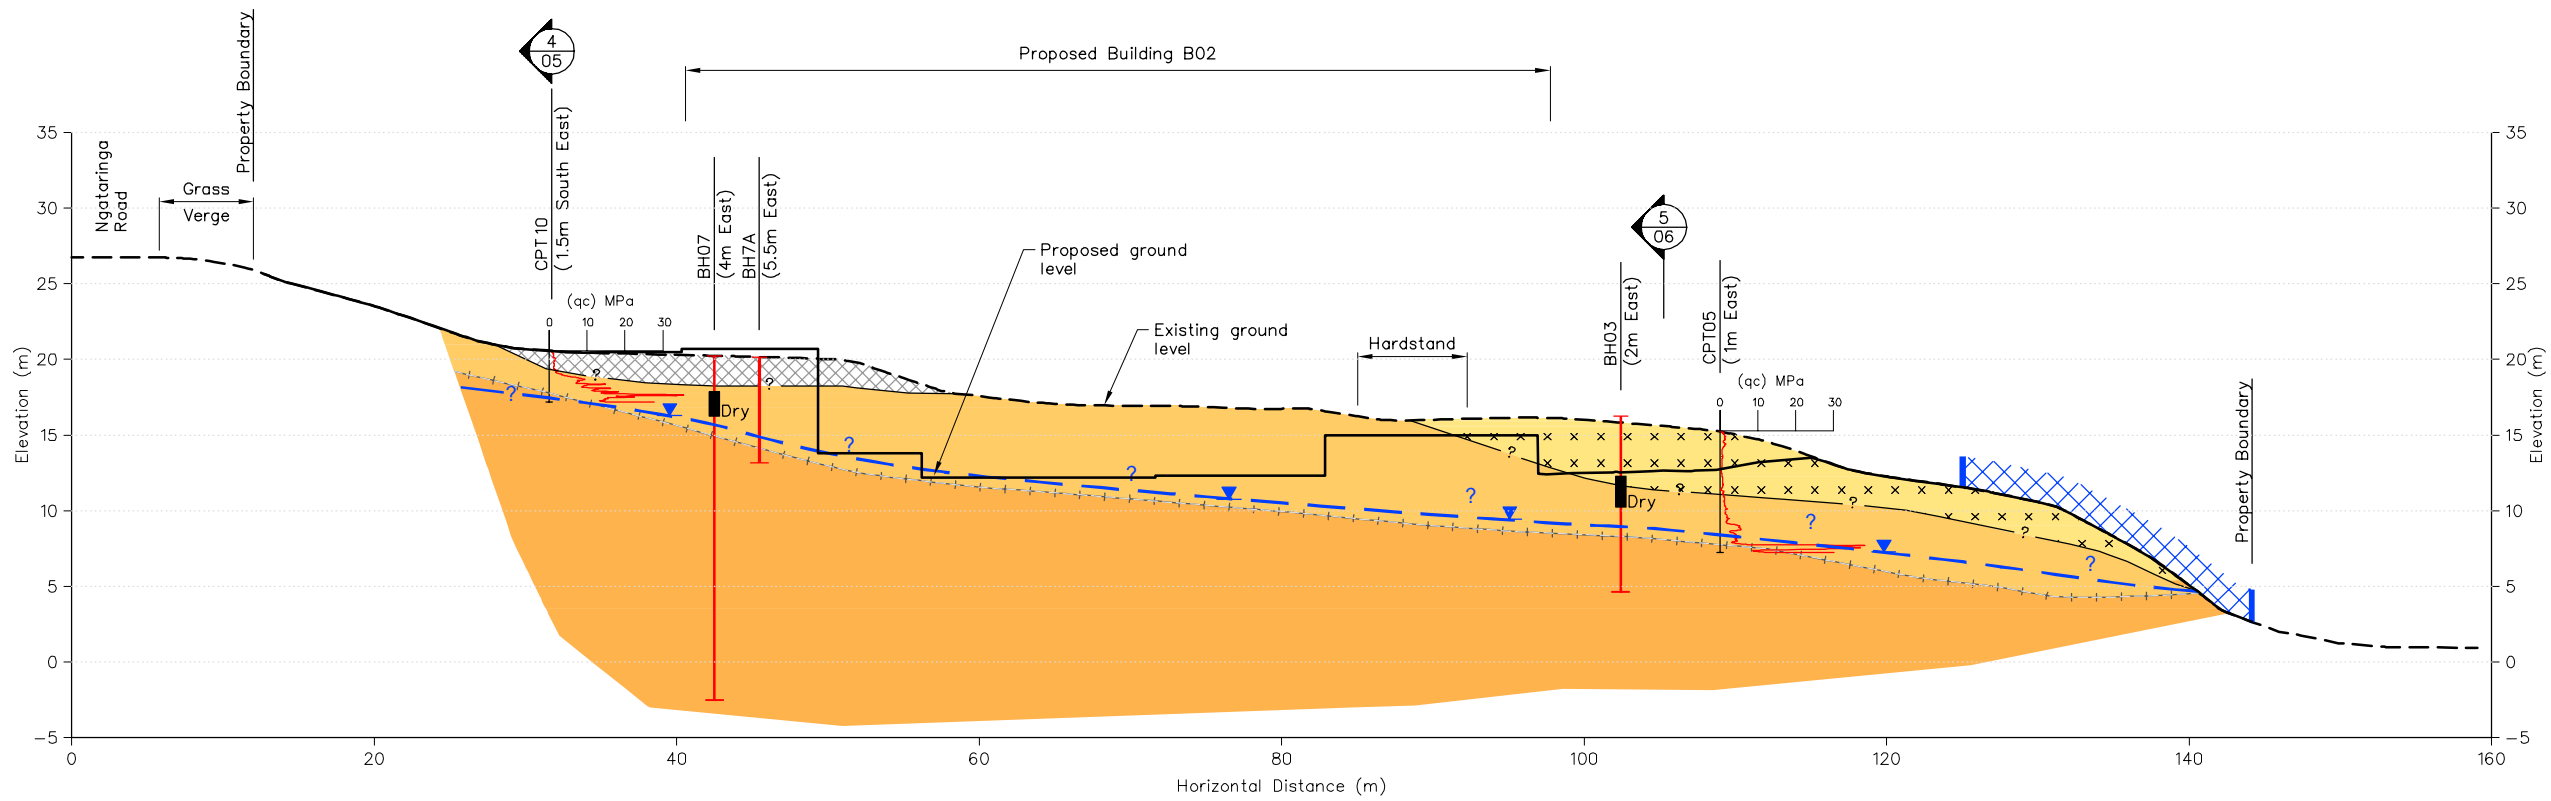
SCALES (AT A3 SIZE) AS SHOWN		
PROJECT No. 29452		
FIG. No.		REV.
Figure 3		0

SECTION 1 1
SCALE 1:500 01 02

SECTION 2 2
SCALE 1:500 01 02

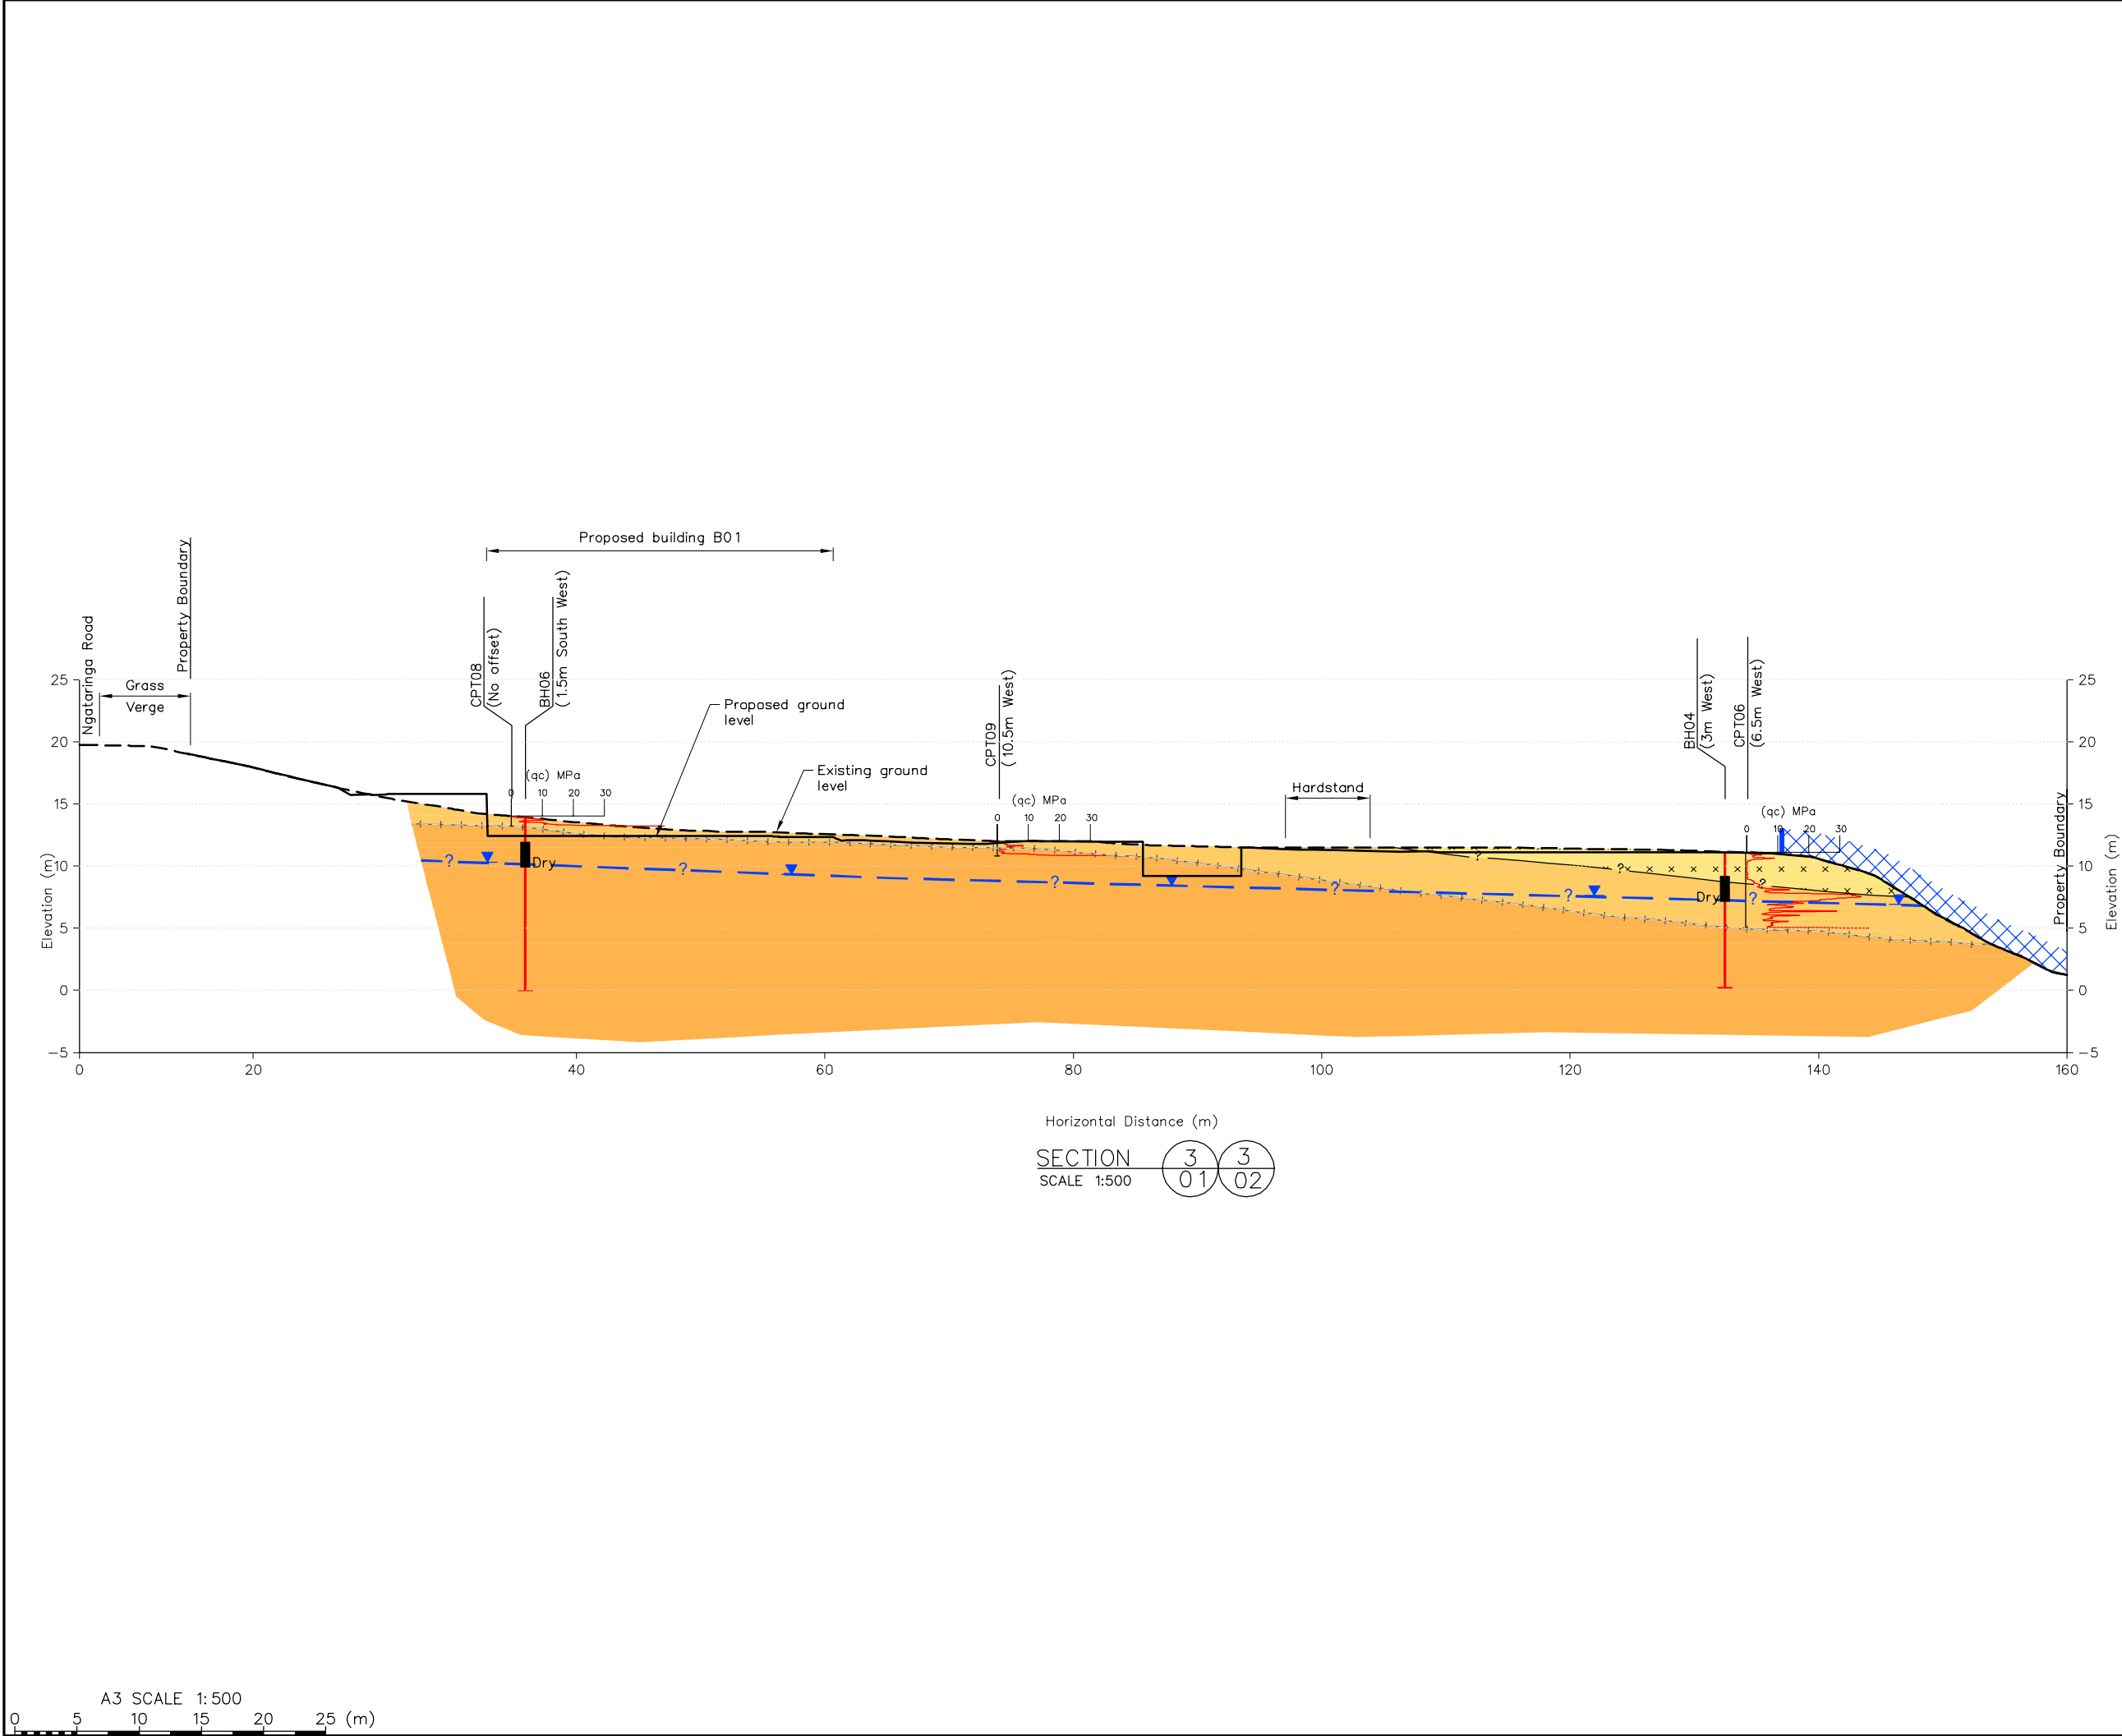
SCALES (AT A3 SIZE) AS SHOWN	
PROJECT No. 29452	
FIG. No. Figure 4	REV. 0

- NOTES :
1. All dimensions are in millimetres unless noted otherwise.
 2. Contours and Cadastral GIS information supplied by Auckland City Council.
 3. Height datum is Auckland Vertical Datum 1946 (MSL).
 4. All test locations are approximate only.
 5. Geological boundaries are inferred, based on geotechnical investigations undertaken at point locations. Actual conditions may vary from the assumed model.
 5. Building layout shown is approximate only and based on preliminary concept drawing by Ryman Ltd. received by Tonkin & Taylor Ltd on 22 November 2013.

Geological
Cross Section 3
(Sheet 2 of 4)
