Ryman Healthcare Limited

Ngataringa Road, Narrowneck

Volume Two

Appendices

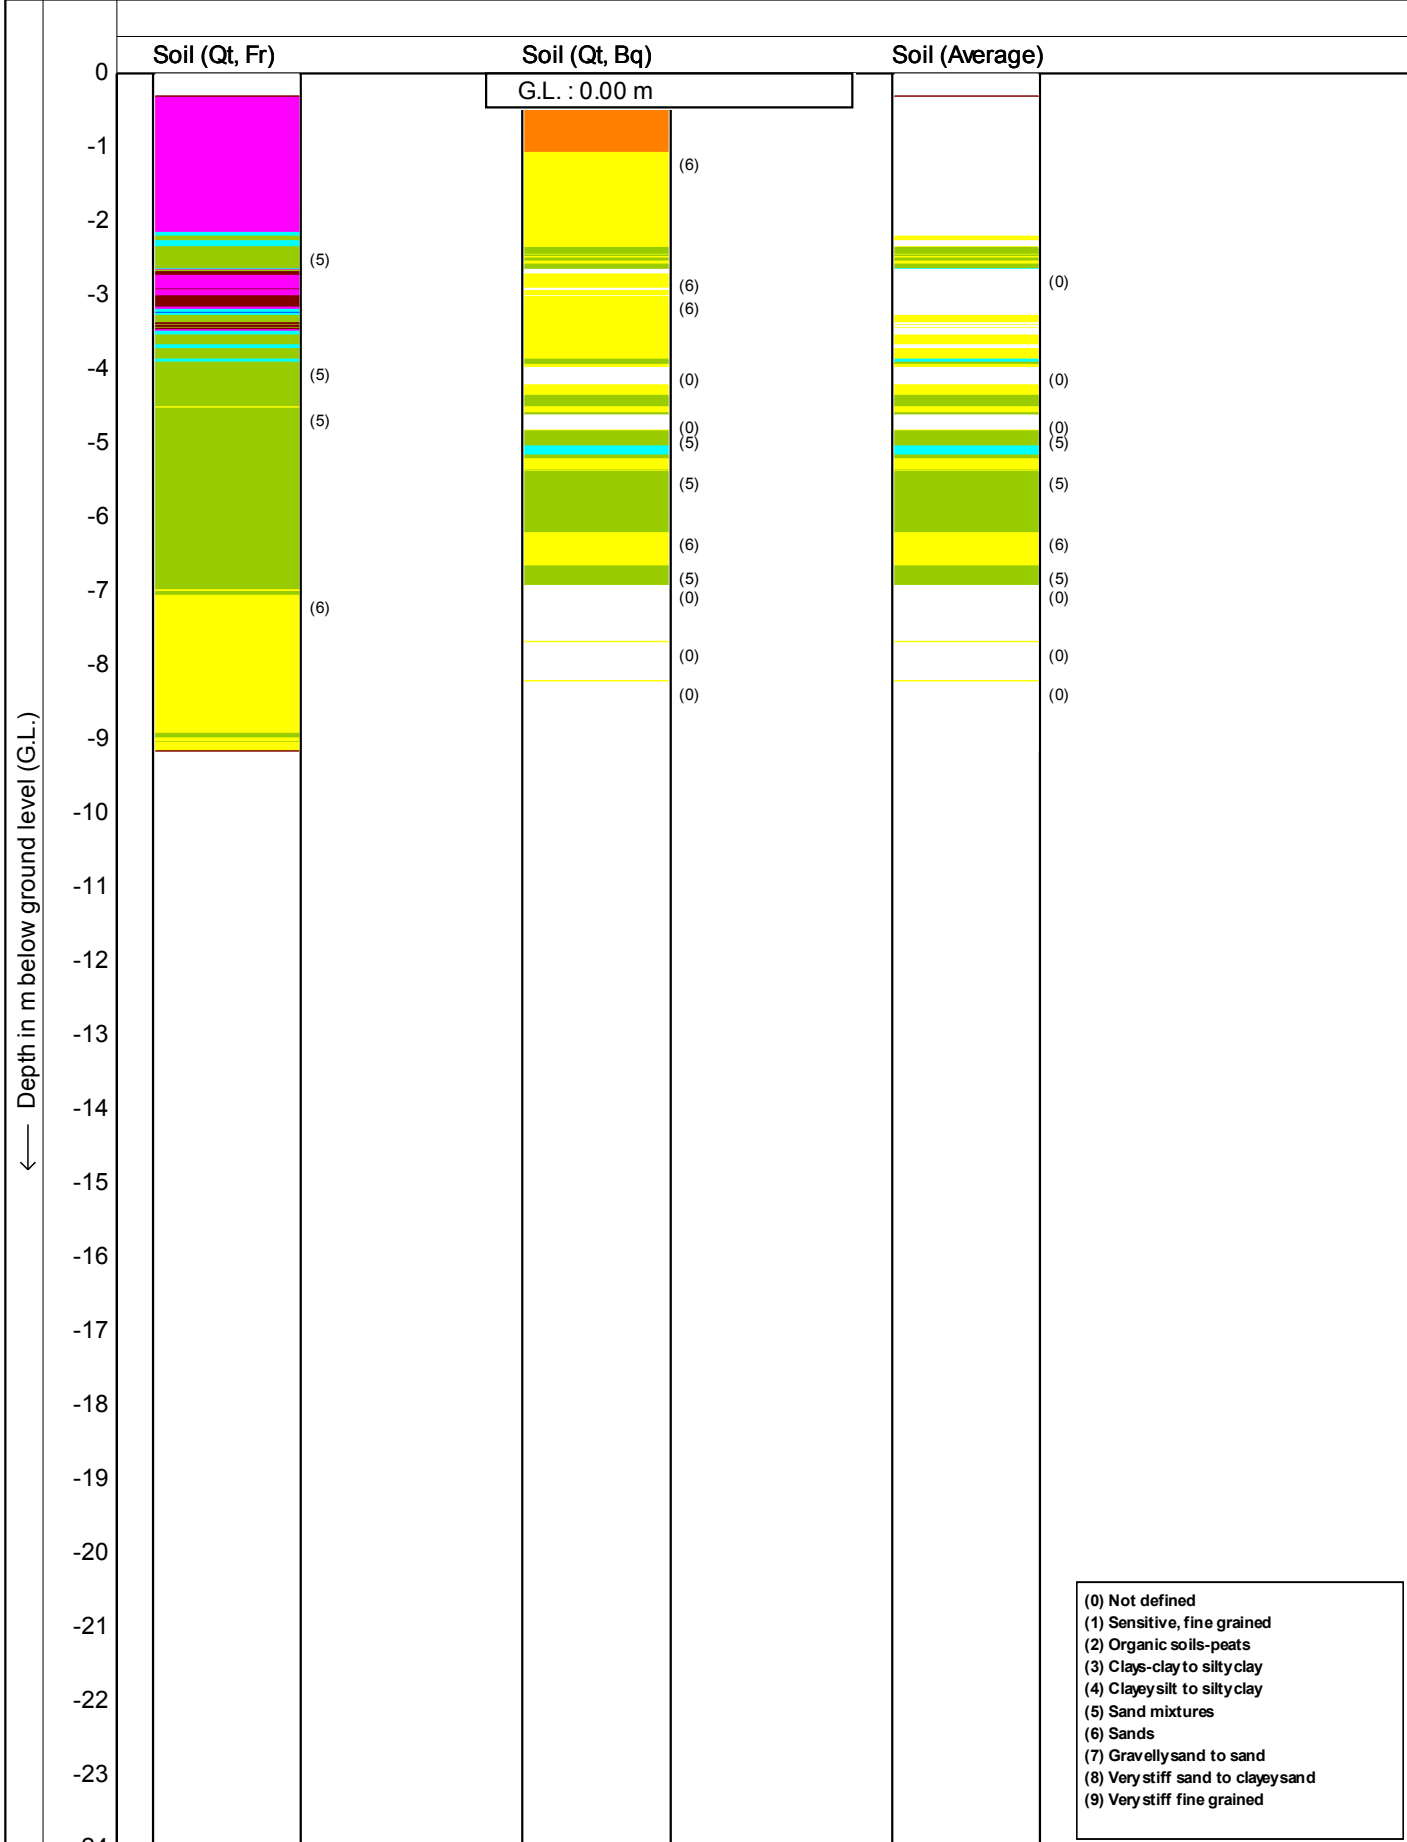
Soil behaviour type classification after Robertson 1990		Test according A.S.T.M. Standard D 5778-12		Date : 5-11-2013	
Project : Site Investigation		Location: Ngataringa Rd - Devonport - Auckland		Cone no. : C10CFIIP.C13184	
Position: 0, 0 RD		Project no. : 05TT17		CPT no. : 01	
				13/14

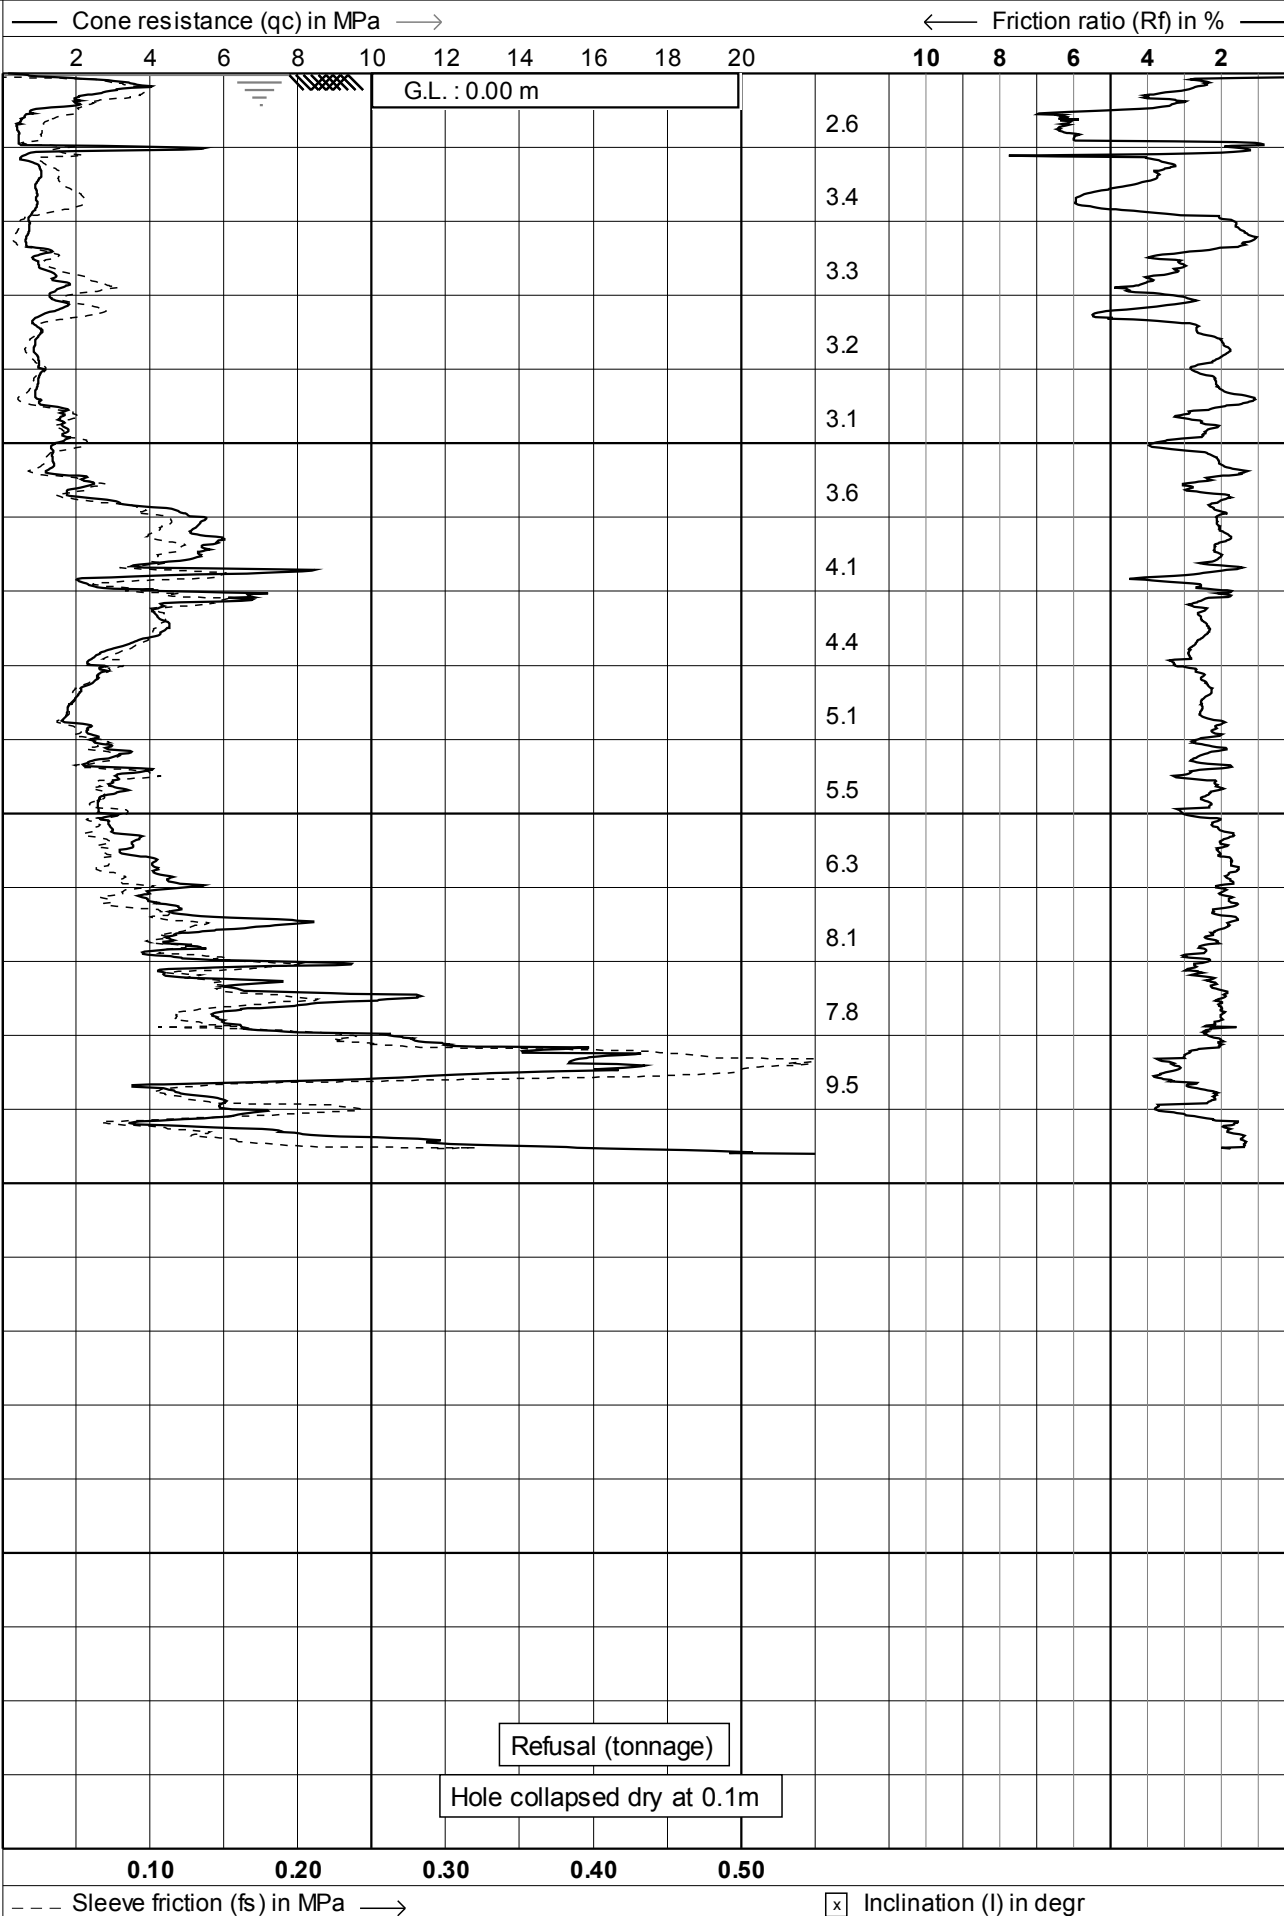
Test according A.S.T.M. Standard D 5778-12
Project : **Site Investigation**
Location: **Ngataringa Rd - Devonport - Auckland**
Position: **0, 0 RD**

Date : **5-11-2013**
Cone no. : **C10CFIP.C13184**
Project no. : **05TT17**
CPT no. : **02**

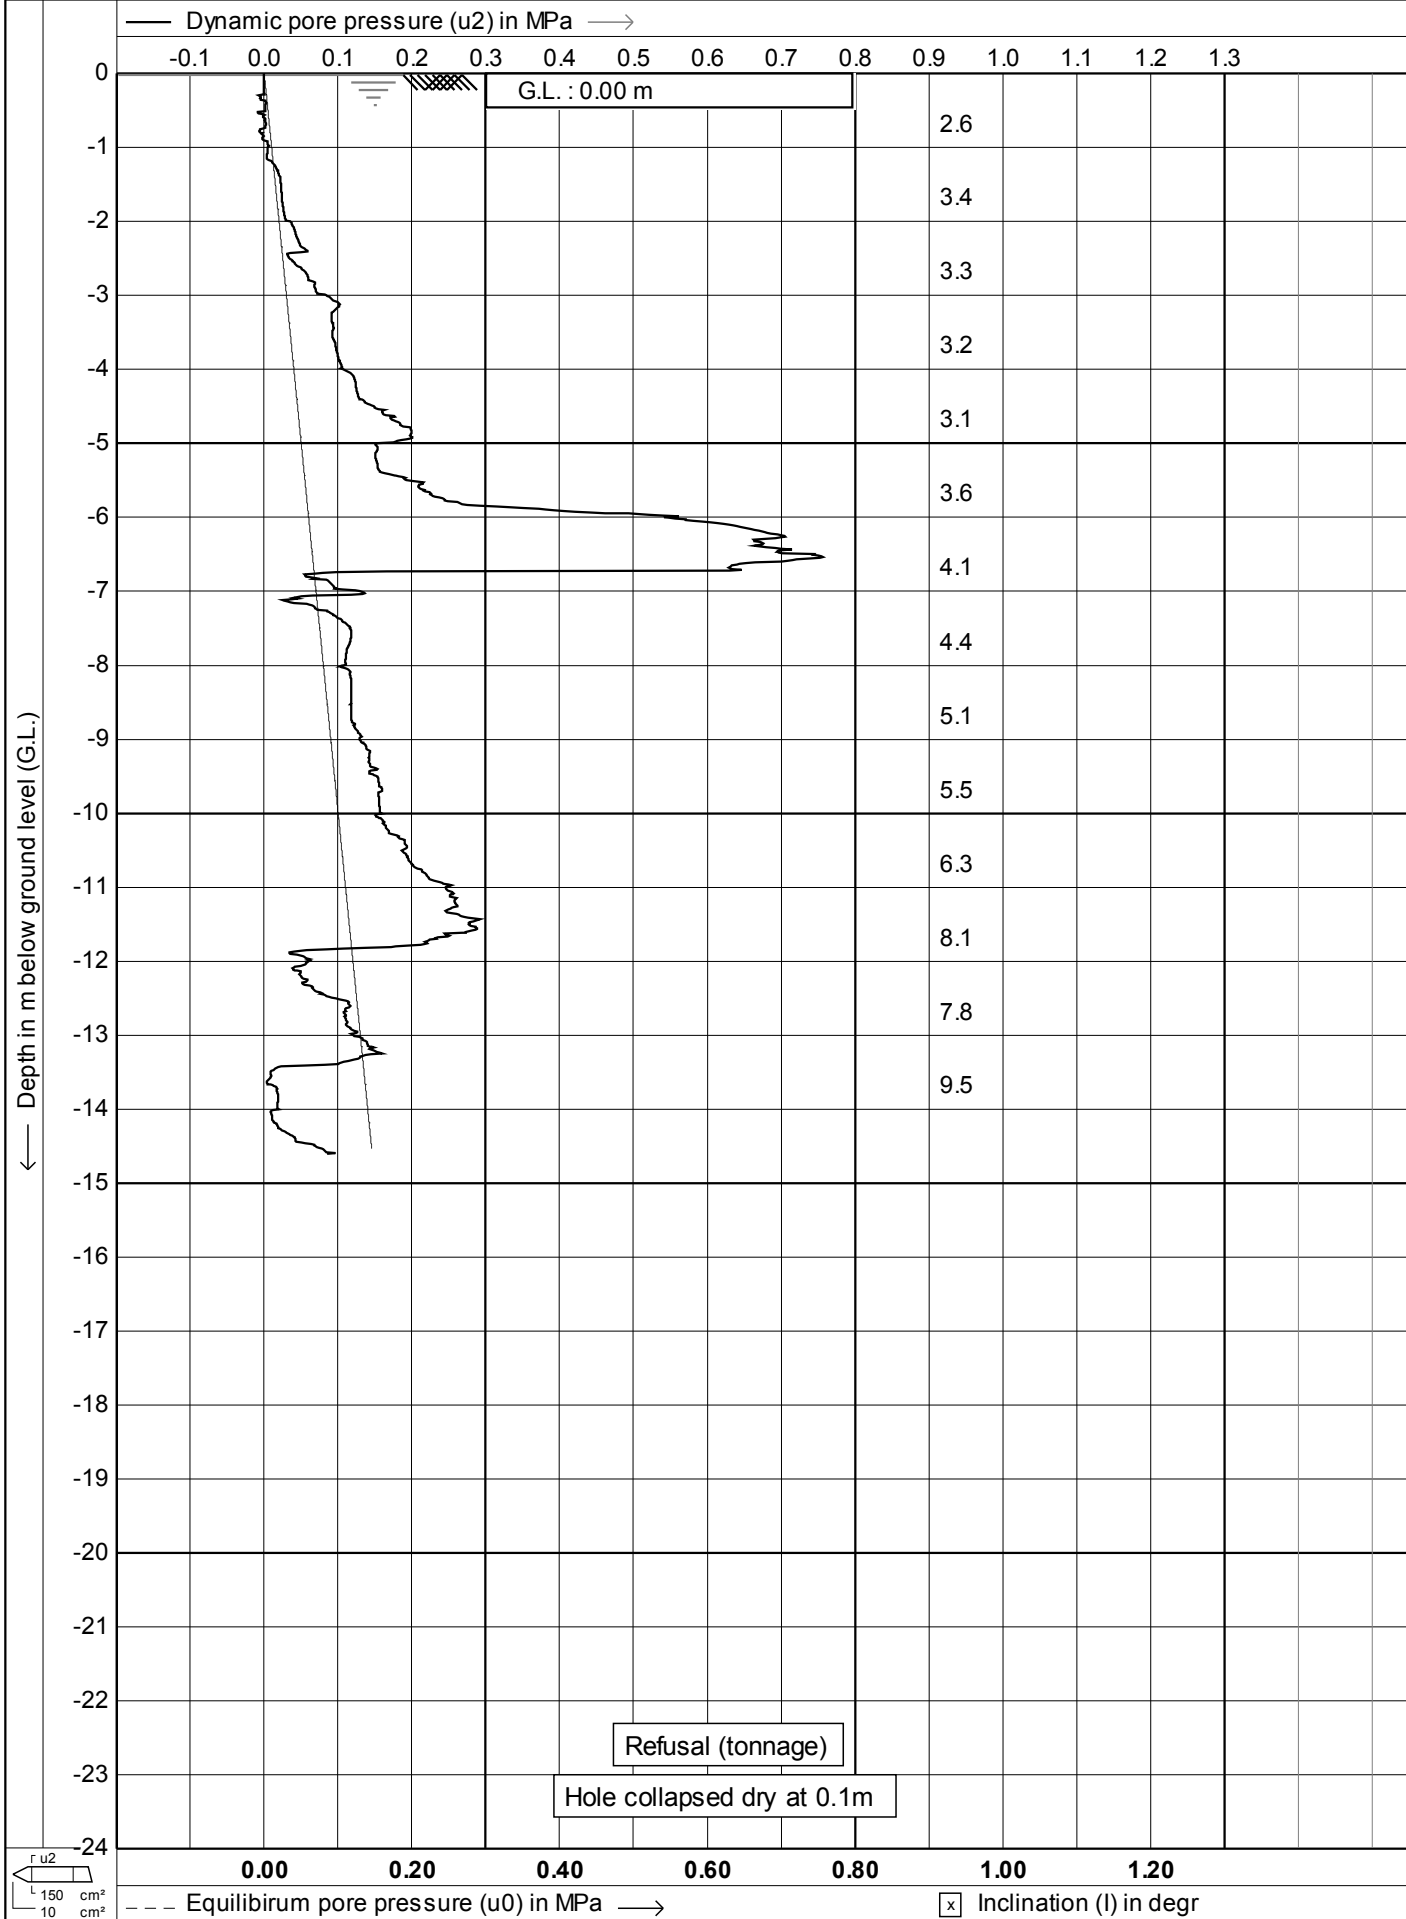
Test according A.S.T.M. Standard D 5778-12		Date : 5-11-2013	
	Project : Site Investigation		Cone no. : C10CFIP.C13184	
	Location: Ngataringa Rd - Devonport - Auckland		Project no. : 05TT17	
	Position: 0, 0 RD		CPT no. : 02	2/14

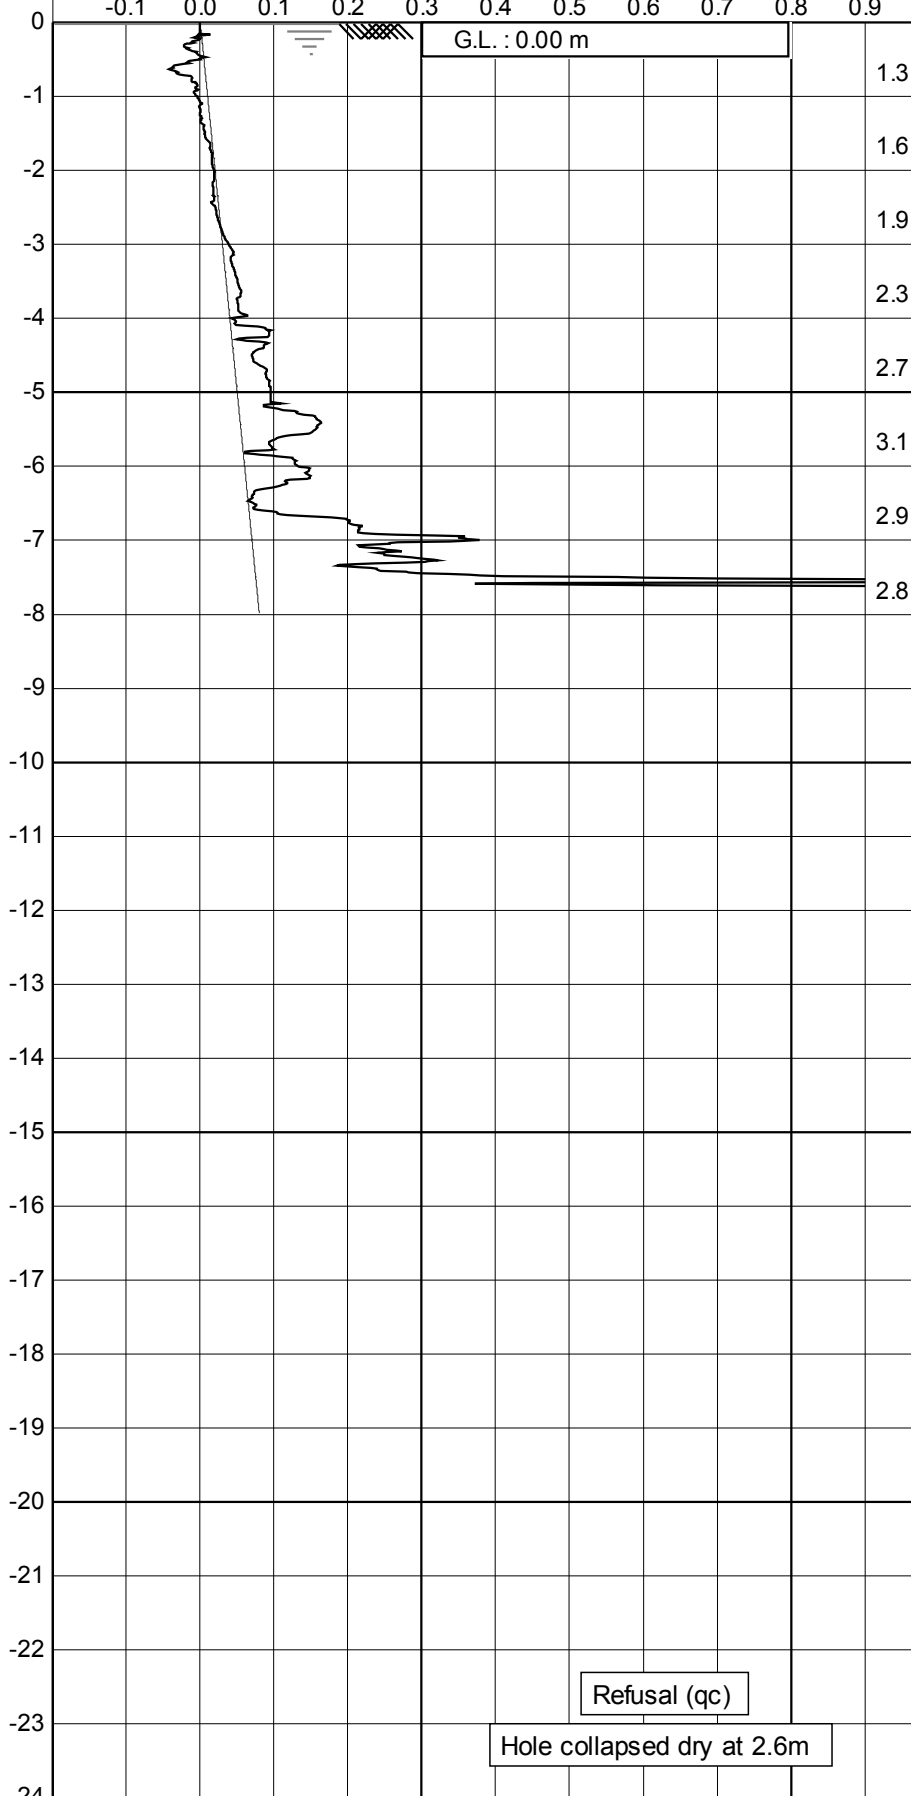
Refusal (qc)

Hole collapsed dry at 2.6m

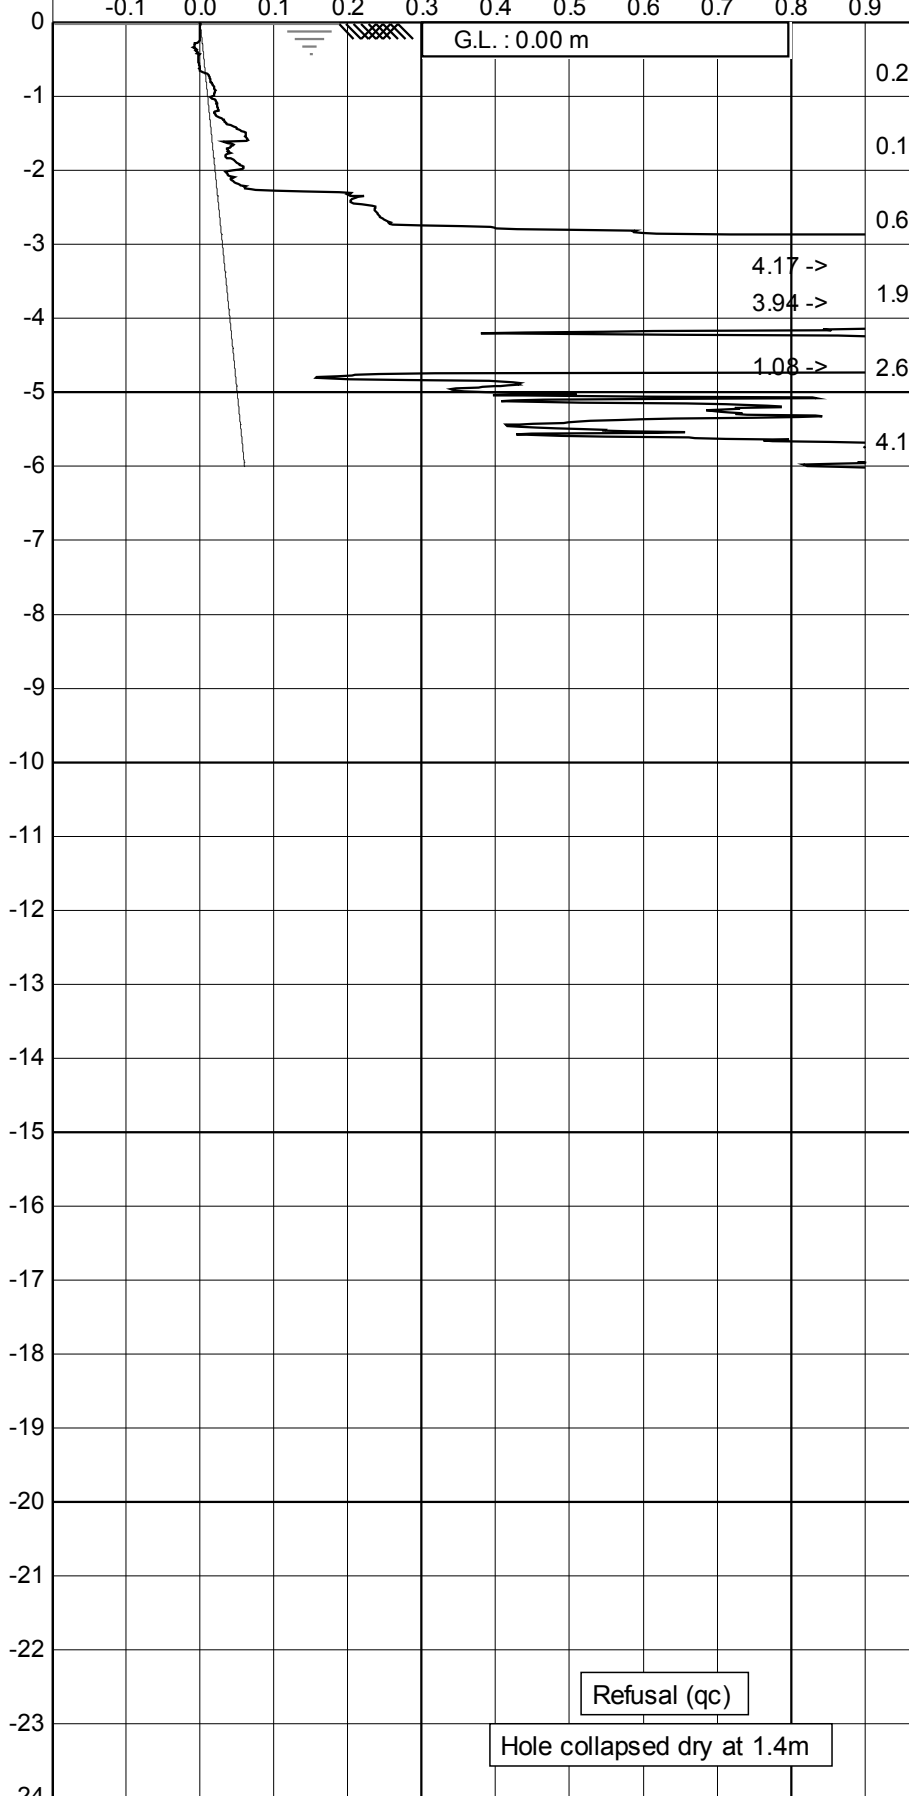
Refusal (qc)

Hole collapsed dry at 1.4m

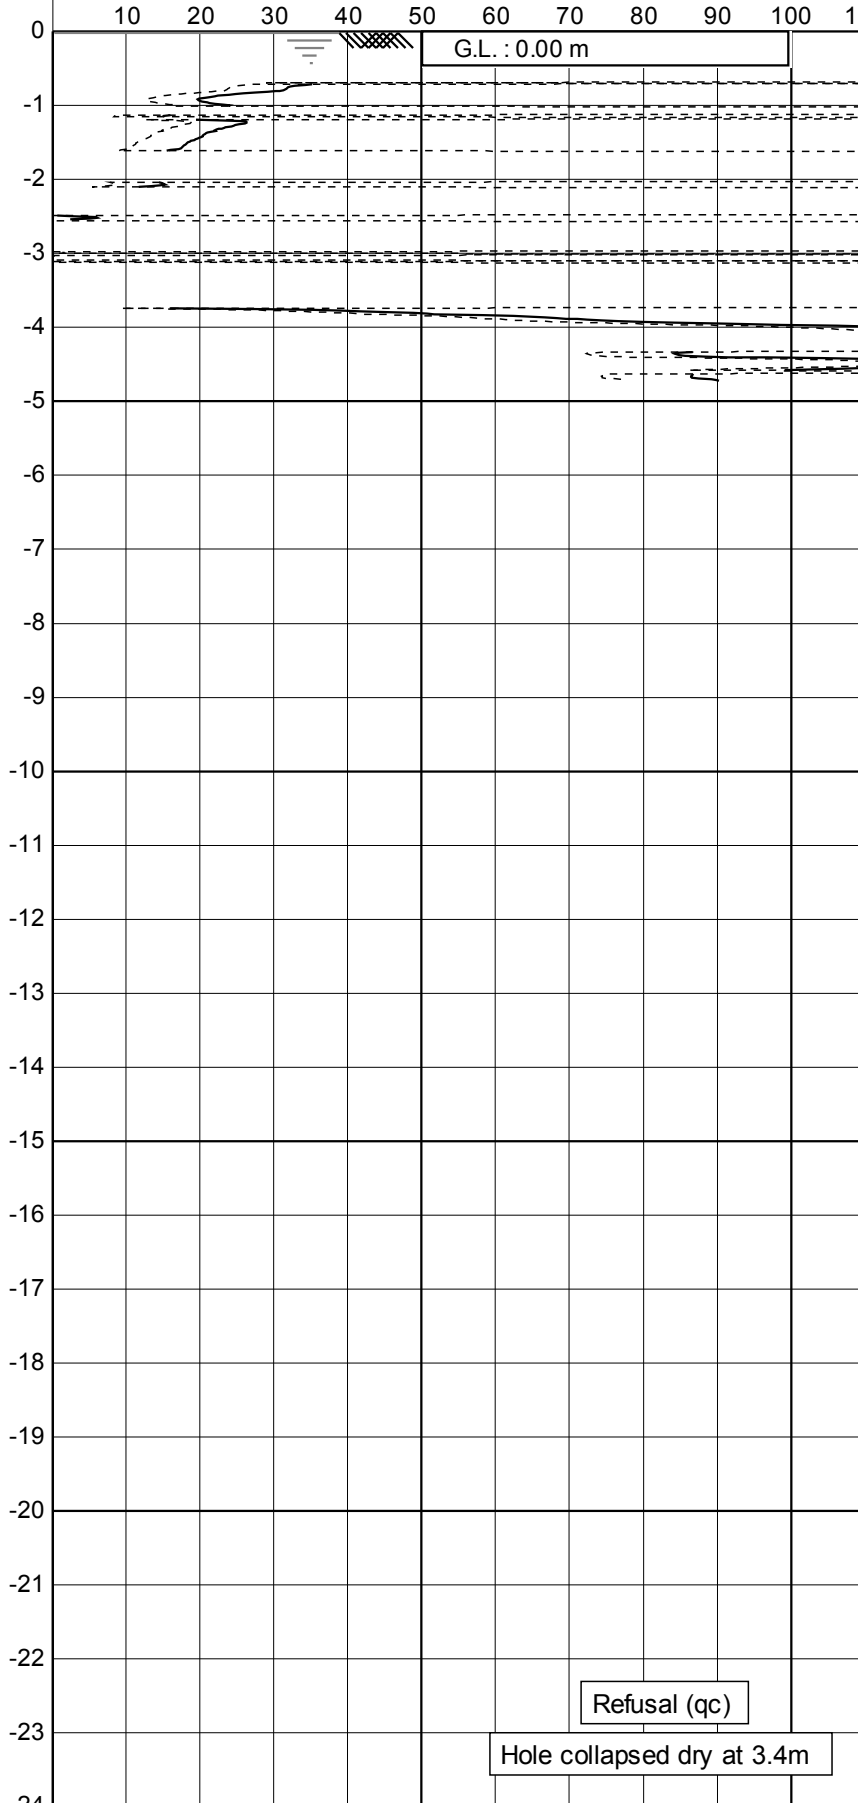
Refusal (qc)

Hole collapsed dry at 3.4m
